Designing a Culvert Management System for the Town of Spencer, MA

A Major Qualifying Project

In Civil Engineering by:

Date: March 26, 2015

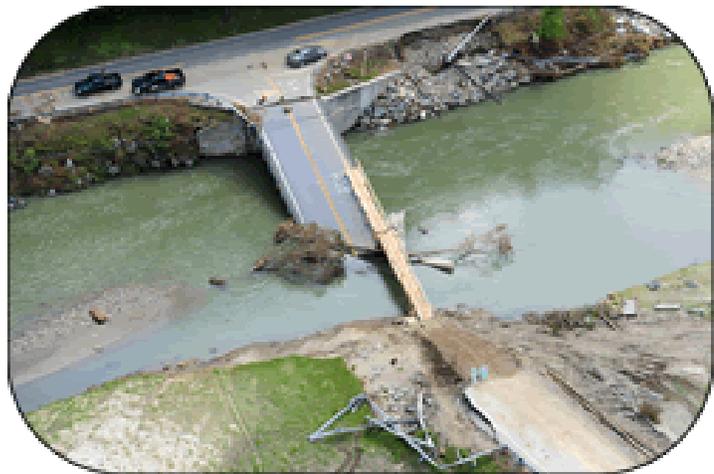
Figure 1: Rochester Bridge in Vermont

The impacts of Hurricane Irene throughout the State of Vermont in August of 2011 were tremendous and daunting simply because of the vast area of destruction. Rivers and streams grew, after 7" of rain in some places, unproportioned to any infrastructure in place. 225

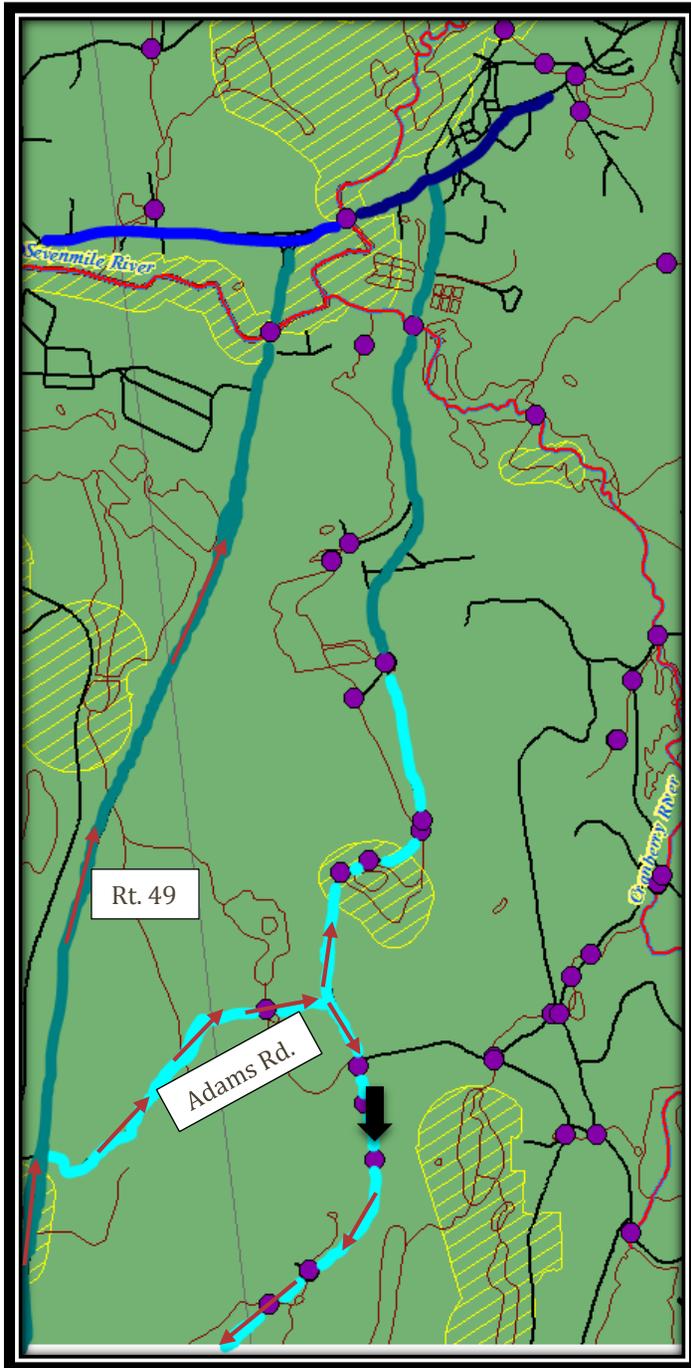
South Spencer Road 3

- ❖ Natural debris clogging at inlet and outlet
- ❖ Strong sulfuric smell in area
- ❖ Cracking in road above culvert

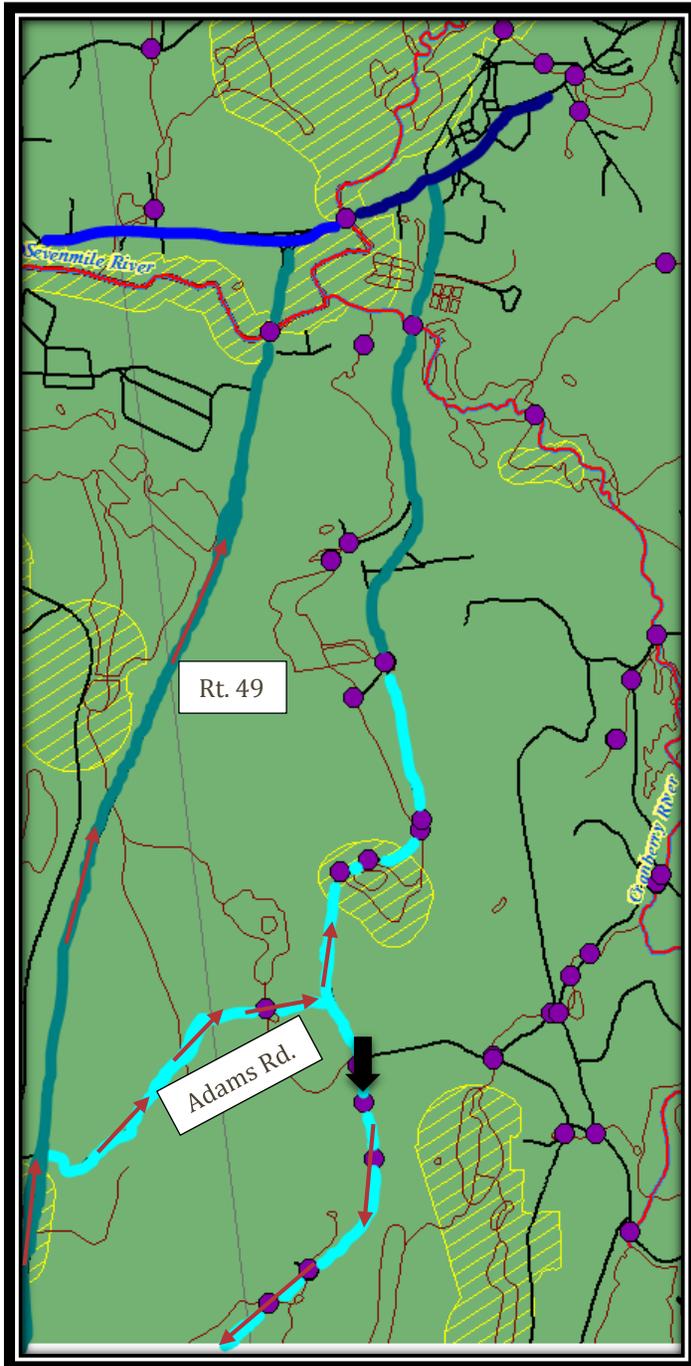
South Spencer Road 4

- ❖ Headwall is in poor condition
- ❖ Road was recently paved above culvert

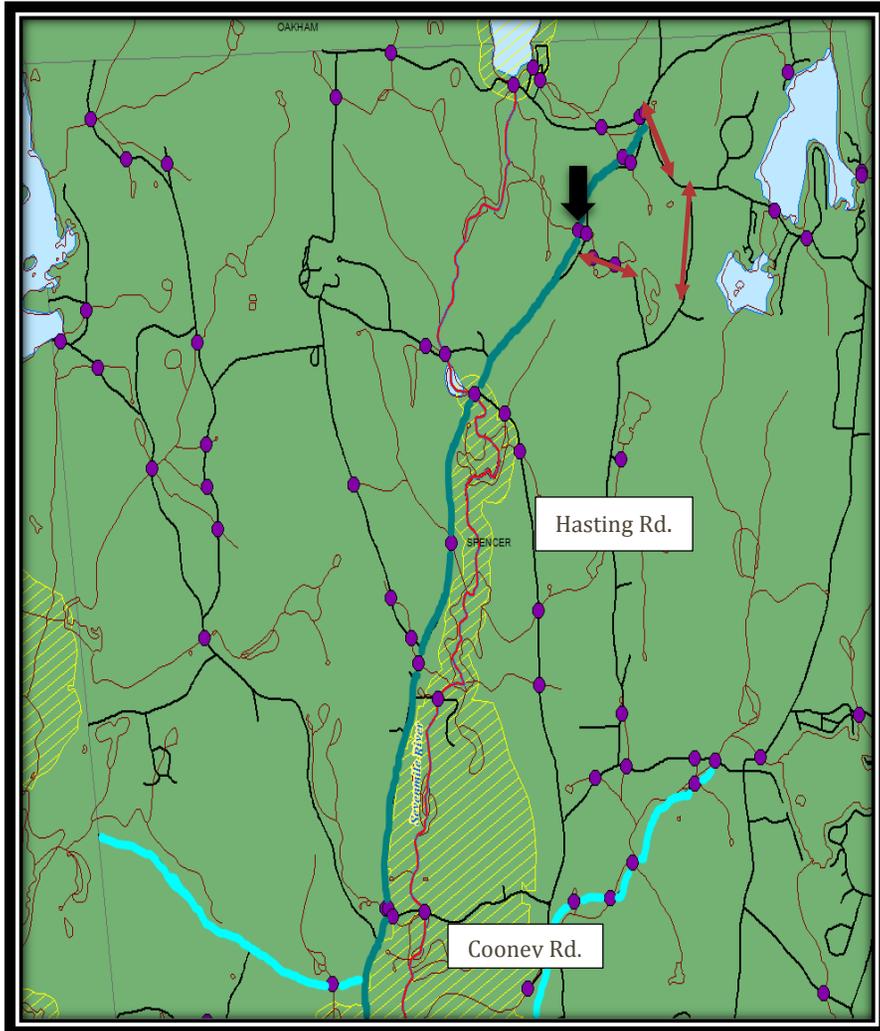
- ❖ This crossing system includes water leading to multiple priority habitats to the North.
- ❖ The detour during construction would lead to the East, down McCormick to Thompson Pond Rd. This adjustment would allow for steady flow of traffic but the road conditions may limit larger vehicles.
- ❖ High elevation levels between the road crossing and the stream bed could make failure a major concern. Lengthy reconstruction time would impact Spencer commuters heading towards Paxton and I-190.

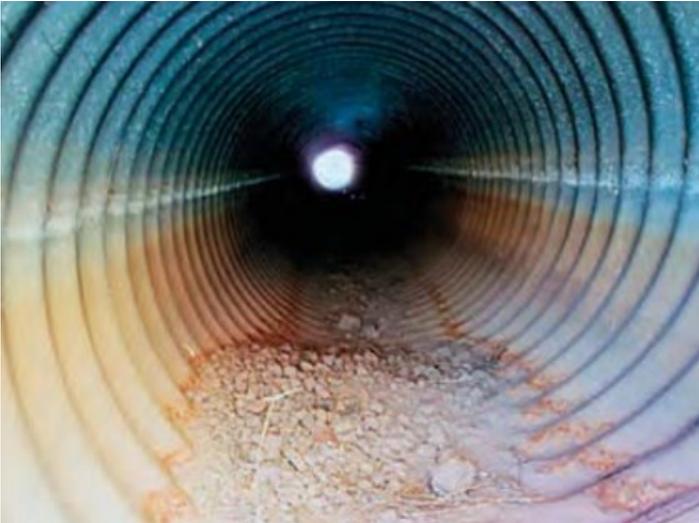
Good

No visual damage or only superficial corrosion or scaling of the invert.<sup>1</sup>

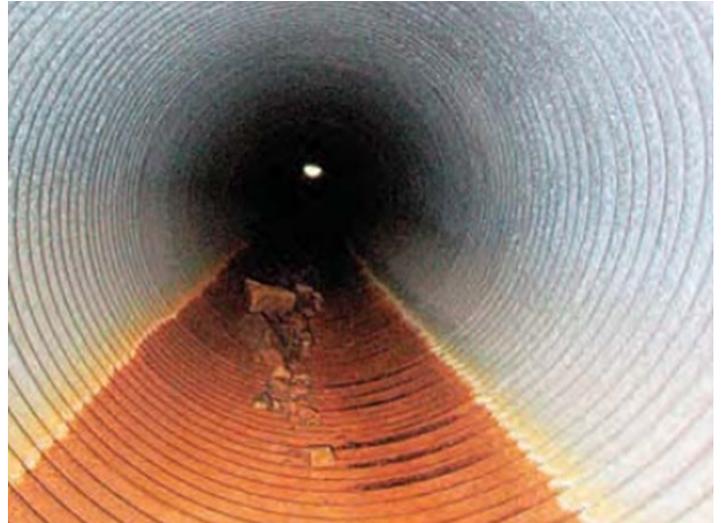
Fair

Minor corrosion and pitting, no holes or distortion. Cannot penetrate metal with sharp point of geology hammer. Minor isolated spalls in concrete.<sup>1</sup>

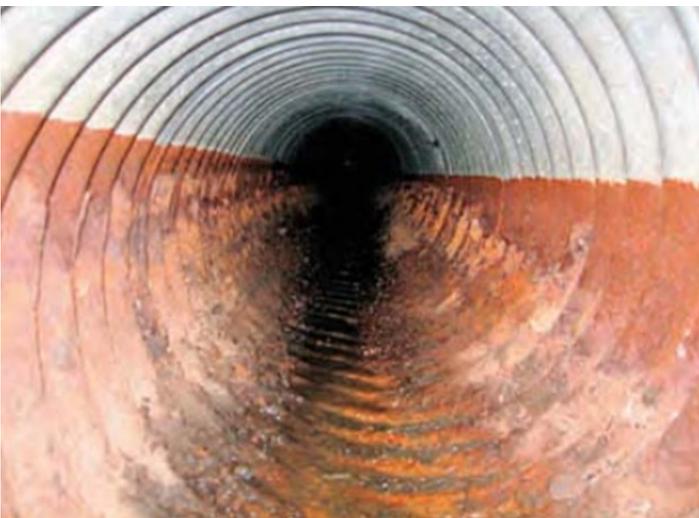
Poor

Perforations visible and/or connection hardware failing (metal). Heavy abrasion and scaling with exposed steel reinforcement (concrete). Heavy abrasion or scour damage (plastic). Displaced mortar and/or blocks, holes in invert area (masonry).<sup>2</sup>

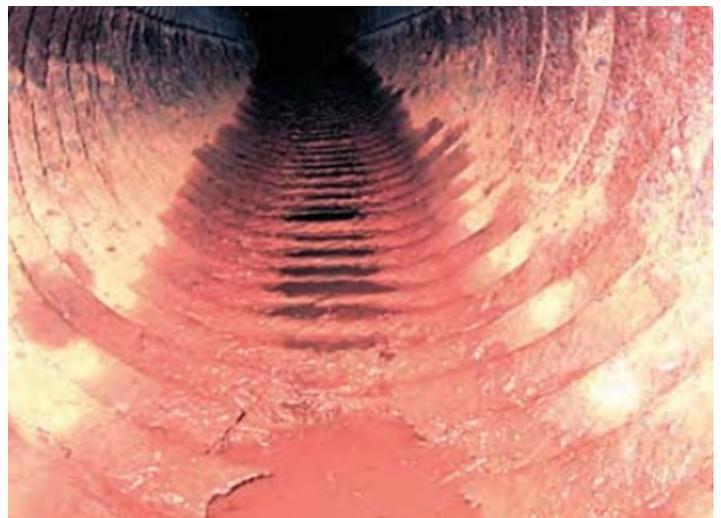
Critical

Holes or section loss with extensive voids beneath invert and/or embankment/roadway damage. Holes and gaps with extensive infiltration of soil, bedding, or backfill material (masonry).<sup>2</sup>

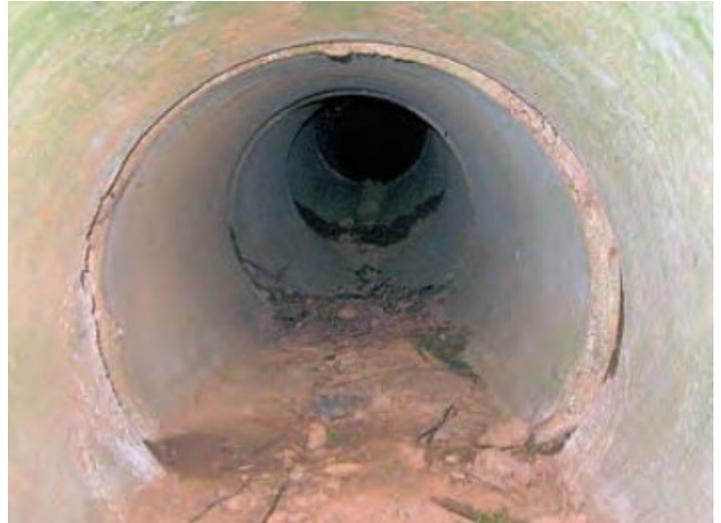
Fair

Minor separation of joints and seams up to 1", minor backfill infiltration.<sup>1</sup>

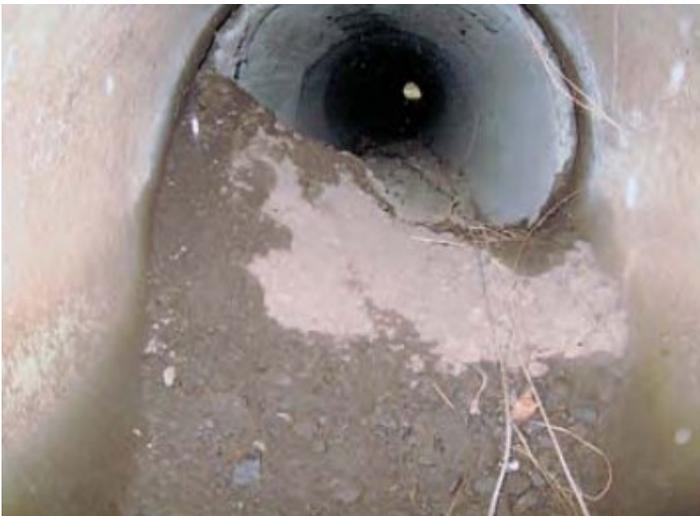
Poor

Significant separation of joints and seams between 1" to 3"; infiltration of backfill into culvert; voids visible in fill through offset of joints.<sup>1</sup>

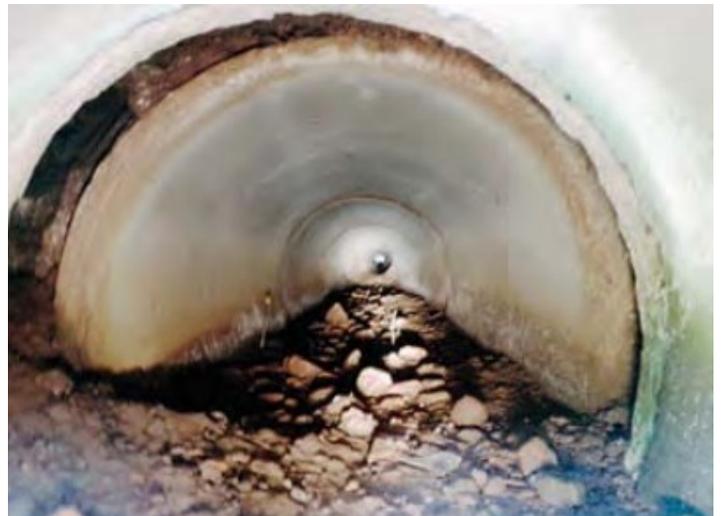
Critical

Severe separation of joints and seams greater than 3"; infiltration of backfill into culvert; large voids visible in fill through offset of joints.<sup>1</sup>

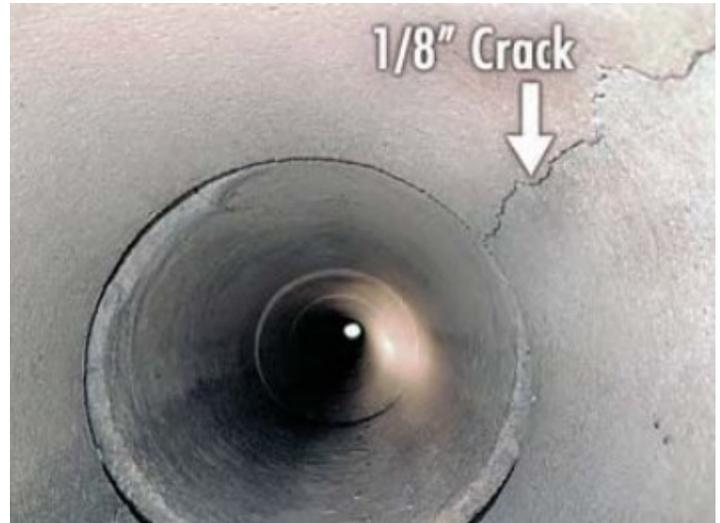
Fair

Longitudinal cracks less than 1/8" in width, spalls up to 1/4" deep.<sup>1</sup>

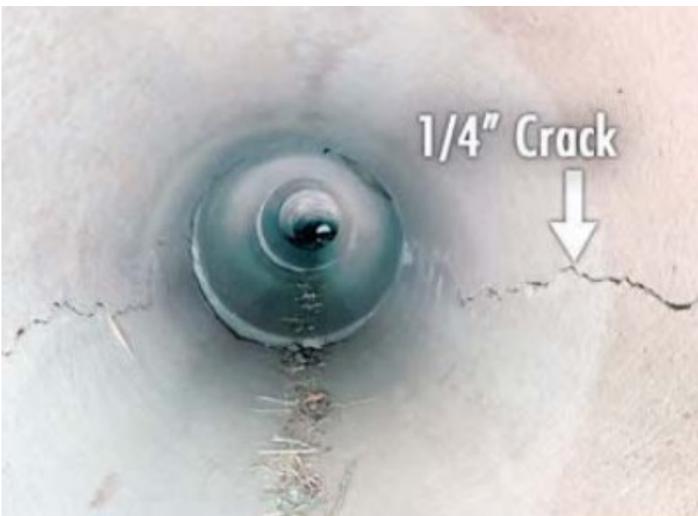
Poor

Longitudinal cracks between 1/8"-1/4" in width, spalls larger than 1/2" deep, and spalls have exposed rebar.<sup>1</sup>

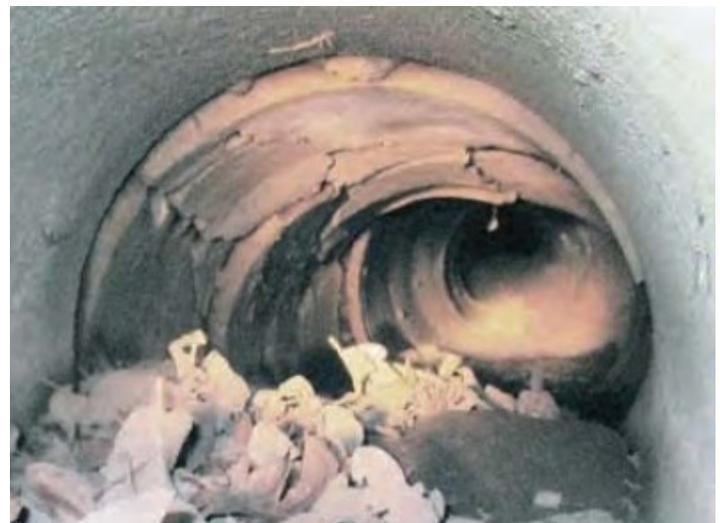
Critical

Severe cracking and spalls greater than 1/2" on culvert walls, sections of culvert are partially collapsed, major corrosion of rebar.<sup>1</sup>

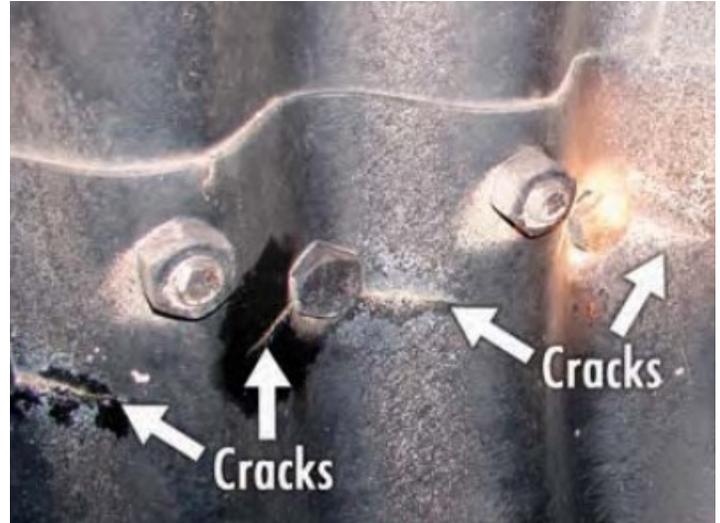
Fair

Minor cracking around bolt holes or seams at isolated sections.<sup>1</sup>

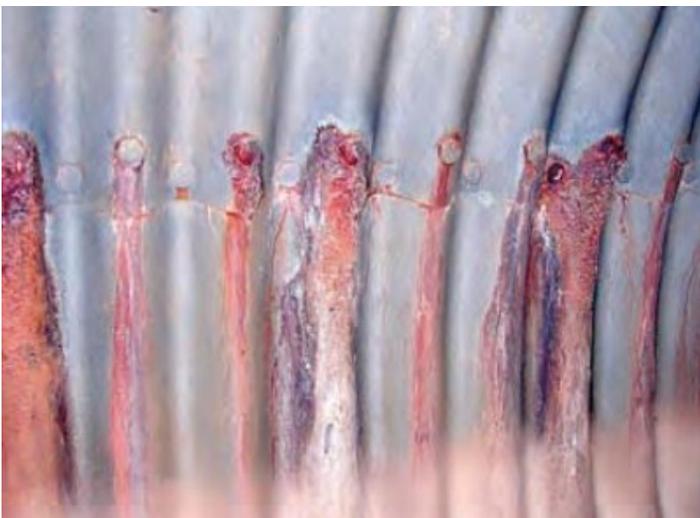
Poor

Significant cracking and/or deterioration along bolt holes and isolated seams of plates.<sup>1</sup>

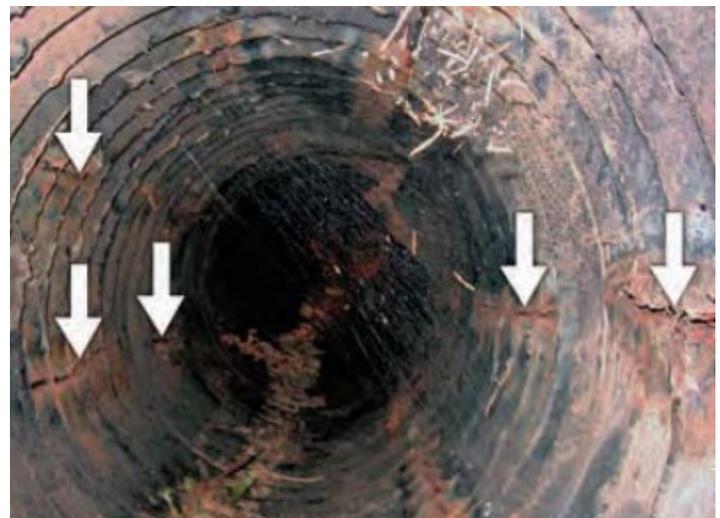
Critical

Severe cracking and or deterioration along bolt holes and along seams of plates.<sup>1</sup>

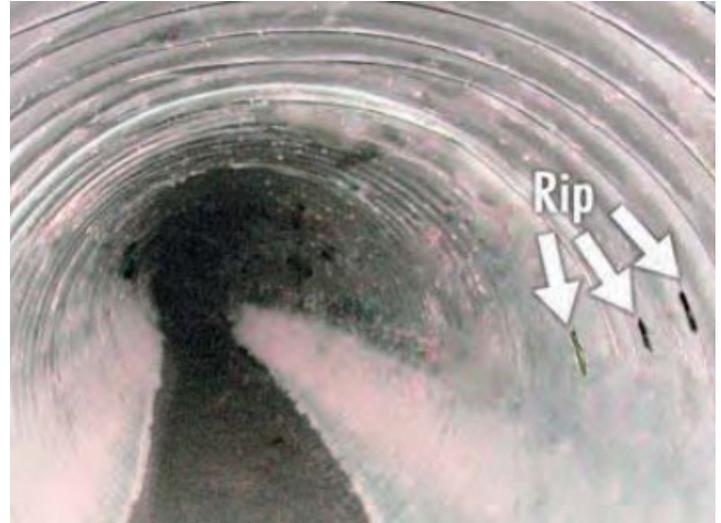
Minor isolated rip or tear caused by debris less than 6" in length and 1/2" in width. Minor cuts or gouges to end sections from maintenance or construction activities.<sup>1</sup>

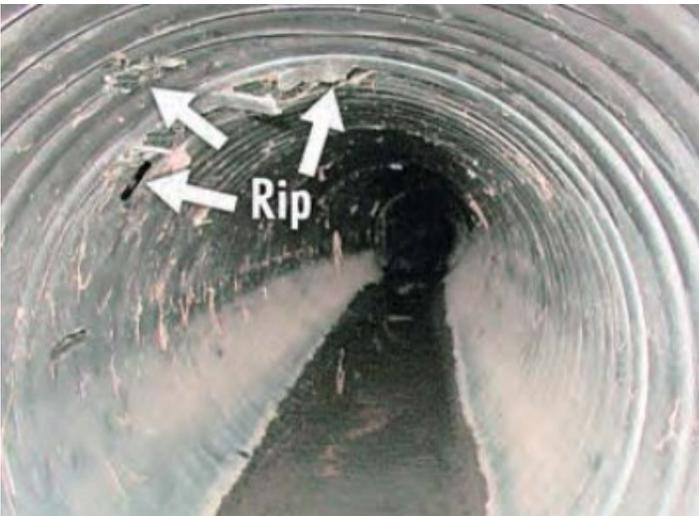
Critical

Cracking, splits or tears over 6" in length and up to 3/4" in width. Openings in pipe causing loss of backfill material.<sup>1</sup>

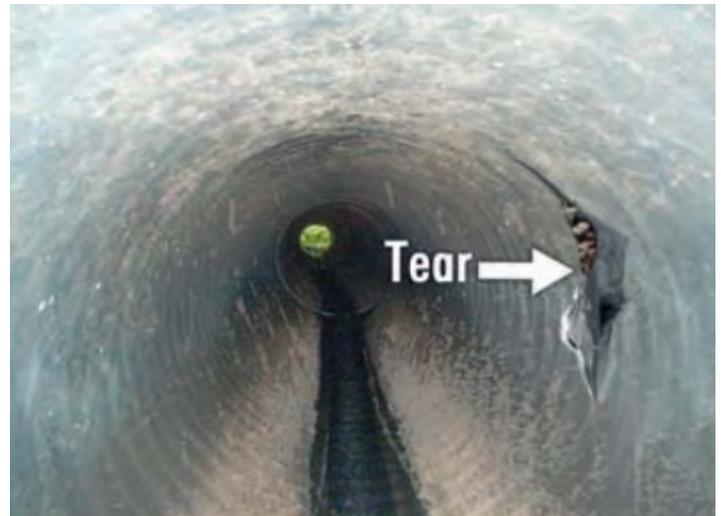
Cracking, splits, punctures, or tears over 6" in length and over 1" in width. Openings in pipe causing loss of backfill material.<sup>1</sup>

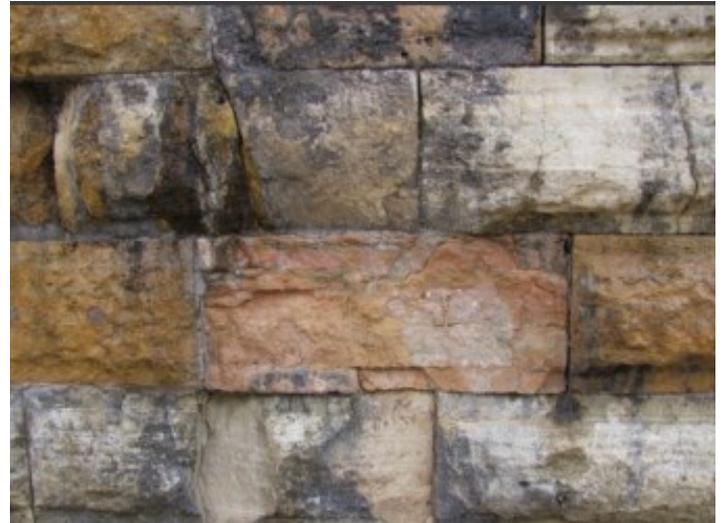
Fair

Minor to moderate deterioration. Masonry may have moderate weathering or cracking (mortar joints may have minor deterioration). Joints may have minor separation, misalignment, or leakage.<sup>3</sup>

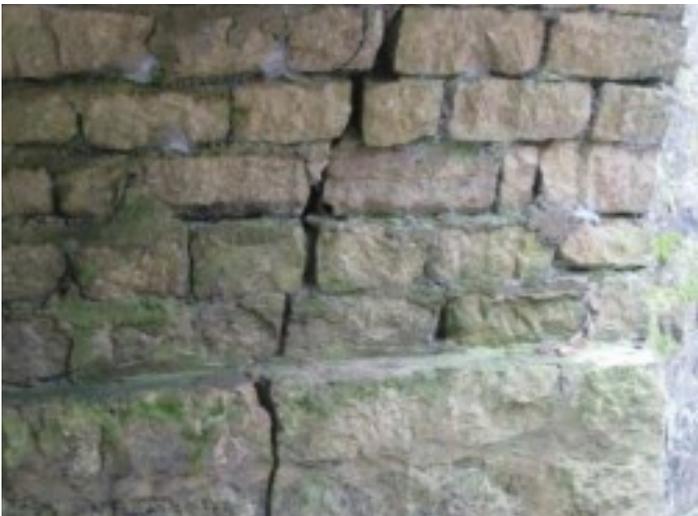
Poor

Extensive deterioration, but the function or structural capacity of the culvert has not been significantly impaired. Masonry may have weathering or cracking. Joints may have significant separation, misalignment, or leakage (there may be evidence of backfill infiltration).<sup>3</sup>

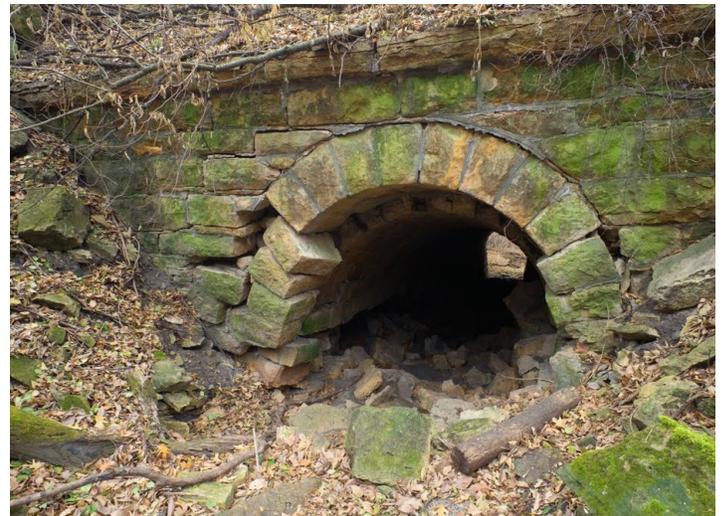
Critical

Culvert has severe or critical deterioration. Function or structural capacity of the culvert has been severely impacted—immediate repairs or structural analysis may be required. Masonry may have severe weathering or spalling. Joints may have severe misalignment or leakage.<sup>3</sup>

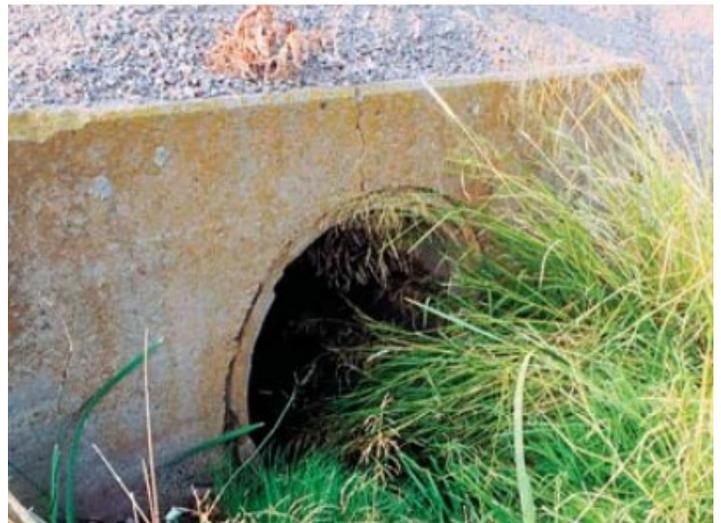
Fair

Minor cracks and spalls in concrete. Minor rotation and/or displacement with gap in barrel seam. Minor footing exposure.<sup>4</sup>

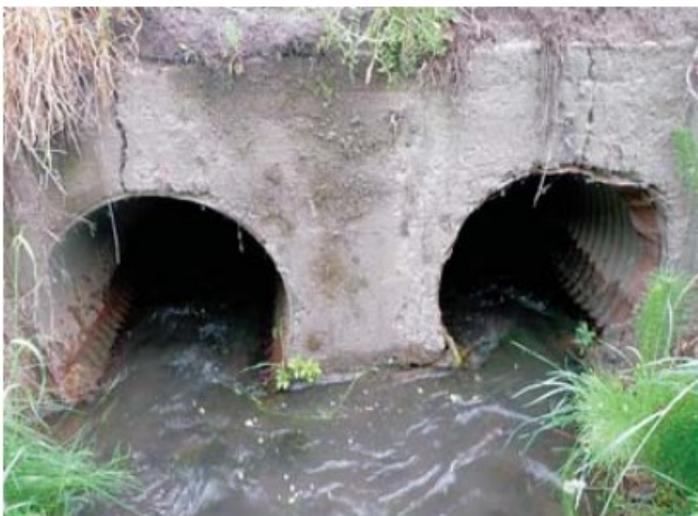
Poor

Area affected by cracking and spalling is >50% and/or rebar exposed. Significant displacement at cracks or wall rotation causing a gap at the wall-to-barrel interface >4". Footing exposed and undermined.<sup>4</sup>

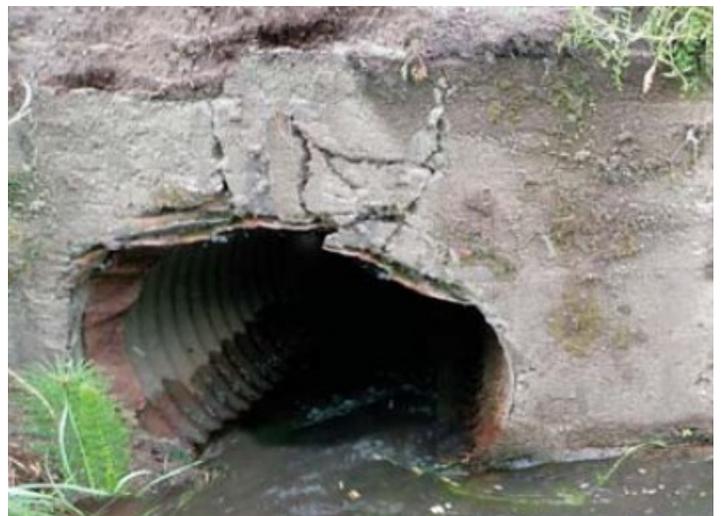
Critical

Partially or totally collapsed, with resultant damage to embankment and/or roadway damage.<sup>4</sup>

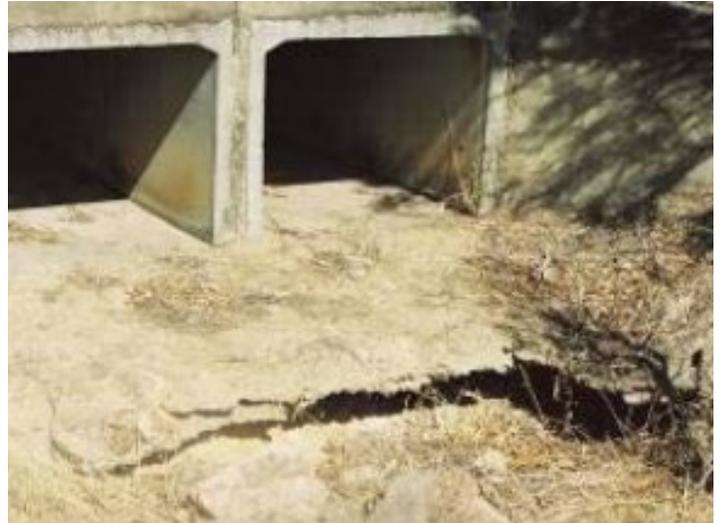
Fair

Minor cracking but no visible piping or undermining.<sup>4</sup>

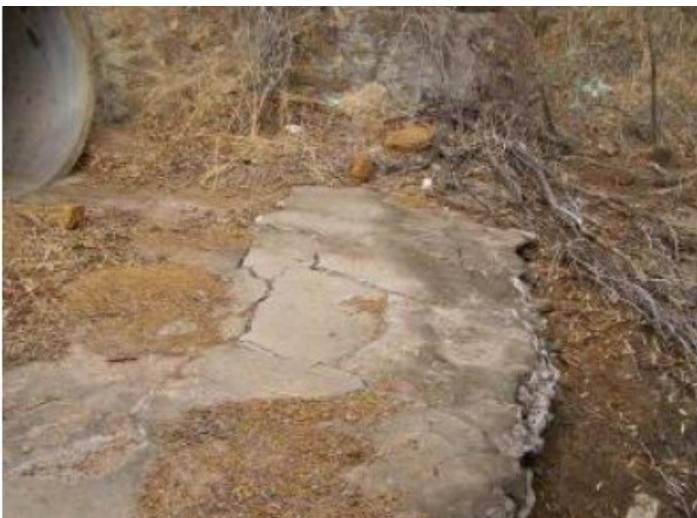
Poor

Significant cracking affects >50% of apron.  
Significant piping or undermining.<sup>4</sup>

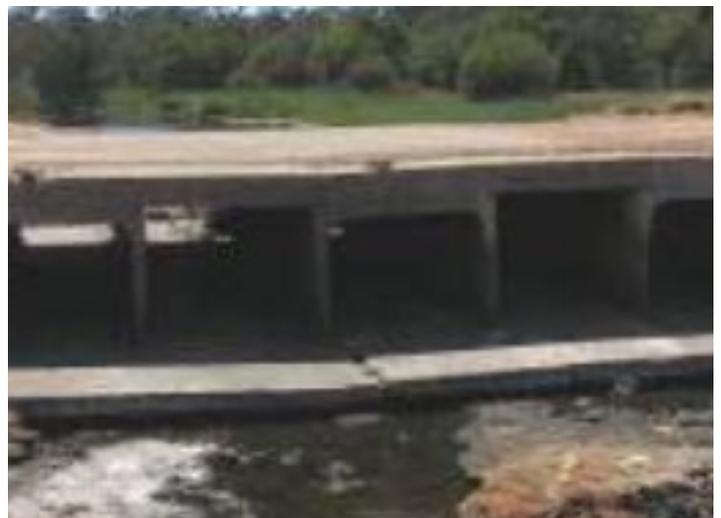
Critical

Partially or totally collapsed, significantly effecting performance and/or causing embankment and/or roadway damage.<sup>4</sup>

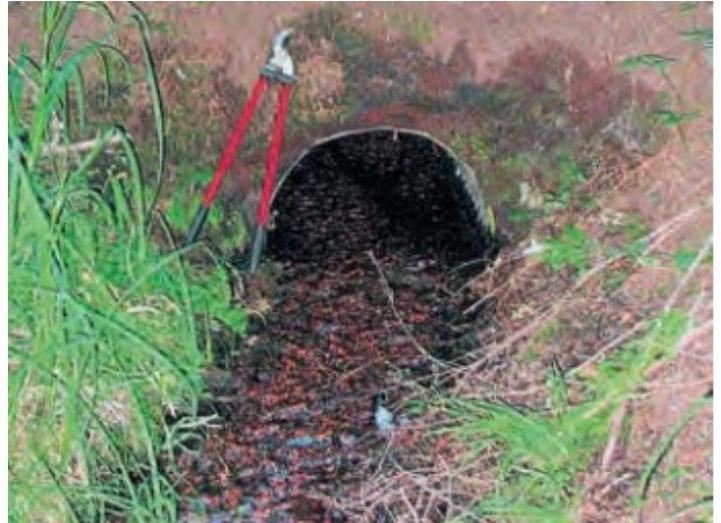
Fair

Embankment moist only in areas surrounding culvert barrel. No evidence of flow or sediment transport observed.<sup>1</sup>

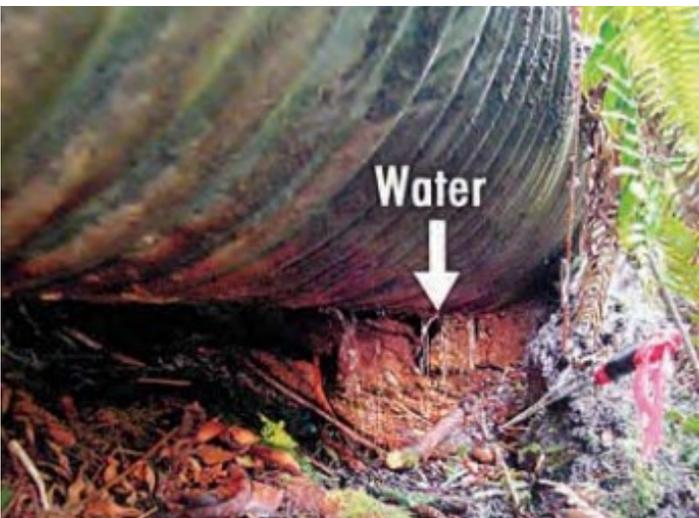
Poor

Evidence of seepage through the embankment along the outside of the culvert barrel, sediment transport not observed.<sup>1</sup>

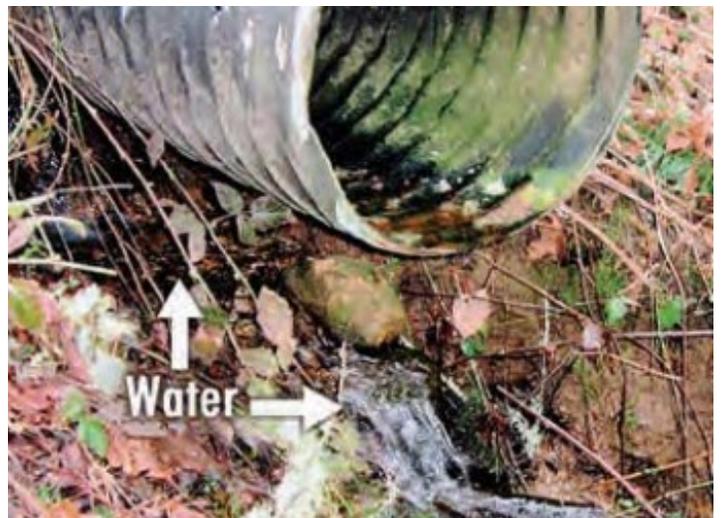
Critical

Evidence of flow through embankment along the outside of culvert barrel. Evidence of sediment transport observed.<sup>1</sup>

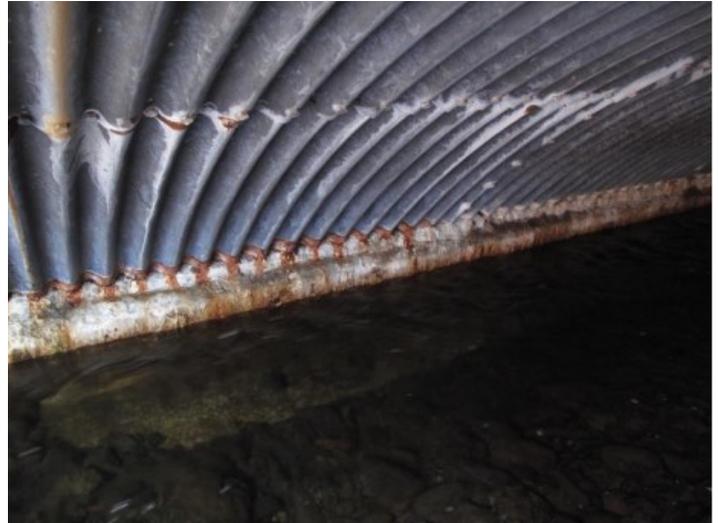
Fair

Minor to moderate deterioration. Concrete - moderate cracking, scaling or leaching (minor delamination or spalling). Masonry - moderate weathering (minor joint deterioration). Slight settlement or undermining. Minor footing exposure.<sup>3</sup>

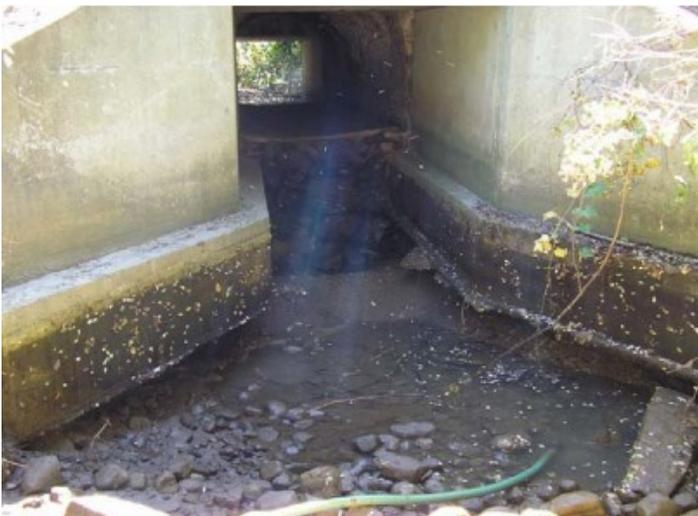
Poor

Extensive deterioration. Concrete - extensive cracking, scaling or leaching (delamination or spalling may be prevalent). Masonry - extensive weathering (significant joint deterioration). Significant settlement or undermining. Footing exposed and undermined.<sup>3</sup>

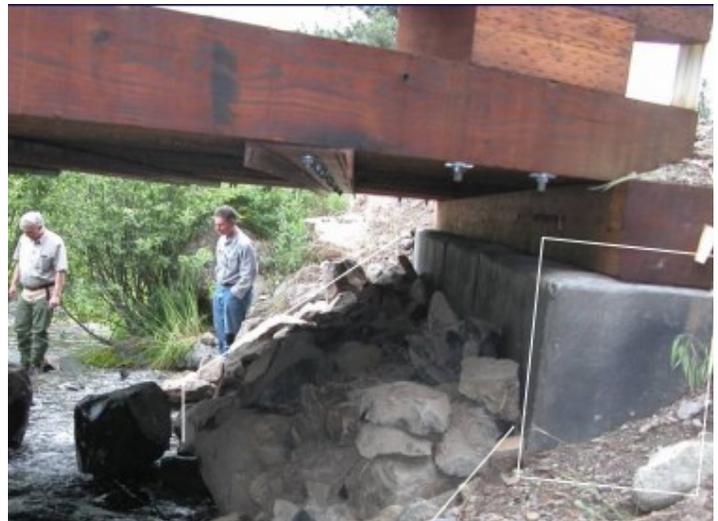
Critical

Severe or critical deterioration. Function or structural capacity of the culvert has been severely impacted - immediate repairs or structural analysis may be required. Concrete - severe cracking, scaling, delamination, or spalling. Masonry - severe weathering (failed joints or displaced masonry blocks) Severe settlement or undermining.<sup>3</sup>

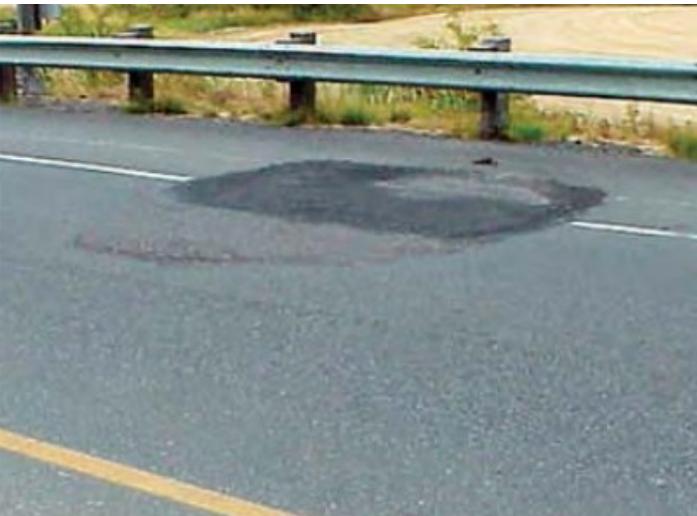
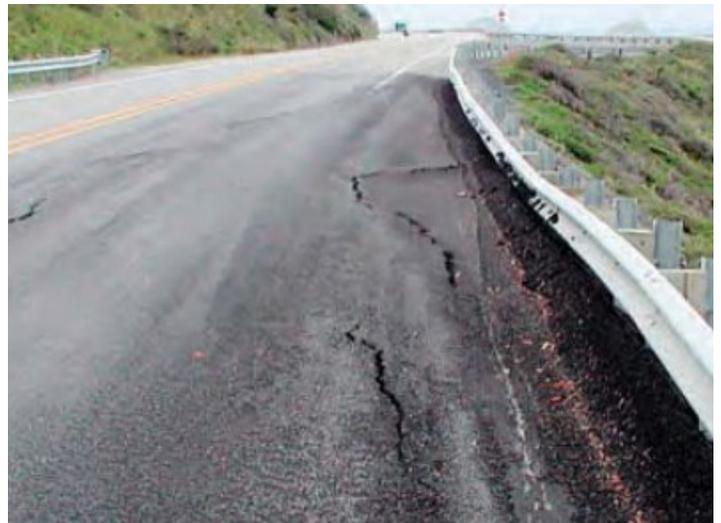
Critical

Significant cracking, spalling, potholes, or maintenance patches affecting up to 20% of any single travel lane or shoulder.<sup>1</sup>

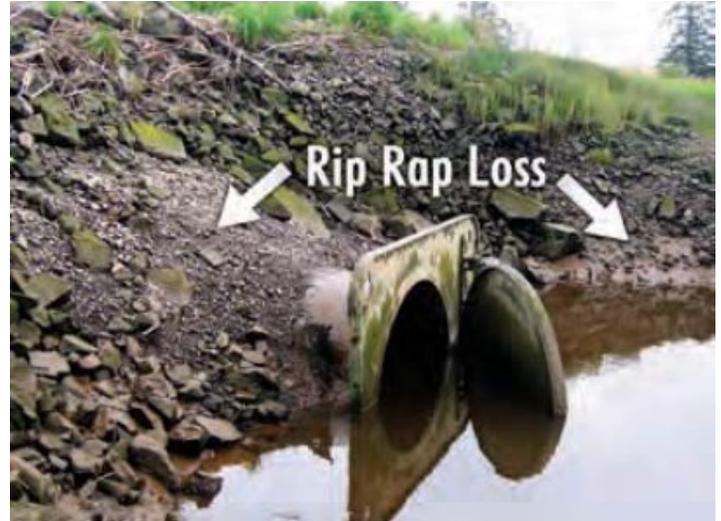
Fair

Riprap starting to wash away, minor erosion, and embankment protection is in need of minor repairs.<sup>1</sup>

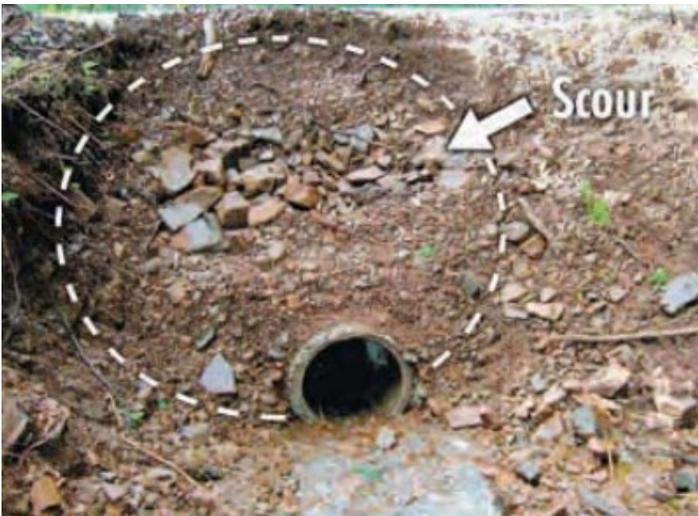
Poor

Embankment protection is severely undermined causing significant erosion of embankment and should be reviewed for repairs.<sup>1</sup>

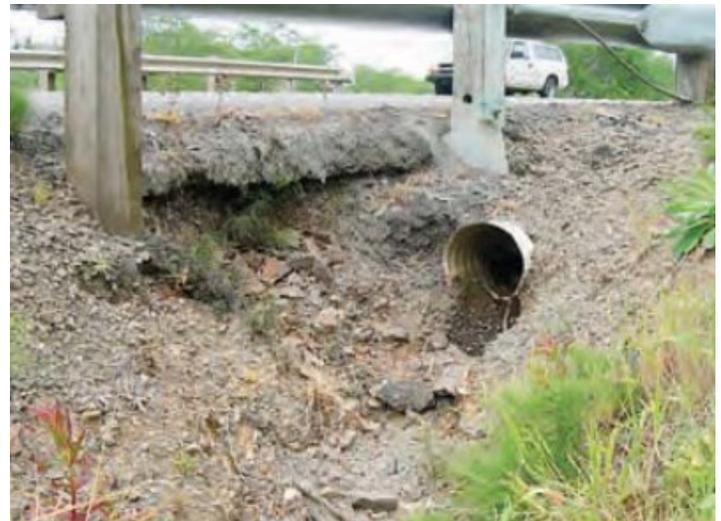
Critical

Embankment protection has failed causing severe scour of embankment and threatening the stability of the roadway embankment.<sup>1</sup>
