20 April 2016

Existing Building Analysis for existing structure:

## **Lake Street School Spencer Massachusetts**

Lake Street School  
Spencer, MA  
Existing Conditions Systems Report  
J#683 001 00.00  
L#511101/Page 1/March 3, 2016

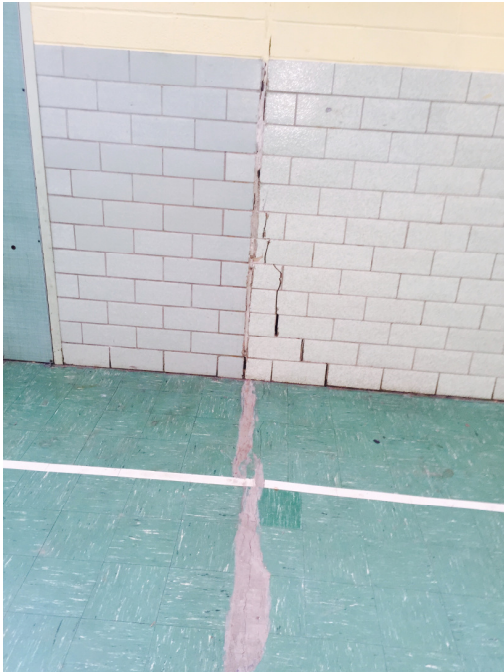
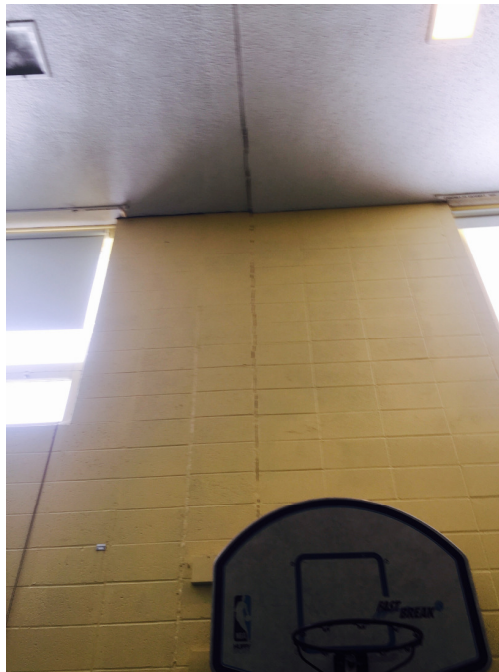
There are areas that exhibit cracking in the finishes as well as the substrate and potentially structure below. In addition to an area in a corridor, there appears to have been significant settling along the line of the extension of the multi-purpose room with cracking evident across the entire line of the addition at the floor, walls and ceiling finish. ***Please refer to detailed structural information contained within this report (Attachment C).***

Cracking at multi-purpose room addition

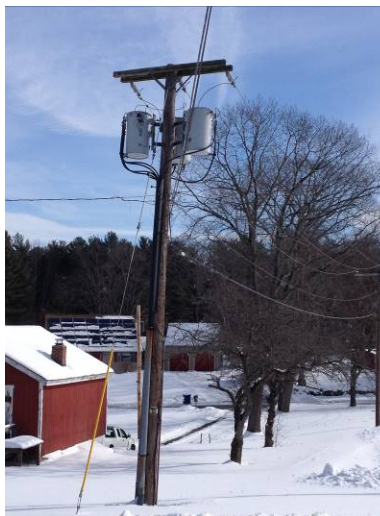
*Pole Mounted Transformers*

The primary three phase service runs overhead to (3) pole mounted transformers with the utility pole located near the boiler room.

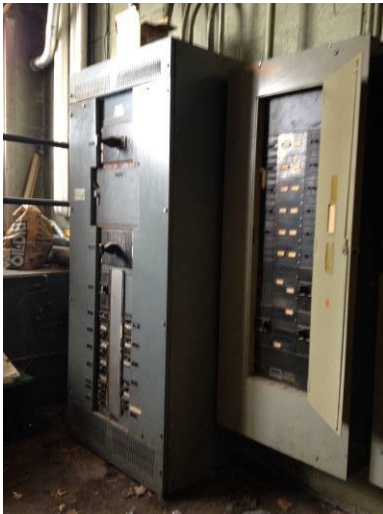
*Switchboard & Distribution Panel*

The secondary service runs underground in (2) 4" conduits between the pole and the switchboard in the boiler room. The switchboard is rated at 800 amperes, 120/208V, 3 phase, 4 wire and is located in the boiler room. The switchboard and most panelboards were manufactured by Federal Pacific during the 1977 addition and are in poor condition. Other panelboards are original to the 1956 building and are also in poor condition. Panelboards are located throughout the facility in none electric closets. Switchgear is obsolete and replacement breakers are difficult to obtain.

The switchgear should be replaced under a renovation program.

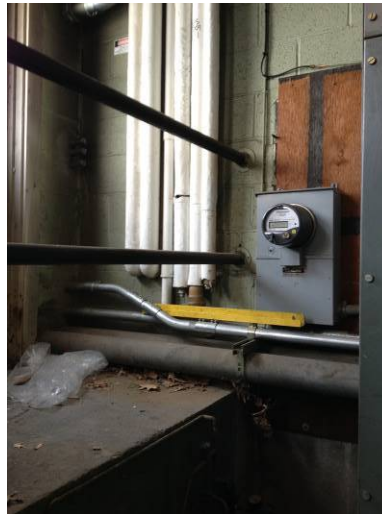
*Exposed Secondary Conduits*

The (2) 4" incoming secondary conduits run exposed through the stair platform within the boiler room prior to connecting to the main breaker; code requires minimum 2" concrete cover over conduits.

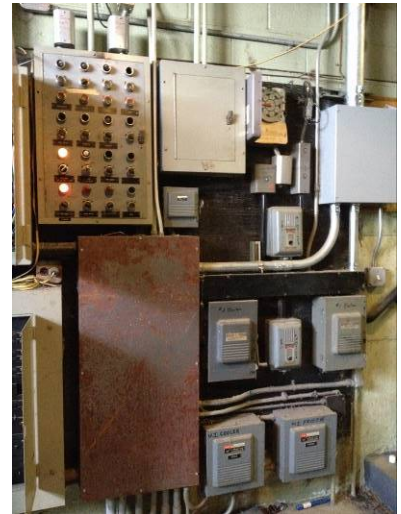
*Motor Controls*

Most motor starters and disconnect switches are also original and in poor condition.

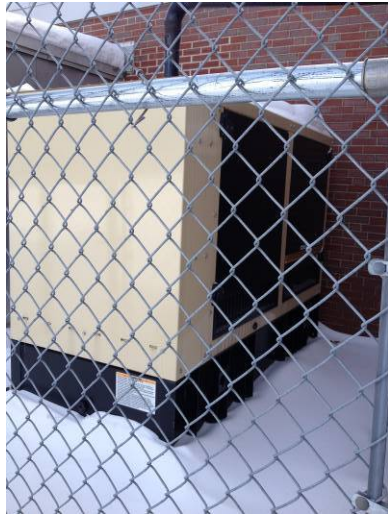
*Generator*

The facility has a 30kW, 120/208V, 3 phase, 4 wire exterior diesel generator with an integral base mounted fuel tank. The generator has a 2 /12" flue pipe to above the roof line.

An exterior automatic transfer switch and panelboard and throughout the facility is located outside the boiler room the emergency system backfeeds the existing emergency panels in the boiler room. The generator and ATS were manufactured by Kohler and are in good condition. The generator is undersized for the facility.

The emergency system should be replaced under a renovation program.

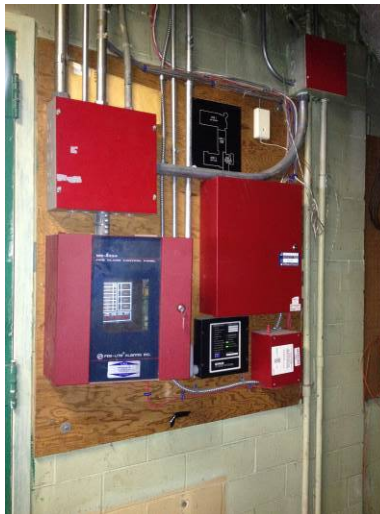
*FACP & Generator Annunciator*

The fire alarm system consists of a Fire-Lite MS-4424, 4 zone, non-addressable control panel located in the boiler room area. The alarm transmission is via a digital communicator to a remote central station.

The fire alarm system offers inadequate coverage of detection and notification devices for a non-sprinklered building. Current code requires voice evacuation in lieu of horns for K-12 Educational Facilities.

The fire alarm system should be replaced under a renovation program.

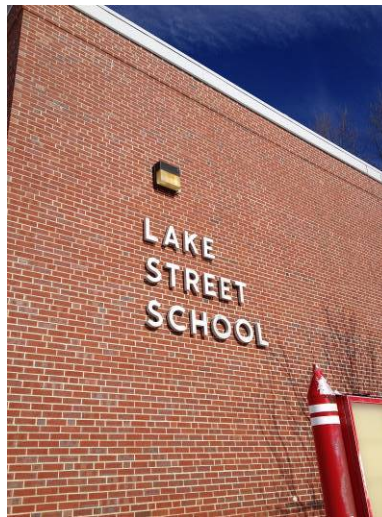
*Wall Pack on Building*

The exterior lighting consists of building mounted HID wall packs. There are no pole lights for parking areas.

Exterior lights should be replaced with LED sources of the cut-off type.

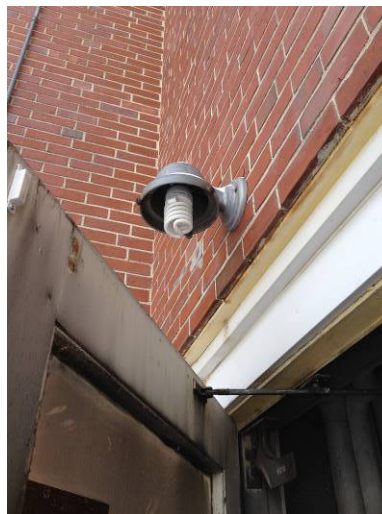
*Wall Sconce Over Door*

Wall sconces over doors have compact fluorescent lamps, some damaged.

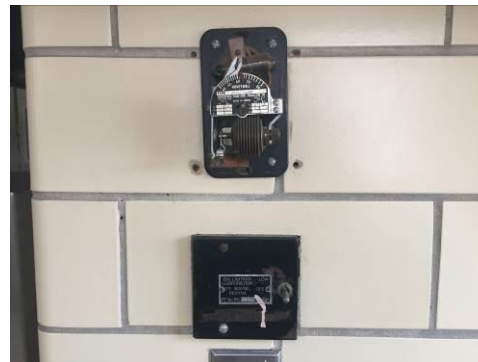
Typical Damaged Thermostat

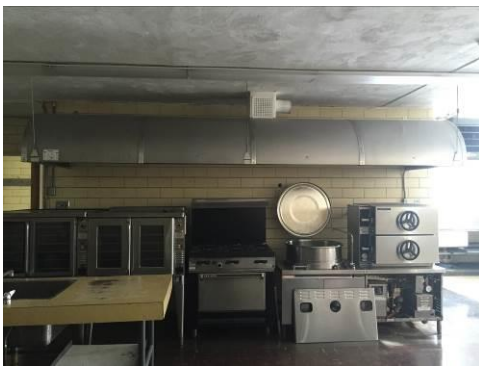
Kitchen Exhaust Hood

The kitchen is equipped with a cooking hood however it does not contain a fire suppression system, it does have a dedicated roof mounted exhaust fan however there is no mechanical ventilation unit for makeup air. Makeup air for the hoods exhaust system is accomplished through a wall mounted louver which opens upon activation of the kitchen hood. The kitchen itself is heated through the use of a vertical style propeller unit heater which is controlled via a standalone thermostats, which does appear to be damaged. The adjacent locker room area is heated with wall mounted fin tube radiation which is controlled via a wall mounted pneumatic thermostat which is damaged. Also located within the kitchen is a dishwashing system, this system is equipped with what appears to be a stainless steel exhaust duct which travels up to the roof. This system appeared to be relatively new however it was unknown if the system was functional. Overall the equipment associated with the equipment within this space does not meet today's standards and code requirements.

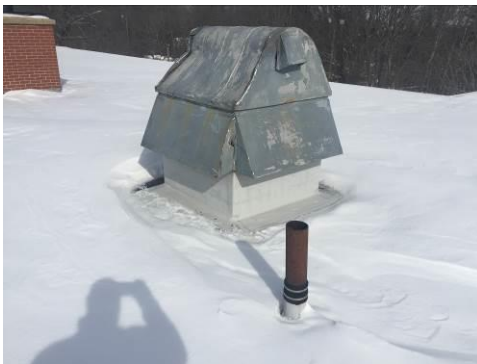
Original Roof Mounted Exhaust Fan

Throughout the building general exhaust is provided through the use of roof mounted exhaust fans. These fans are located in areas such as toilet rooms, storage rooms, custodial closets, mechanical spaces and electric rooms. The manufacture varies and so does the installation date, some fans are original while other appear to have been replaced. All the fans are associated with their own independent galvanized sheet metal duct distribution systems and all terminate within the spaces with ceiling or wall mounted grilles. Overall some fans were operating while others were not, the original exhaust fans appear to have reached the end of their serviceable life.

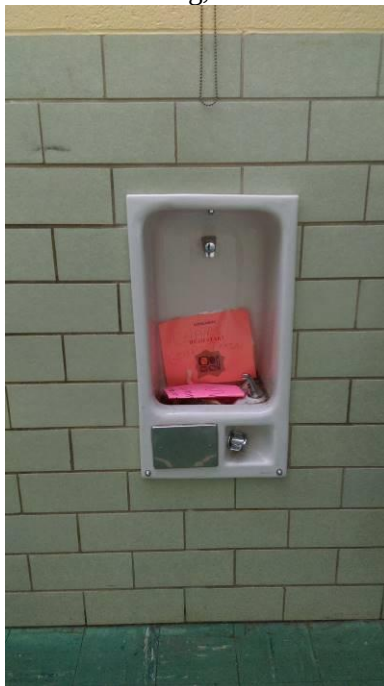
*Drinking Foundation*

Drinking fountains consist of vitreous china, recessed fixtures.

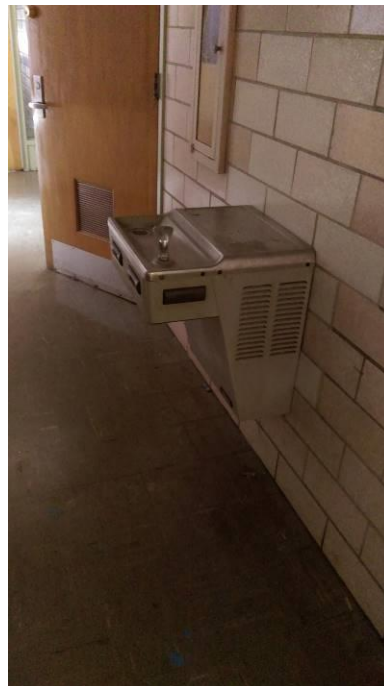
*Water Cooler*

Electric water coolers are wall hung, surface mounted and non-accessible.

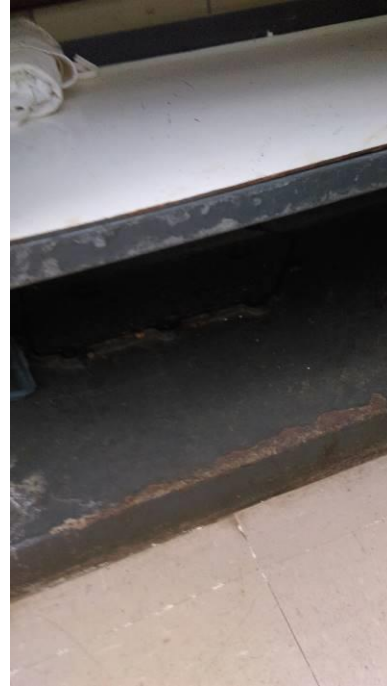
*Grease Interceptor in Floor*

Kitchen area fixtures are in fair condition. The pot washing sink is fitted with a point-of-use, in-ground grease interceptor. The General Kitchen drainage is not directed to an exterior grease trap.

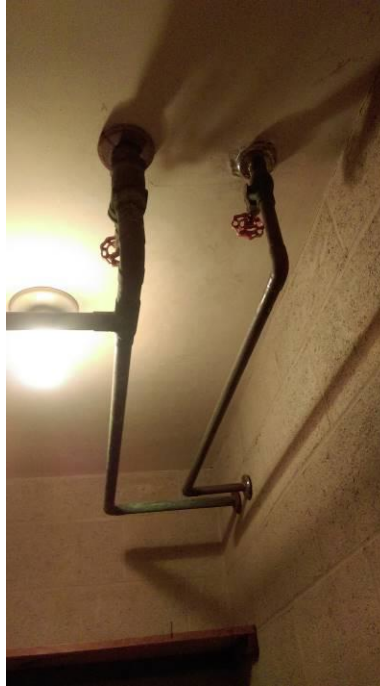
*Water Piping with Gate Valves*

Piping, where exposed, appears to be copper with sweat joints. The majority of the piping is insulated although there are many locations where insulation is missing. Original gate valves are used for isolation purposes. The gate valves have exceeded their life expectancy. In portions of piping that have been replaced, ball valves have been installed. Due to the lack of accessibility a major renovation should include all new domestic water piping.
