20 December 2016

Building Analysis for existing structure: **Sugden Building Block, Spencer Massachusetts**

Richard Sugden Commercial Block Building
Spencer, MA
Plumbing Existing Conditions Systems Report
J#683 002 0000
L#53665/Page 1/September 22, 2016

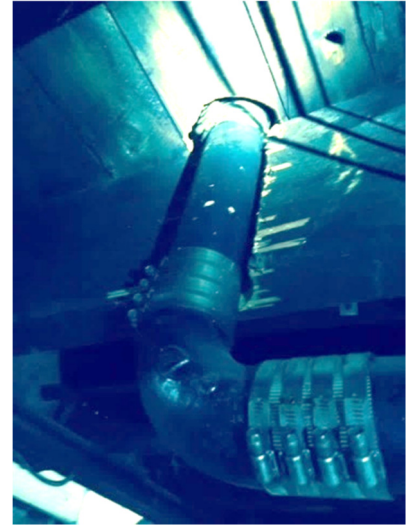
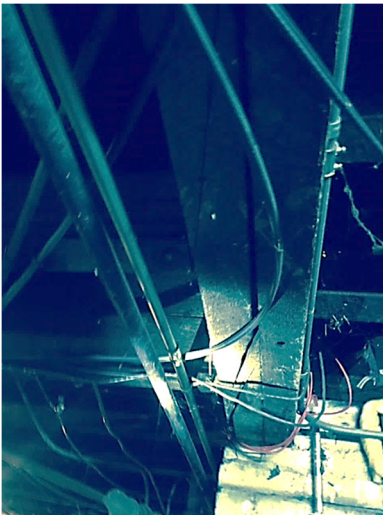
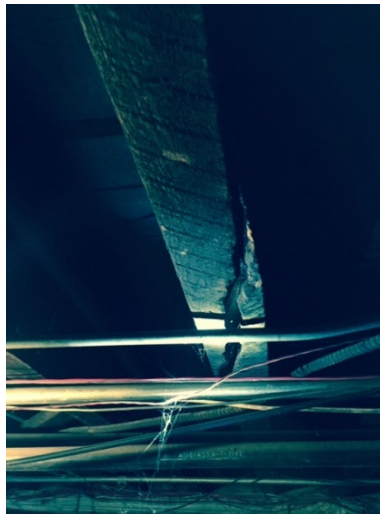
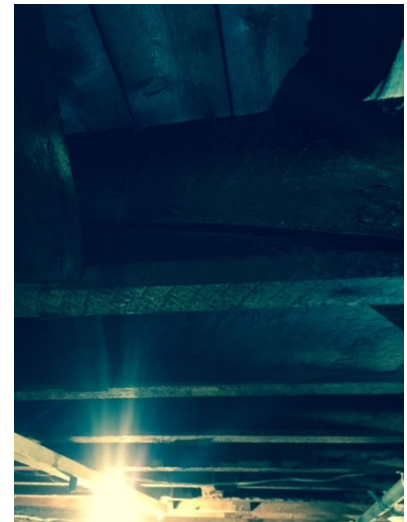
While no investigation into hidden voids or non-accessible spaces such as the underside of the roof, were performed during this visit, all framing is assumed to be heavy timber as is the floor framing which is visible from the basement below. The first floor framing, in the basement area does contain joists that have cracked, deflected or have been improperly cut to run piping or other items over the years and there are many joists that will require replacement or repair. Additionally, there is insufficient support at most joists.

Splitting, cracking and improperly supported joists (first floor framing)

- **Brick masonry bearing walls and piers:** All brick masonry bearing walls and piers should be repointed / repaired as required.
 - **Cracked, split or improperly cut joists:** All joists that have failed or have been improperly cut should be replaced or repaired with an approved method.

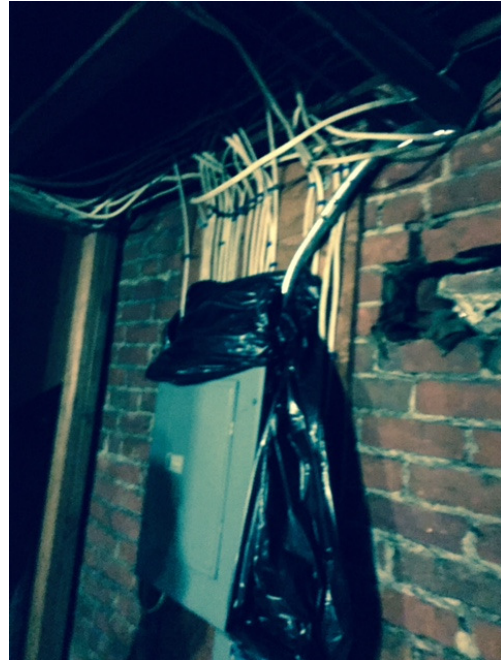
Leak issues at basement electric panel

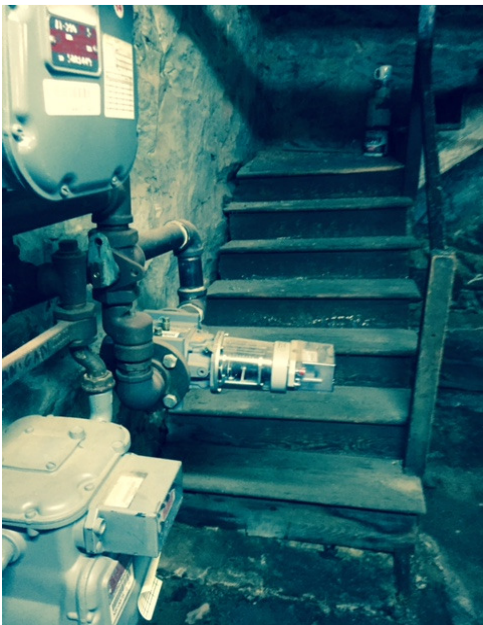
Gas meter blocking stair run at basement

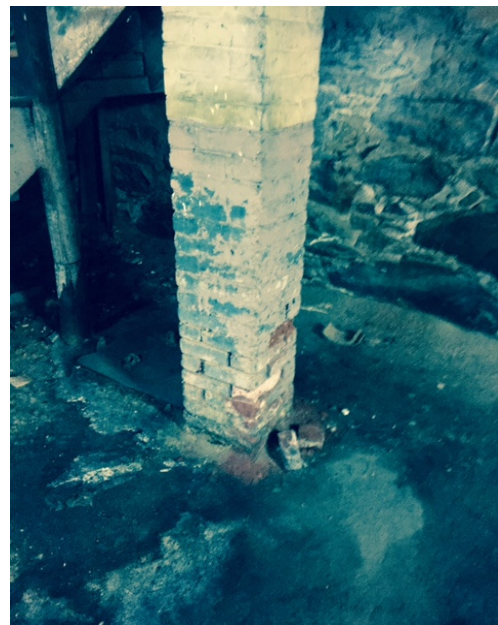
Deteriorating brick pier in basement

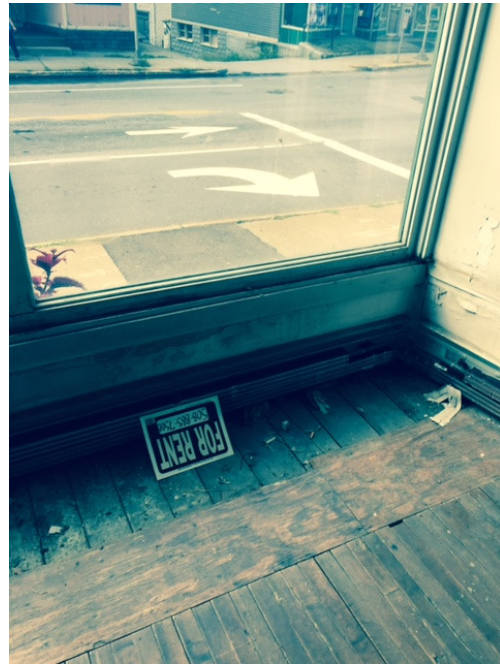
First floor – deteriorated floors

- **Flooring:** All uneven or damaged floors should be replaced; other floors should be repaired as required.
 - **Basement mold issues:** The bacterial growth at the basement should be mitigated and the slab repaired as required. Additionally, older materials such as abandoned suspended ceiling tiles, furnishings and other items should be removed.

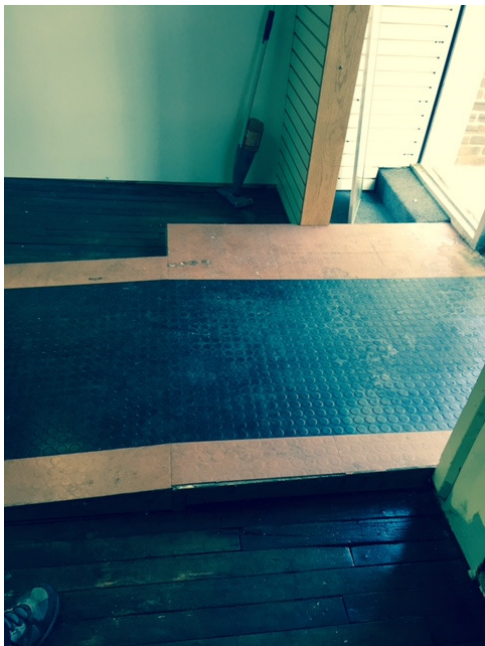
First floor – uneven floor surfaces

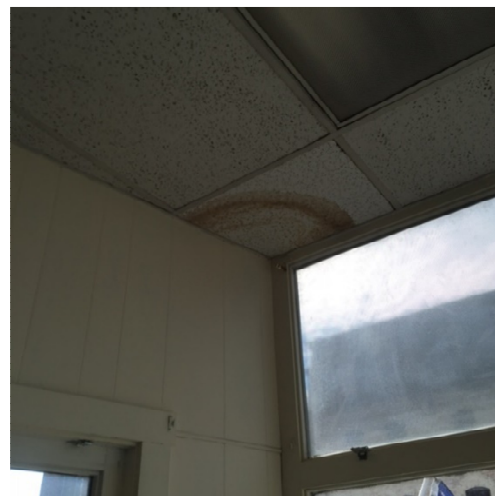
First floor – leak issues

- **Doors and Hardware:** The existing doors and hardware should be repaired or replaced to meet current codes.
 - **Ceilings:** Ceilings should be repaired or replaced due to age of materials or staining due to leak issues over the years.

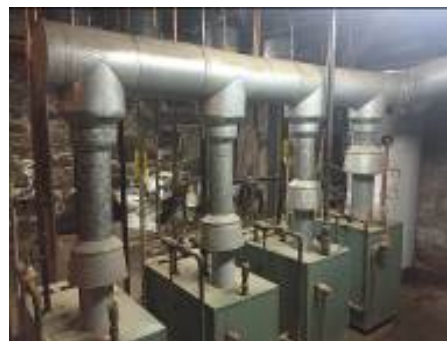
First floor is associated with (4) Peerless firetube boilers, model MMW-85 which were replaced approximately twenty years ago. Each boiler has a single galvanized breeching system from each boiler which combines into one and then exits into an existing masonry chimney. The system has a vertical non-insulated residential style expansion tank. The boiler or piping did not have any inline pumps associated with it, the facility personnel were unaware of any pumps in the system. The boiler plant provides heating for the two suites and the restaurant. There is a total of three programmable thermostats which appear to operate the boilers, zoning of the boilers was unknown however one would assume that the restaurant would utilize two boilers while the other two boilers are used for the two suites.

Boiler Breeching

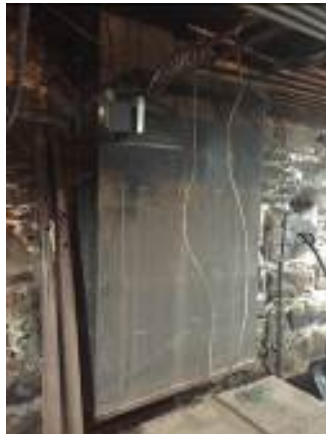
Combustion air for the power plant is through (1) individual combustion air duct which travels from a wall mounted louver and drops down to approximately 18" above the floor. The opening was equipped with an electronic motorized damper which is controlled via a wall mounted switch. This condition is not code compliant and should be connected to each of the boiler circuits so that it may open if any of the boilers are activated. Also the single wall opening is not code compliant with today's codes and standards. The piping throughout the boiler room is a combination of schedule 40 black steel and copper. The piping appeared to be in fair condition however before a determination can be made various sections of piping should be removed and examined internally for corrosion. The entire piping system is not insulated which does not meet today's codes and standards. Located within the basement there appears to be some old abandoned fuel oil lines which penetrate the exterior foundation wall, these pipes are not capped and are open ended, these should be removed or at a minimum capped. Overall the heating plant is functioning however it is approaching the end of its serviceable life and all the equipment is antiquated and beginning showing signs of corrosion and failure.

Combustion Air Duct

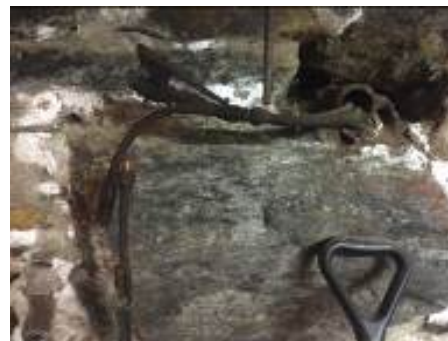
Abandoned Fuel Oil Piping

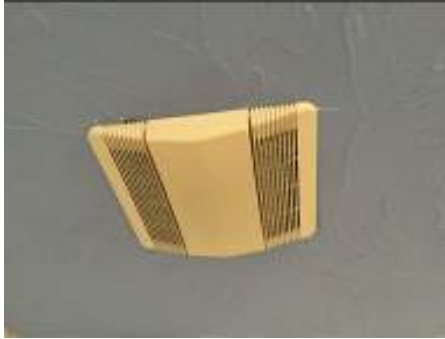
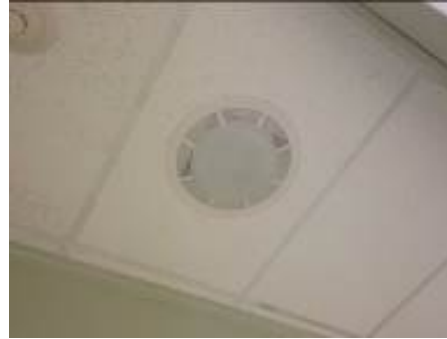
Throughout the bathrooms, general exhaust is provided through the use of residential style exhaust fans. It is unclear as to whether or not these fans discharge the exhaust air into the attic space or if they terminate outside, there were no hooded wall vents visible on the outside of the building. By today's standards and codes these exhaust ducts should terminate outdoors.

Typical Ceiling Exhaust Fan

- **Exhaust Fans:** All exhaust fans should be replaced and a new system provided for storage rooms.
- **Air conditioning:** In addition to aforementioned ventilation system, a central cooling plant should be provided for those spaces requiring cooling.

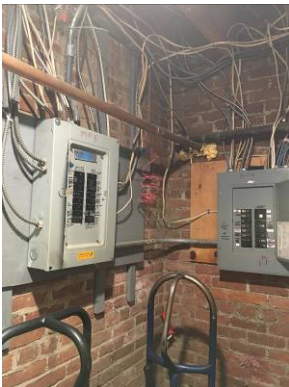
The Switchgear is generally in fair to poor condition and has outlined it's intended useful life. One of the panels in the third floor consists of plug-in fuses and knob and tube wiring, it is not clear if it is still live.

Tenant Panels in Basement

- **Meter Center:** The main meter center should be replaced (main breaker and service may remain).
- **Existing lighting and panels fed with knob and tube wiring:** Remove all existing lighting and panels fed via knob and tube wiring.
- **Emergency Lighting:** Provide additional emergency lighting in common areas and stairwells.
- **Improperly Installed Receptacles:** Replace improperly installed receptacles.
- **Existing Tenant Panels, Feeders, and Romex Branch Wiring:** As each tenant space is renovated, replace all existing panels, feeders and Romex wiring.
- **Energy Improvements:** Provide additional energy improvements such as occupancy sensors and replace all common and tenant lighting with energy efficient LED sources.

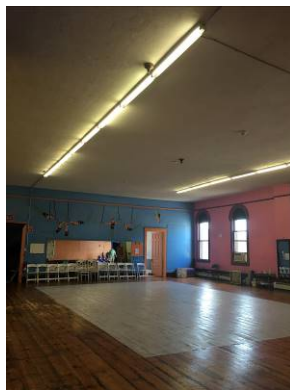
Tenant spaces typically range from open strips with T12 lamps to recessed 2x4 troffers with T12 lamps generally in poor condition.

Tenant with Strips

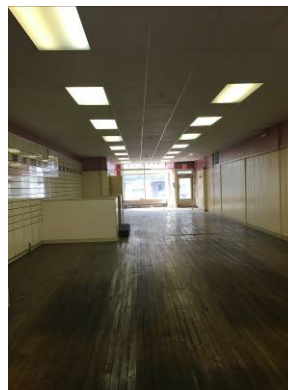
Tenant with Recessed Troffers

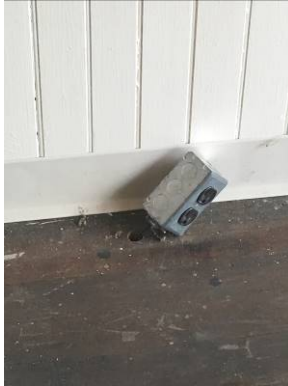
Receptacle density in most tenant spaces is minimal. Some receptacles have been improperly installed.

Tenant Receptacles

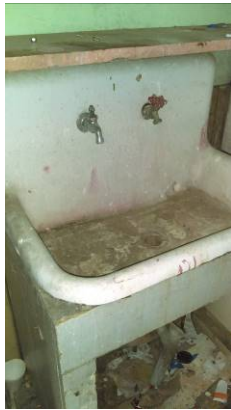
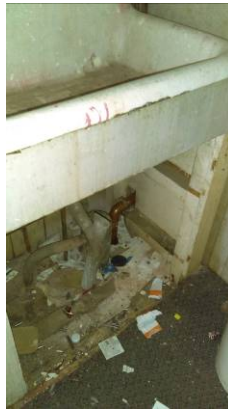
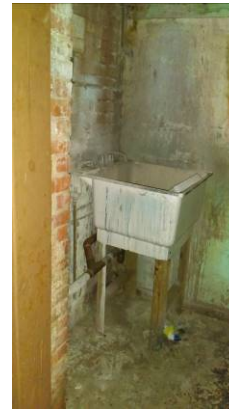
There are multiple original abandoned plumbing fixtures scattered throughout building which are not functioning and have been disconnected from the piping systems.

Abandoned Plumbing Fixture

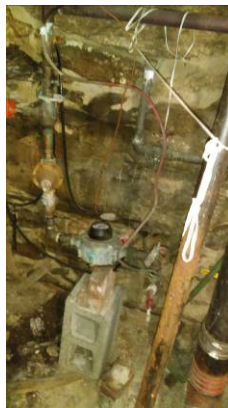
The domestic water is aggressive leading to severe corrosion and early failure of piping, fittings, valves, and insulation.

Main Water Service

Piping, where exposed, appears to be copper with sweat joints. The majority of the piping is not insulated. Due to the lack of accessibility, a major renovation should include all new domestic water piping.

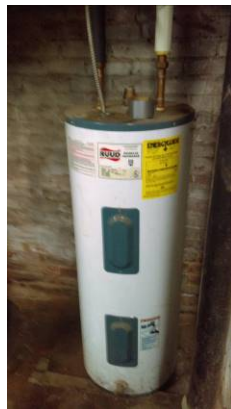
Domestic hot water in the 2 (two) Retail spaces are each generated through electric tank type water heaters. The hot water systems are not recirculated. There are no thermostatic mixing valves on the systems to prevent scalding. There are no expansion tanks on the water heater make up water lines. The electric water heater for one tenant space is 40 gallons with 3.8 kW electrical input. The other tenant space includes a 30-gallon tank with an electrical input of 4.5 kW. Both electric water heaters may be nearing their life expectancy.

Tenant Electric Water Heater

- **Domestic Water Piping:** The existing domestic water piping system should be replaced in its entirety.
- **Water Heaters at Retail Spaces:** The existing electric hot water heaters in the retail spaces should be replaced.
- **Gas Fired Water Heater at Restaurant:** The existing gas fired water heater at the restaurant should be replaced.

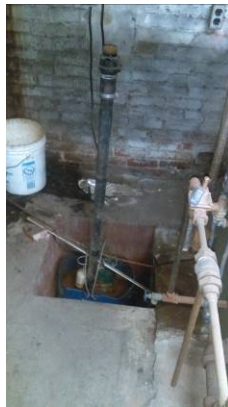
A sump pump exists in a pit of the Basement floor. The pump has been disconnected and abandoned.

Sump Pump

- **Building Systems:** (continued)
 - **Drinking fountains / services sinks:** Code requires that a service sink and drinking fountain be provided at every floor level.
 - **Sump Pump:** Replace the existing abandoned sump pump.
 - **Abandoned Plumbing Fixtures:** Remove all abandoned plumbing fixtures and cap line at source.
 - **Sanitary Waste and Vent Line:** The existing sanitary, waste and vent lines should be investigated with the use of video recording equipment to determination if any blockages exist. Lines should be cleared accordingly.
 - **Insulate Storm Drainage Piping:** Provide insulation at all horizontal storm drain piping.
 - **Domestic Water Piping:** The existing domestic water piping system should be replaced in its entirety.
