TOWN OF SPENCER – LAKE STREET SCHOOL REMOVAL PROJECT

HAZARDOUS MATERIALS SURVEY REPORT

FORMER LAKE STREET SCHOOL
17 LAKE STREET
SPENCER, MA 01562

June 8, 2023
Revised: July 14, 2023
Partner Project No. 22445977

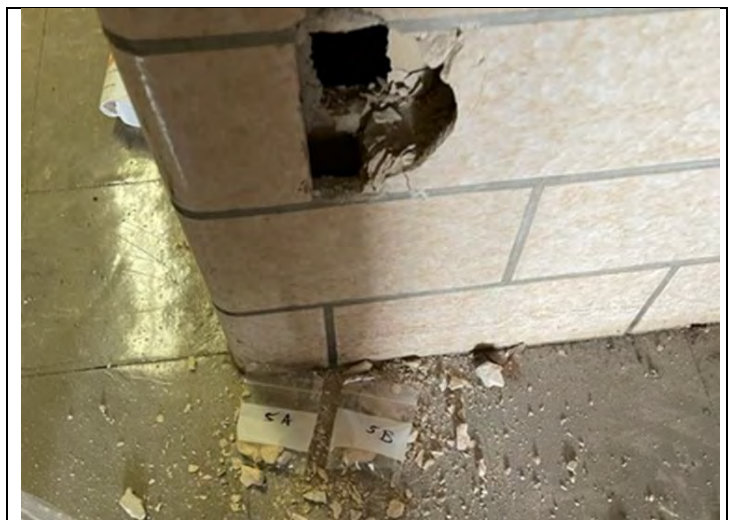
5. View of bathroom floor tiling, mortar, and grout

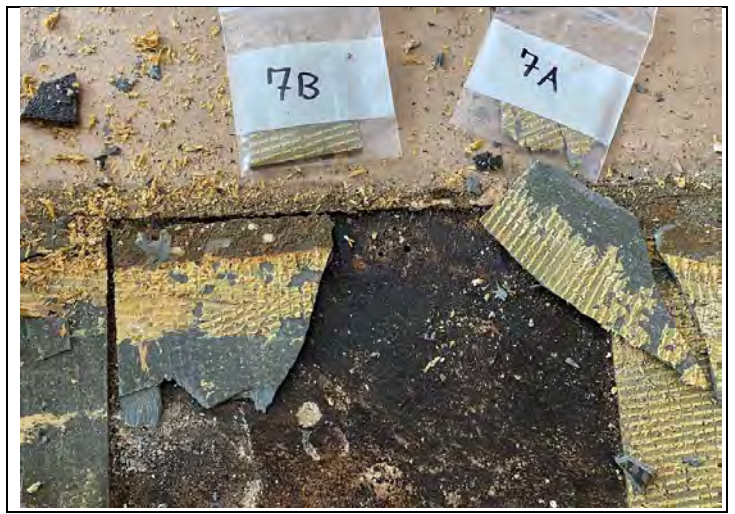
7. View of 6" tan base board

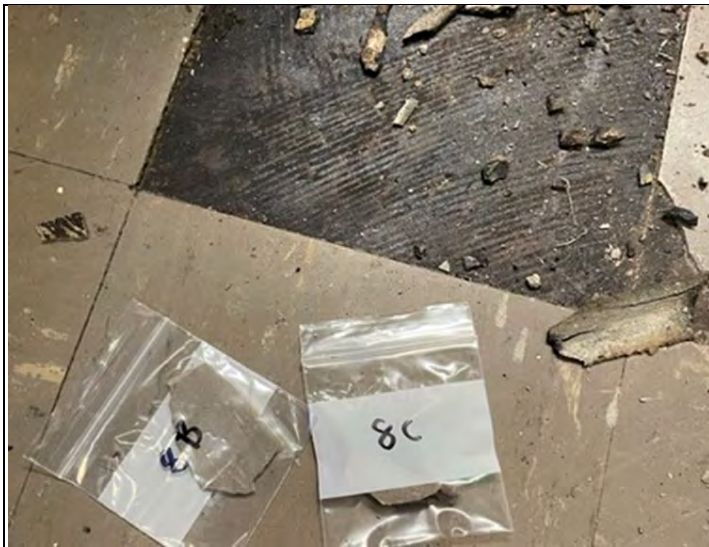
8. View of tan carpet mastic

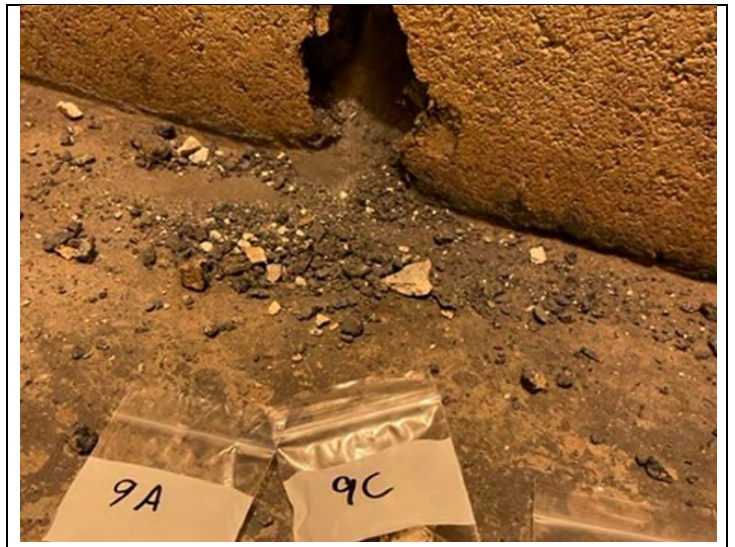
9. View of 9x9 dark gray

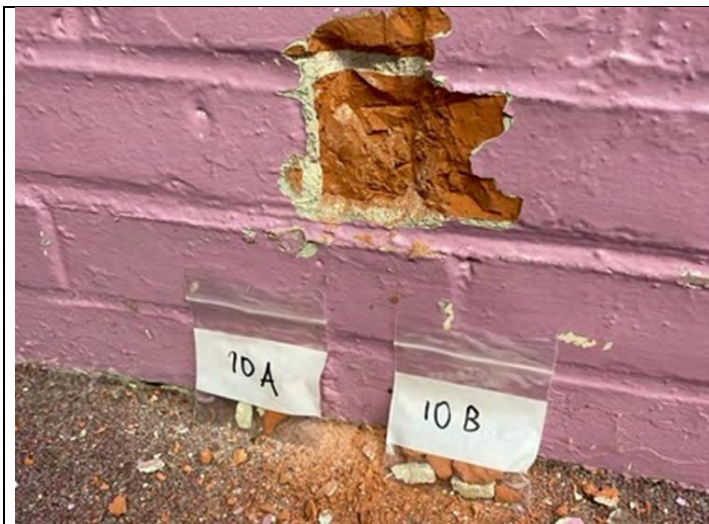
10. View of cinder block.

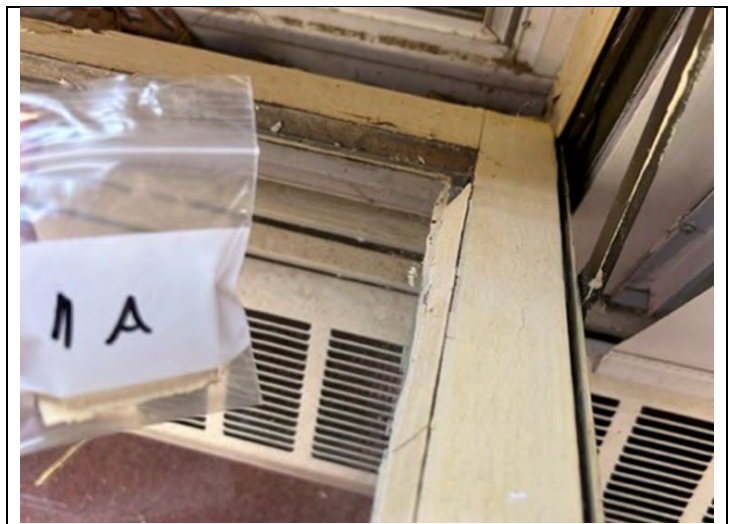
11. View of brick and mortar

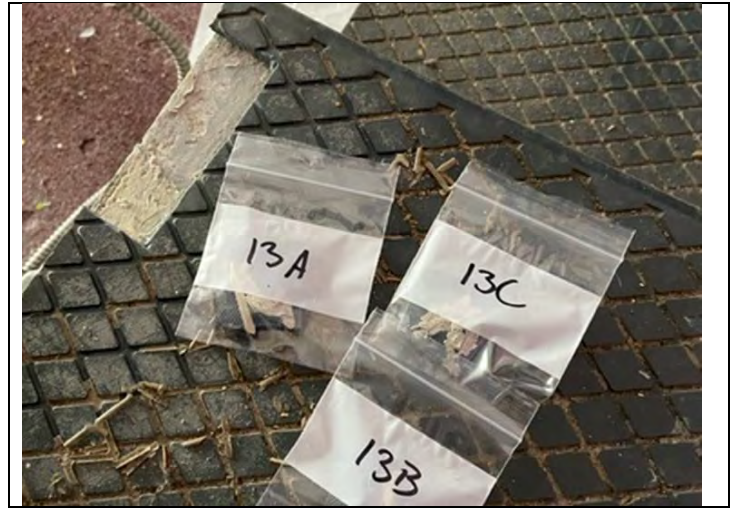
13. View of 4" blue base board

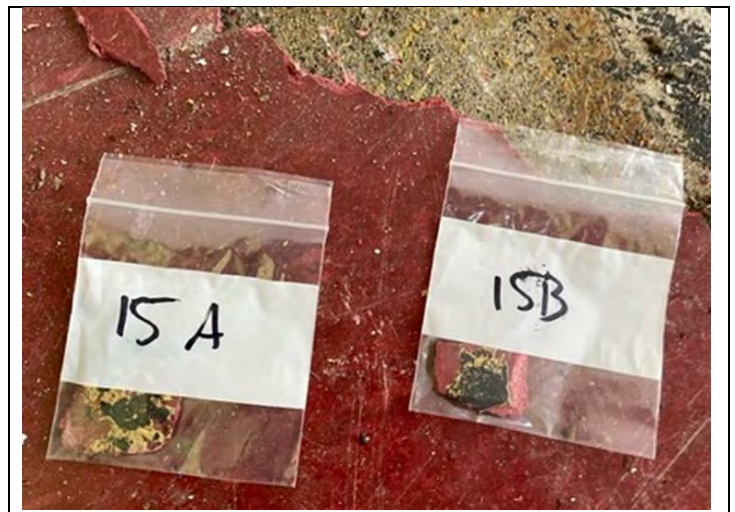
15. View of 9x9 red tile

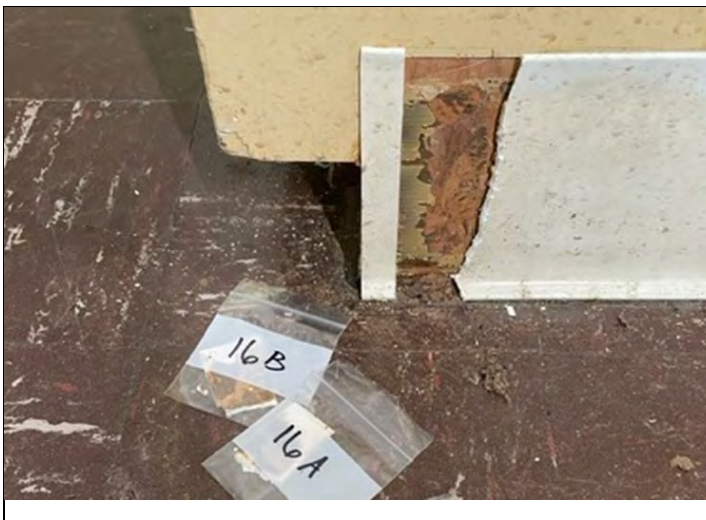
16. View of 12x12 red tile

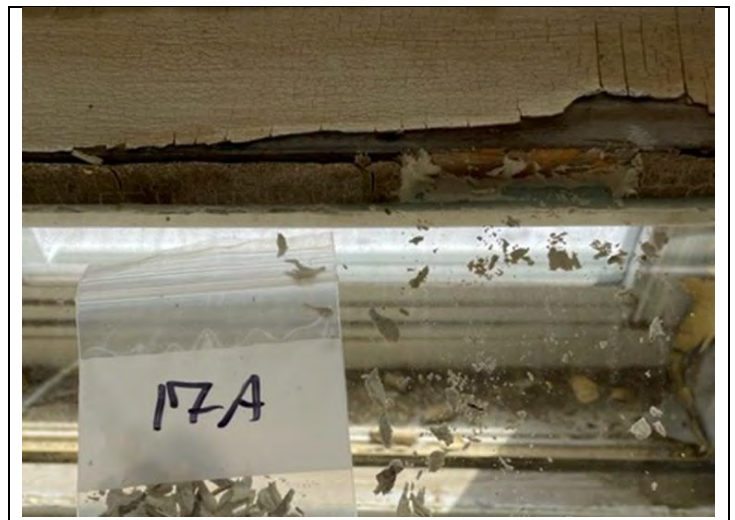
17. View of 6" white base board

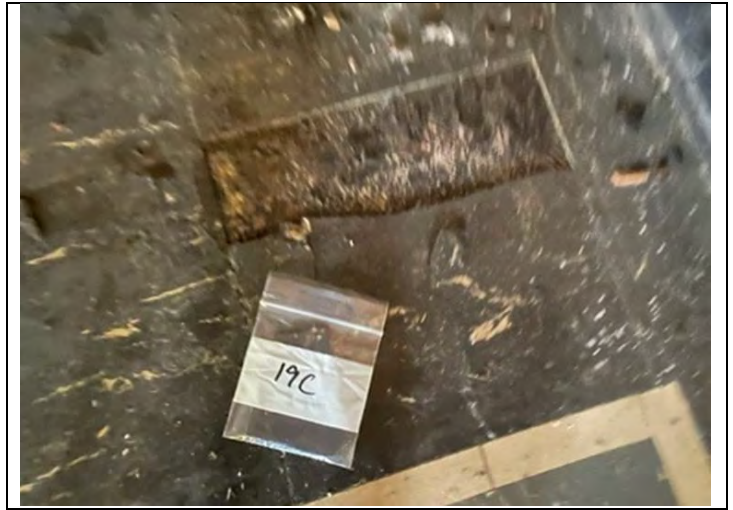
19. View of sound board

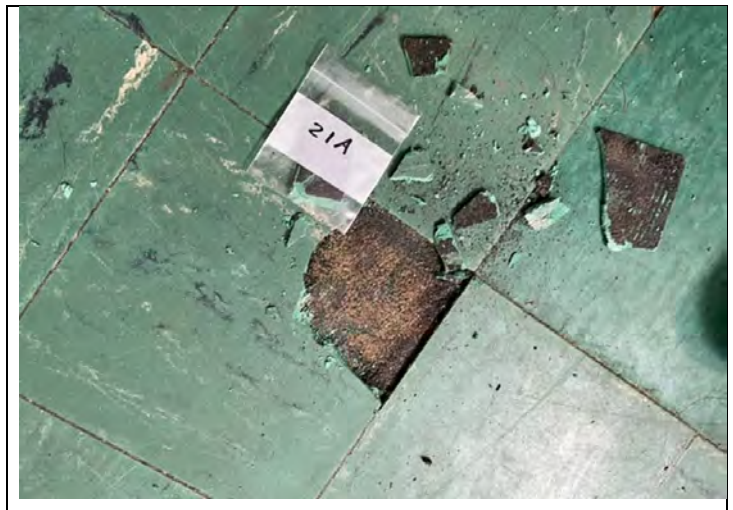
21. View of 4" black base board

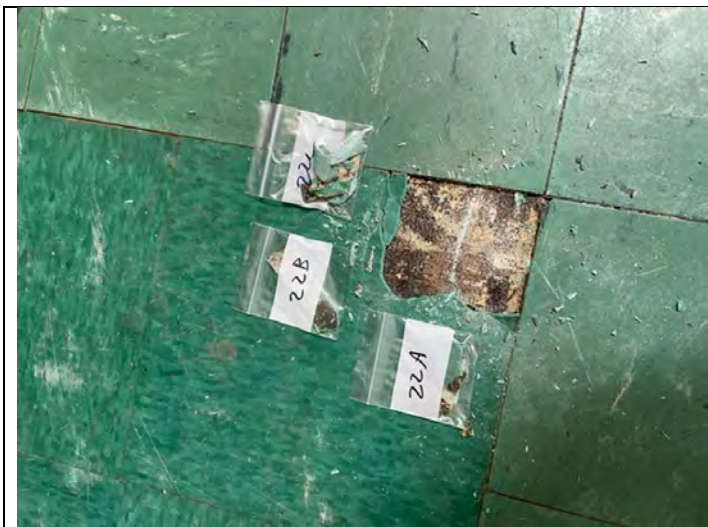
22. View of 9x9 green tile

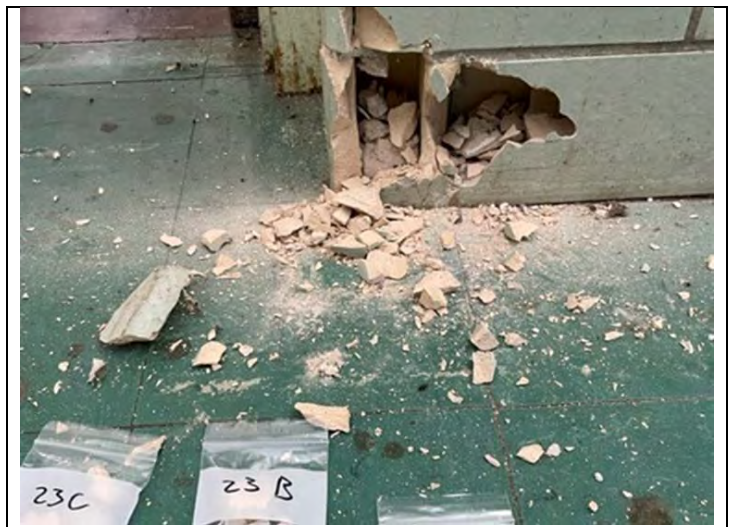
23. View of 12x12 green tile

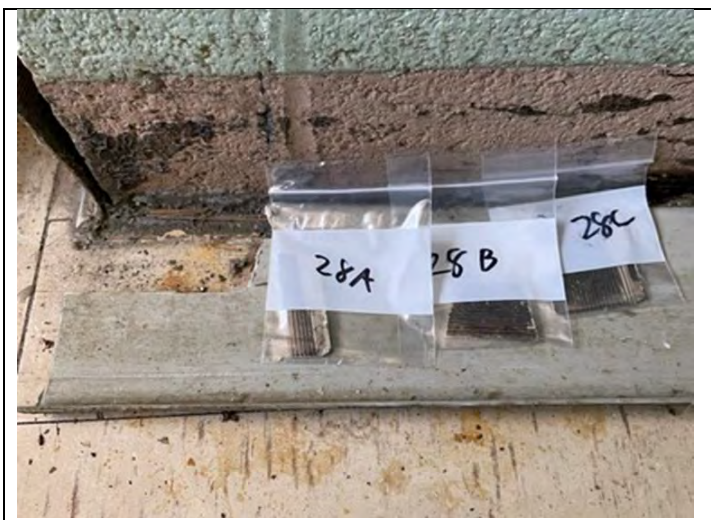
28. View of 12x12 beige yellow floor tile

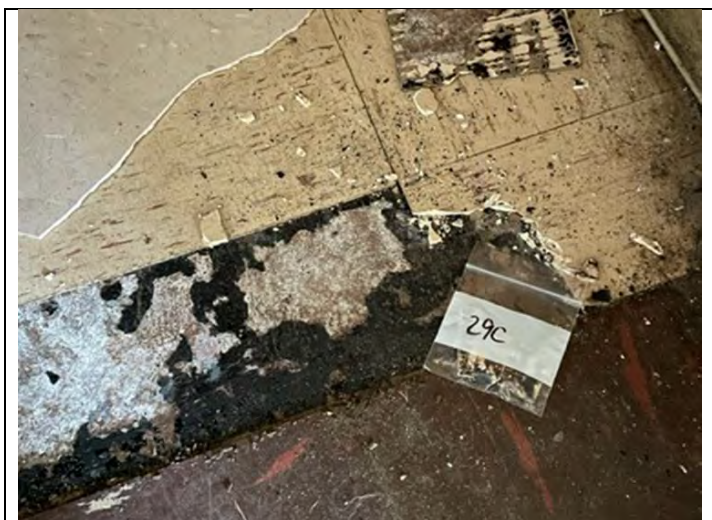
29. View of 4" gray base board

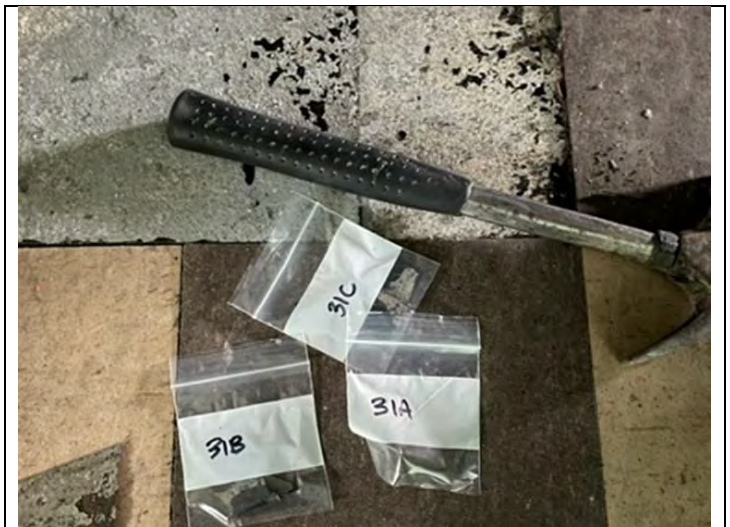
31. View of 9x9 white tile

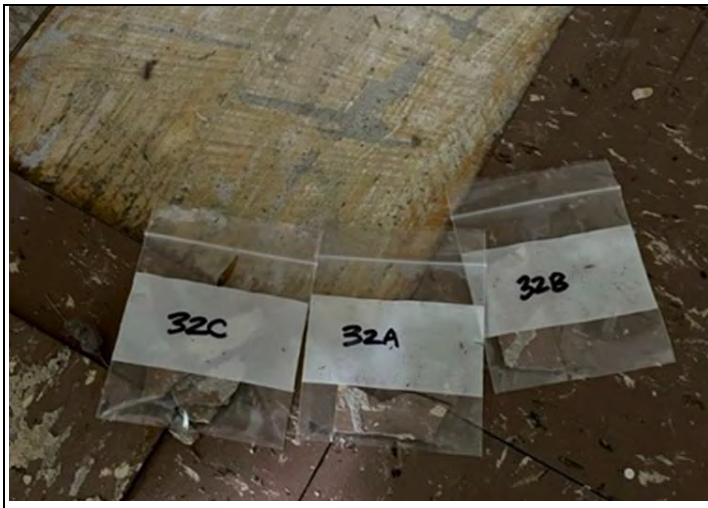
32. View of 9x9 brown tile

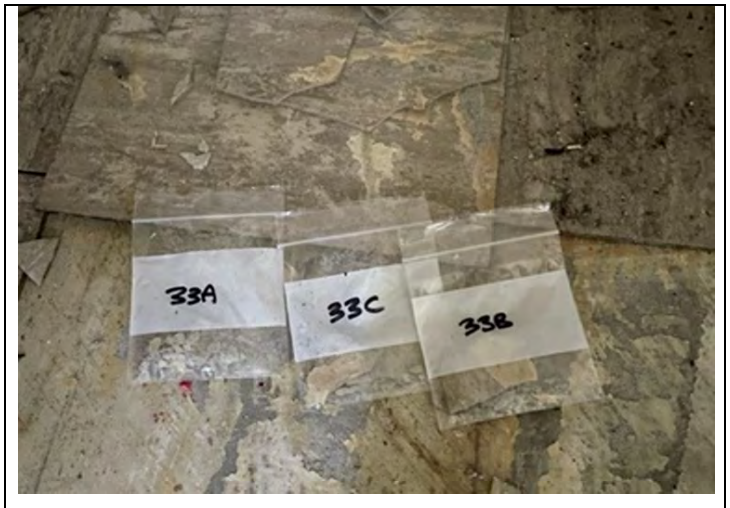
33. View of 9x9 burnt brown tile

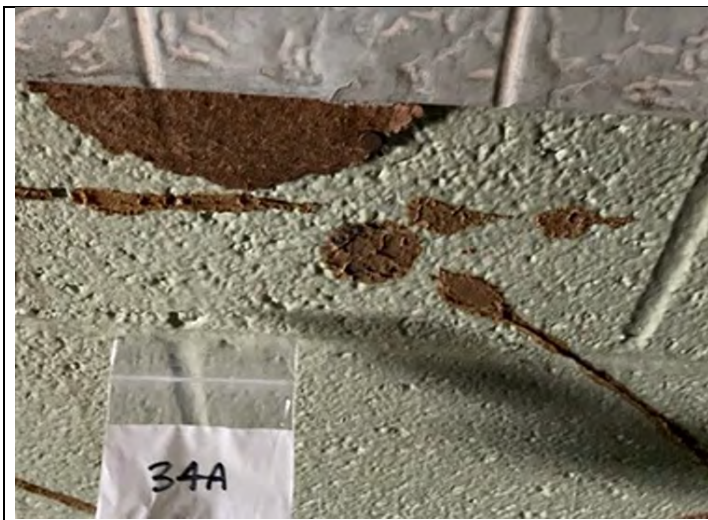
34. View of 9x9 stripy tan tile

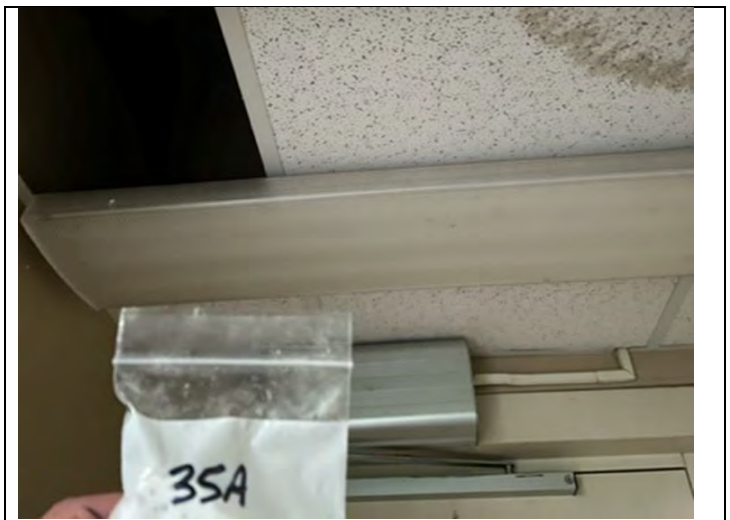
35. View of cream wall mastic

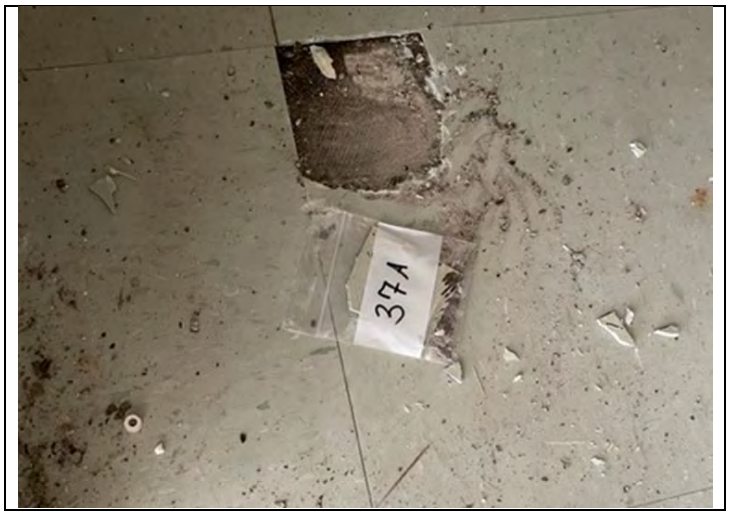
37. View of 12x12 light blue speckled tile

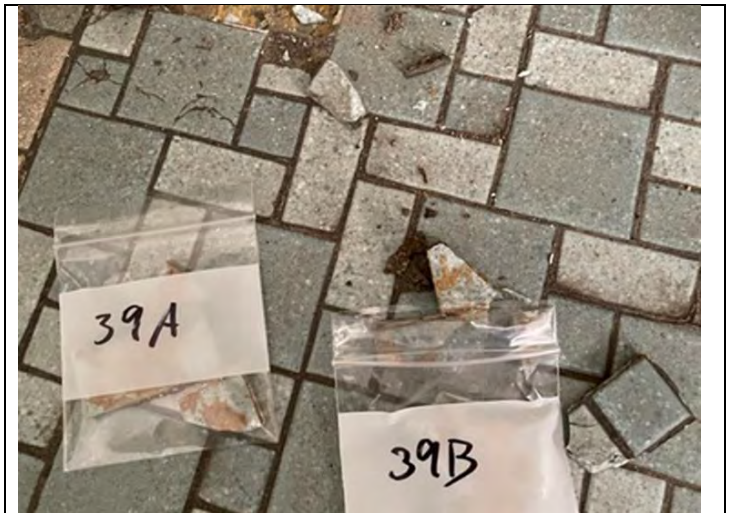
39. View of blue ceramic patterned flooring tiles

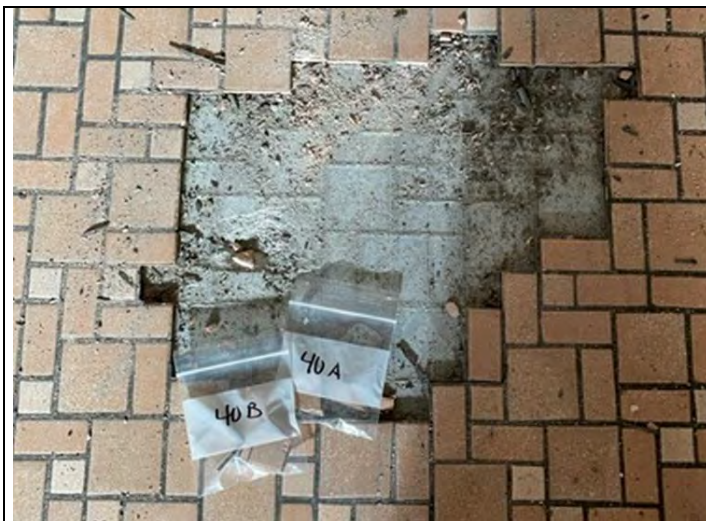
40. View of new light blue ceramic patterned flooring tiles

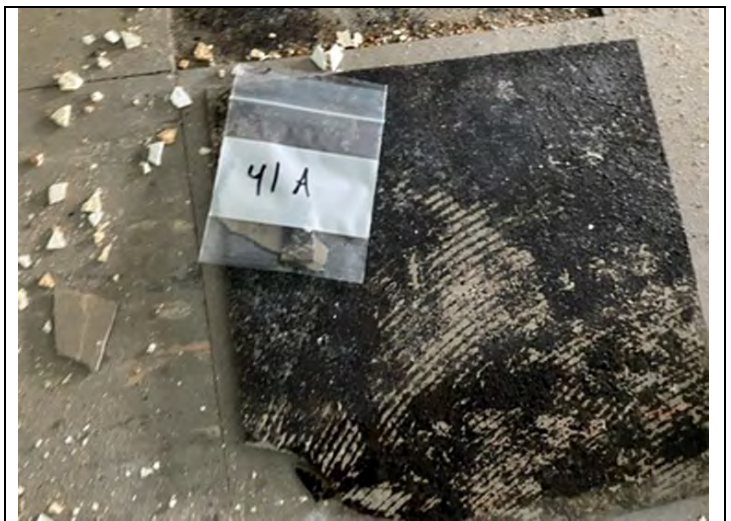
41. View of pink ceramic patterned flooring

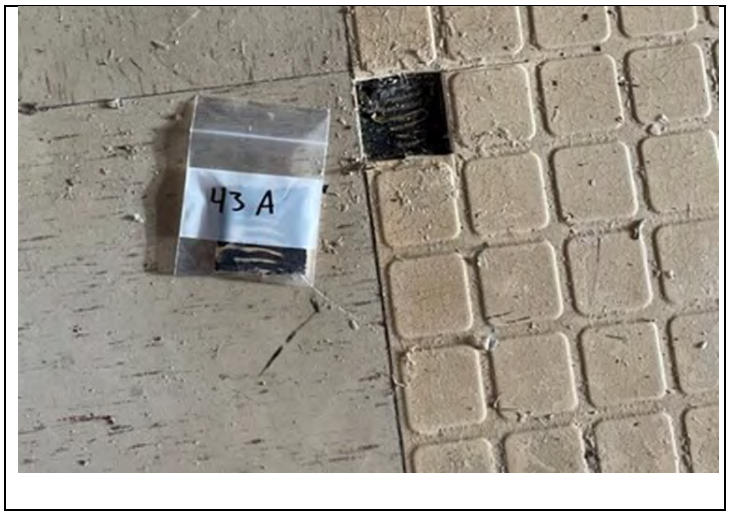
43. View of 9x9 light brown with brown speckled tile

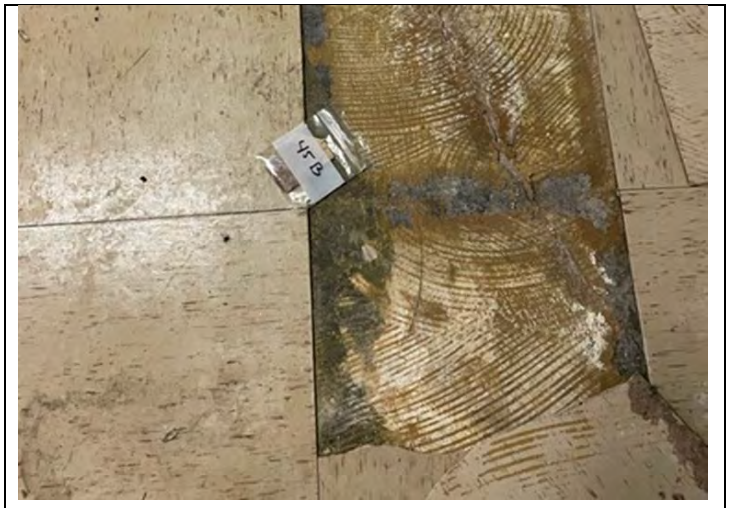
45. View of tan floor tread and tan mastic

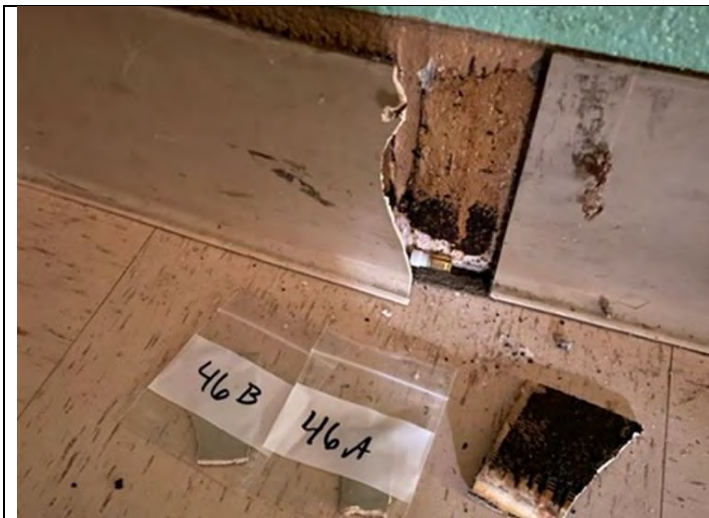
46. View of 12x12 blush lined flooring tile

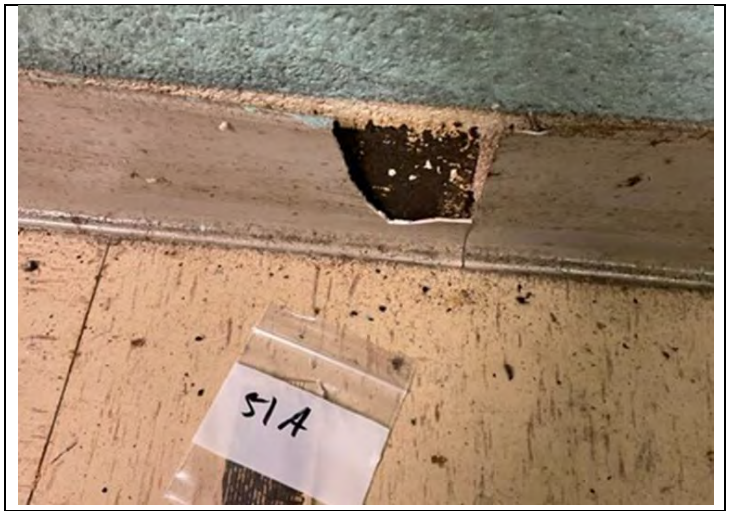
51. View of 12x12 white gray flecked flooring tile 1977

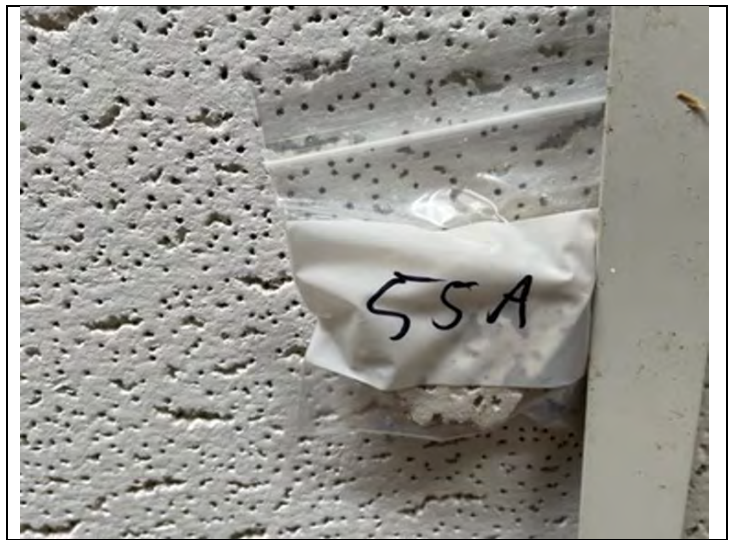
55. View of wormy ceiling tile

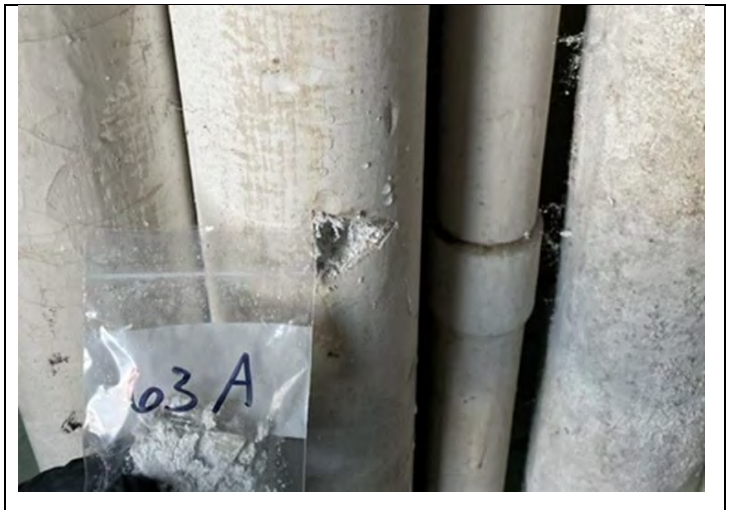
63. View of boiler TSI
