## M E M O R A N D U M

TO: William Cundiff, Supervisor, Highway Department, Town of Spencer

DATE: May 25, 2021

RE: Dry-Weather Outfall Screening Results

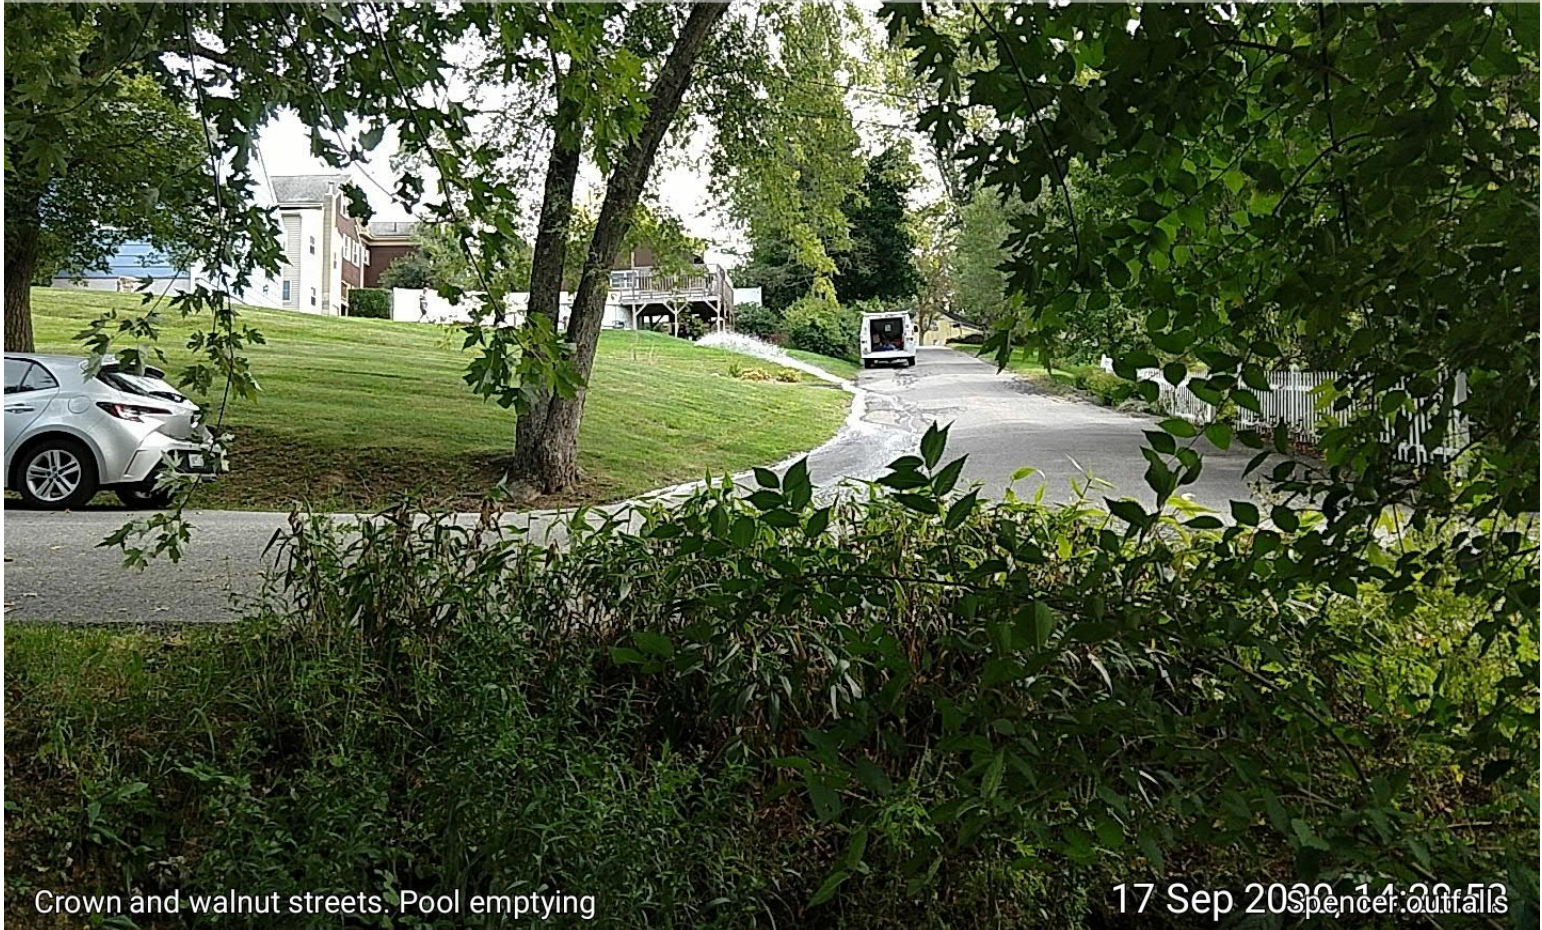
## 4 Crown Street, Spencer, Massachusetts, 01562

During a screening visit of at outfall 41, Fuss & O'Neill staff observed the start of dry-weather discharge, originating from the pool at 15 Bell Street, which was being emptied into the street (*Attachment 3*). The outfall was observed to be dry prior to the flow from the pool. Staff reported a burning sensation in their eyes and nose after the start of flow, suggesting the pool water had not been dechlorinated prior to discharge. We recommend reaching out to the property owners of 15 Bell Street, as well as providing educational messaging town-wide, explaining how to dechlorinate pool water before emptying the pool.

Crown and walnut streets. Pool emptying

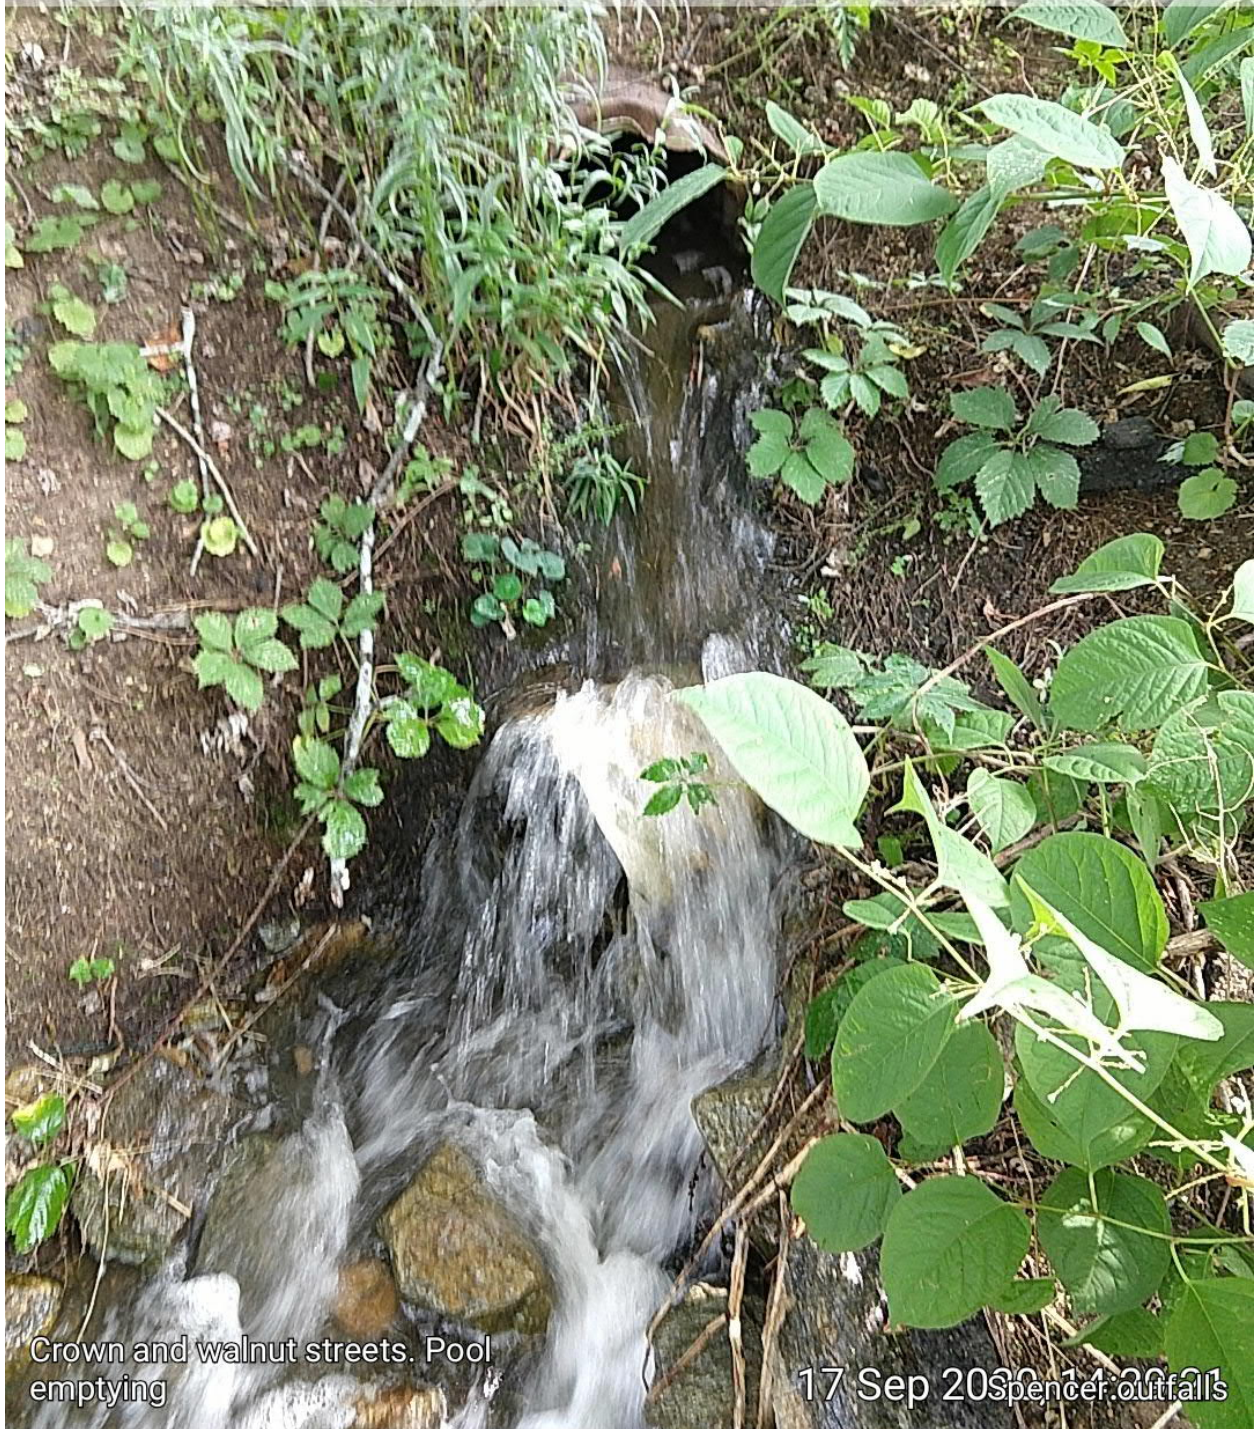
# 4 Crown Street, Spencer, Massachusetts, 01562

Crown and walnut streets. Pool emptying
