Designing a Culvert Management System for the Town of Spencer, MA

A Major Qualifying Project

In Civil Engineering by:

Date: March 26, 2015

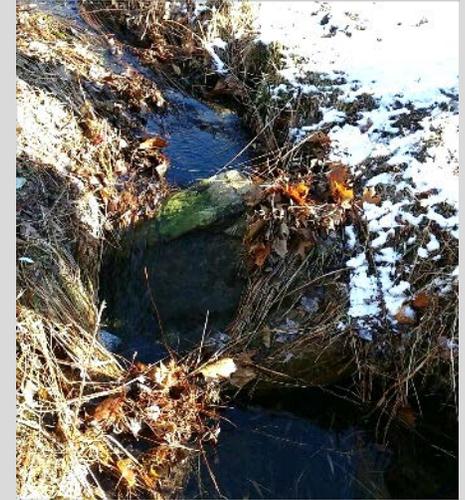
OUTLET

- ❖ Inlet and outlet were almost completely submerged -> could lead to flooding especially with runoff
- ❖ Large rock blocking most of outlet
- ❖ Significant cracking through road above culvert

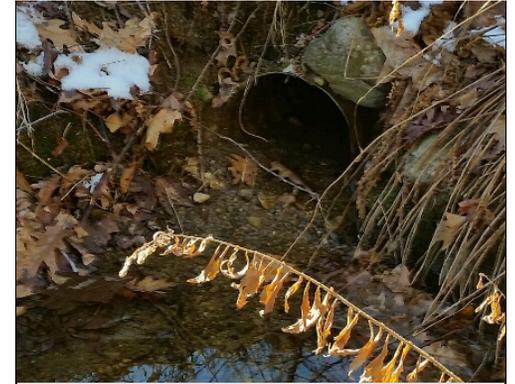
OUTLET

- ❖ Seems to be used for storm runoff rather than a consistent stream flow
- ❖ Tree down right next to outlet

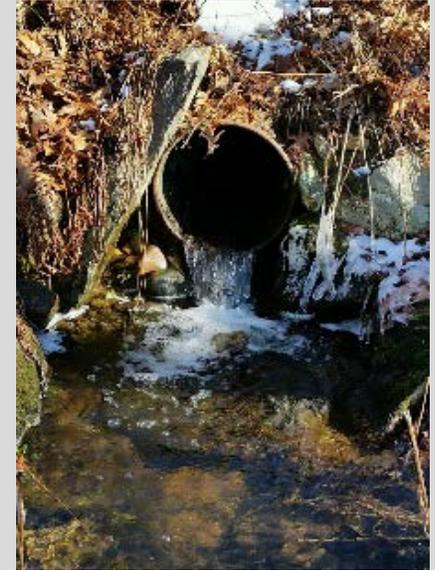
OUTLET

- ❖ Half the road is recently paved above culvert
- ❖ Concrete pipe at inlet and metal pipe at outlet
- ❖ Stream flow internally cascades from one half to the other

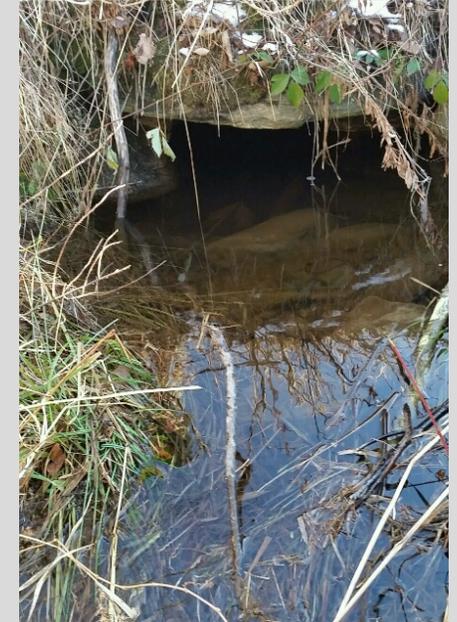
OUTLET

- ❖ Chain link fence about 5' in front of inlet
- ❖ Bog being filled by underground tributaries
- ❖ Inlet and outlet are almost submerged
- ❖ Large amount of scour on outlet side

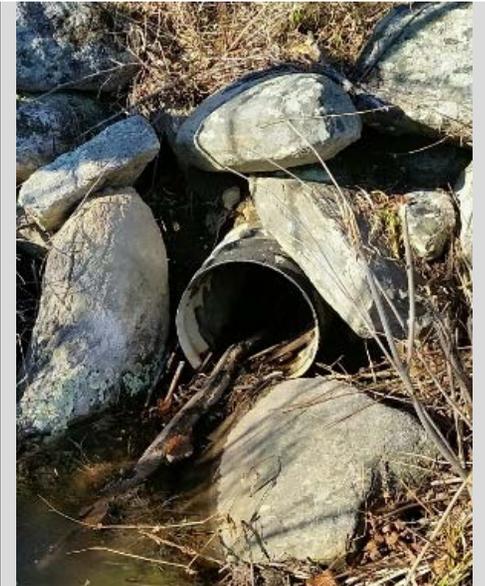
OUTLET

- ❖ Bog being filled by underground tributaries
- ❖ Both inlet and outlet are surrounded by debris
- ❖ Underground stream feeding inlet from both directions

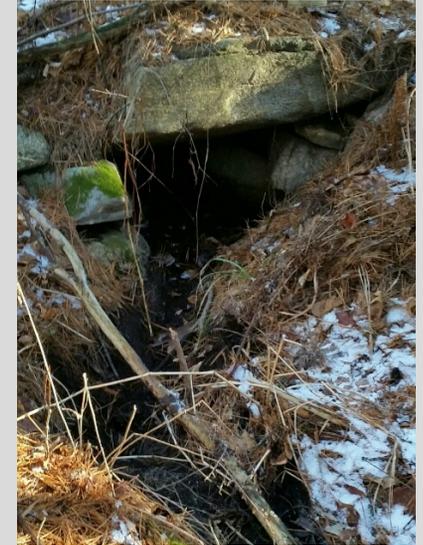
OUTLET

- ❖ Significant pothole on road above crossing
- ❖ Stream goes underground after outlet for about 5 ft. then resurfaces and leads to a wetland

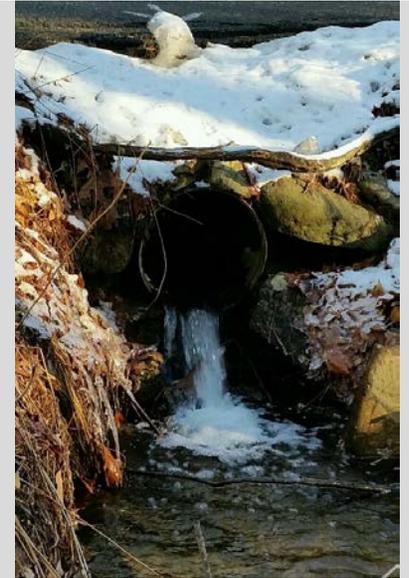
OUTLET

- ❖ About 50 ft. from outlet stream becomes a wetland area
- ❖ Multiple hydraulic jumps within first 20 ft. downstream
- ❖ Rocks and debris gathering at inlet

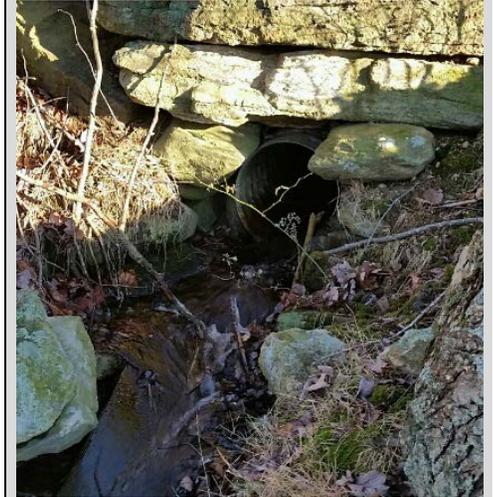
OUTLET

Characteristic	Field Observation
Date observed	12/14/2014
Type	Dam/Metal Pipe
Diameter	14.5"
Length	43'
Funding	Town
Stream Name (Tributary)	Unknown (Cranberry River)
Water Depth	1"
Outlet Drop	2", Freefall onto Cascade

Structural assessment results:  
**good condition (0.76/1)**

- ❖ Inlet is a rectangular dam
- ❖ Fish passage here is impossible as stream ends at horse farm on West side

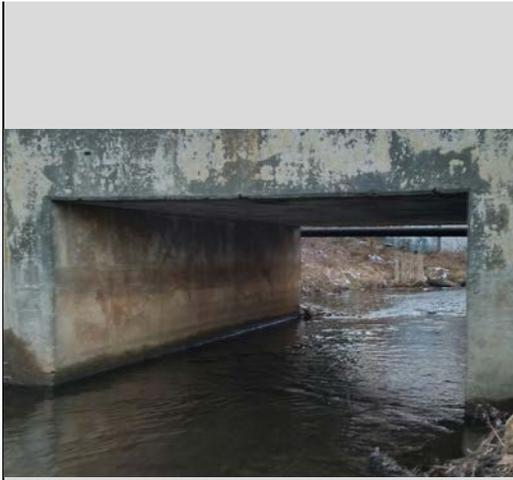
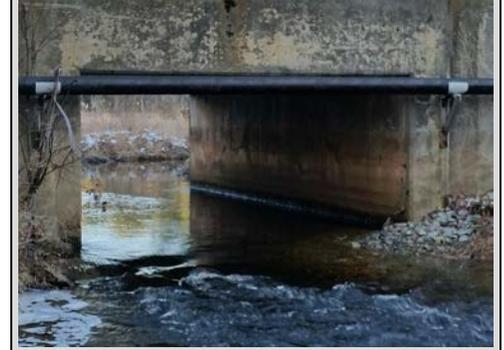
South Spencer Road 10

Characteristic	Field Observation
Date observed	12/14/2014
Type	Open-Bottom Box
Width x Height	12' x 5' 6"
Length	27'
Funding	Town
Stream Name (Tributary)	Cranberry River
Water Depth	18"
Outlet Drop	N/A

Structural assessment results:  
**good condition (0.84/1)**

- ❖ Built in 1938
- ❖ Bridge No. – S-23-019
- ❖ Small scour pool at outlet

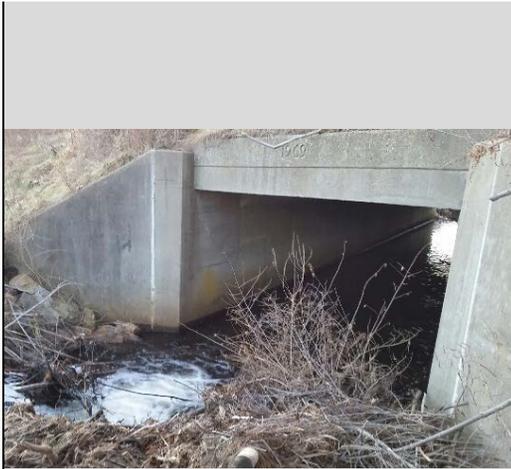
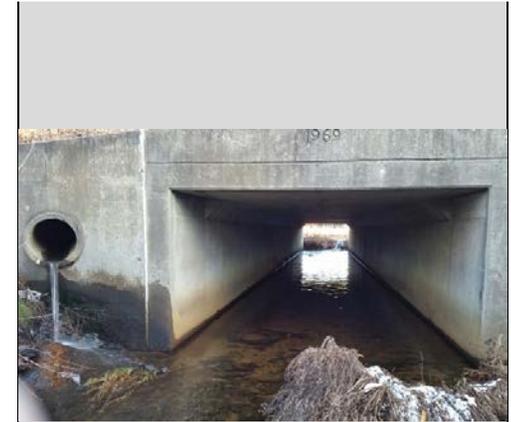
South Spencer Road 11

Characteristic	Field Observation
Date observed	12/14/2014
Type	Box
Width x Height	12' x 6' 7"
Length	68'
Funding	MassDOT
Stream Name (Tributary)	Muzzy Brook
Water Depth	12"
Outlet Drop	N/A

Structural assessment results:  
**good condition (0.80/1)**

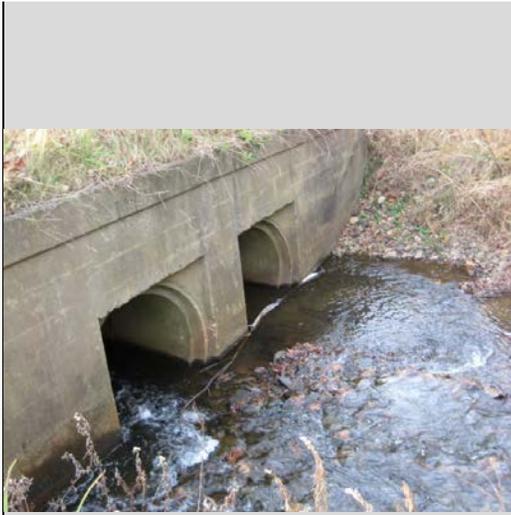
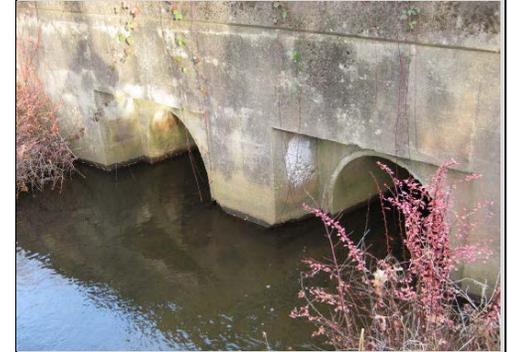
West Main Street 1

Characteristic	Field Observation
Date observed	11/22/2014
Type	Double Pipe
Diameter	48"
Length	44'
Funding	Town
Stream Name (Tributary)	Muzzy Brook
Water Depth	18"
Outlet Drop	N/A

Structural assessment results:  
**good condition (0.89/1)**

- Box replacement

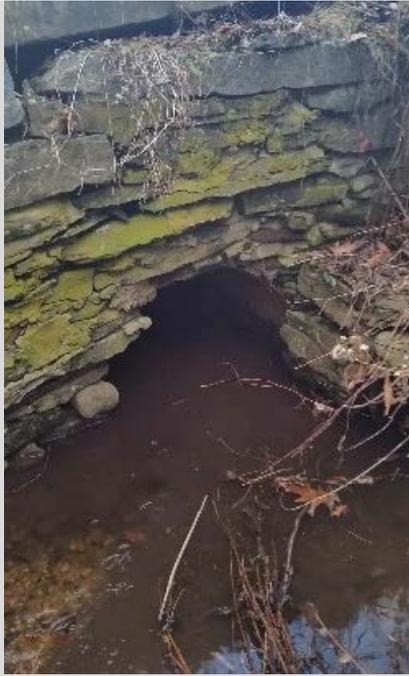
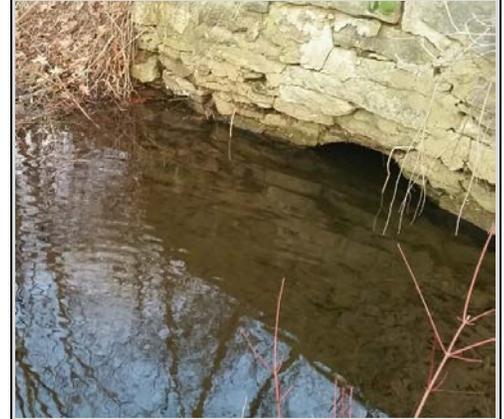
Meadow Road 1

Characteristic	Field Observation
Date observed	12/18/2014
Type	Concrete Pipe
Diameter	36"
Length	60'
Funding	Town
Stream Name (Tributary)	unknown
Water Depth	22"
Outlet Drop	N/A

Structural assessment results:  
**fair condition (0.63/1)**

- Scouring and Erosion
- Road Condition
- Submerged Outlet

- Box replacement

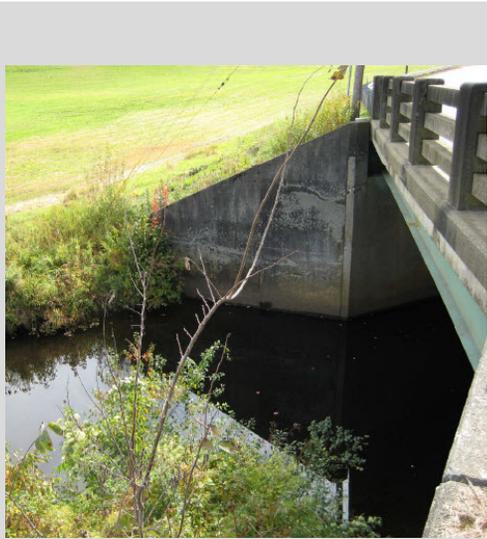
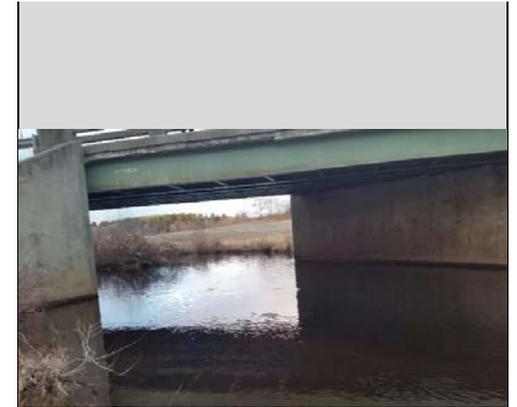
Meadow Road 2

Characteristic	Field Observation
Date observed	12/18/2014
Type	Open-Bottom Box
Length x Width	45' x 12'
Length	32'
Funding	MassDOT
Stream Name (Tributary)	Seven Mile River
Water Depth	24"
Outlet Drop	N/A

Structural assessment results:  
**good condition (0.71\*/1)**

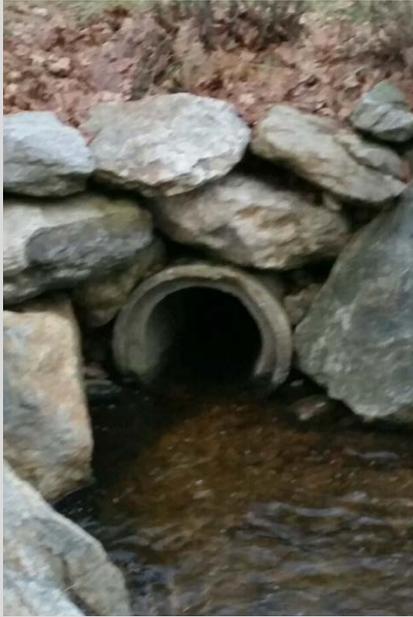
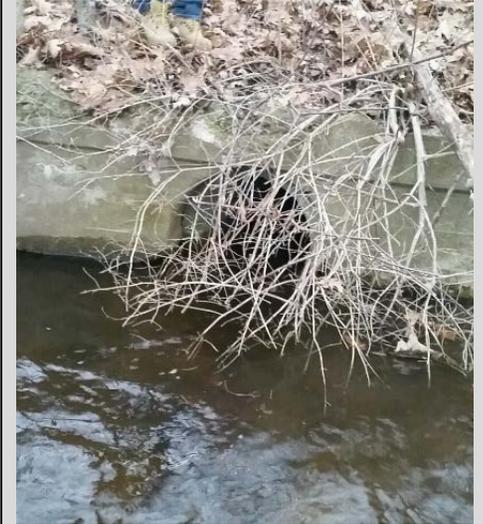
North Spencer Road 1

- ❖ MassDOT last recorded the ADT of this section of Rt. 31 at +7500. The most convenient detour would include multiple roads, leading West on Smithville Cross Rd. to Smithville Rd.
- ❖ The span of the bridge may have originally been similar to the dimensions of the bank. Scouring has continued to widen and deepen this bend in the river underneath North Spencer Road.
- ❖ AASHTO rating of 53.2

Characteristic	Field Observation
Date observed	12/18/2014
Type	Concrete Pipe
Diameter	24"
Length	31'
Funding	Town
Stream Name (Tributary)	unknown (Seven Mile River)
Water Depth	10"
Outlet Drop	N/A

Structural assessment results:  
**good condition (0.78/1)**

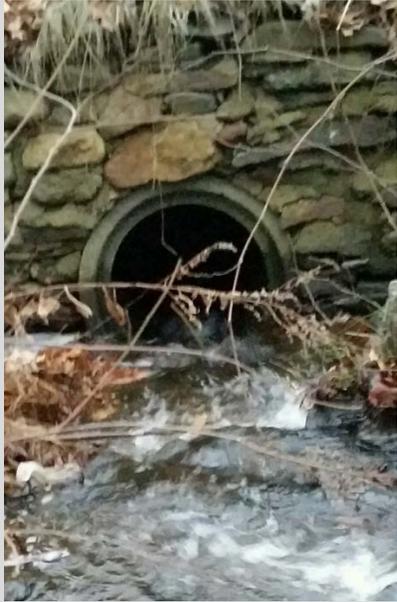
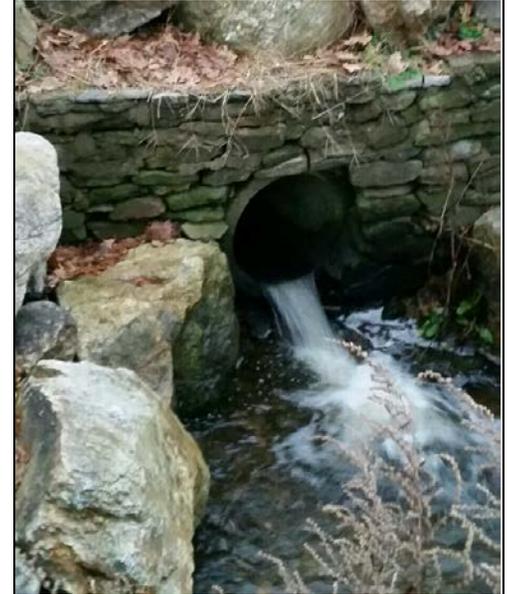
North Spencer Road 2

Characteristic	Field Observation
Date observed	12/18/2014
Type	Concrete Pipe
Diameter	24"
Length	40'
Funding	Town
Stream Name (Tributary)	unknown (Seven Mile River)
Water Depth	2"
Outlet Drop	10", Freefall

Structural assessment results:  
**good condition (0.77\*/1)**

- ❖ Headwall is in poor condition
- ❖ Multiple hydraulic jumps within 30 ft. upstream
- ❖ Mild constriction of stream
- ❖ Leads into pool separating this culvert from North Meadow Rd Culvert 2

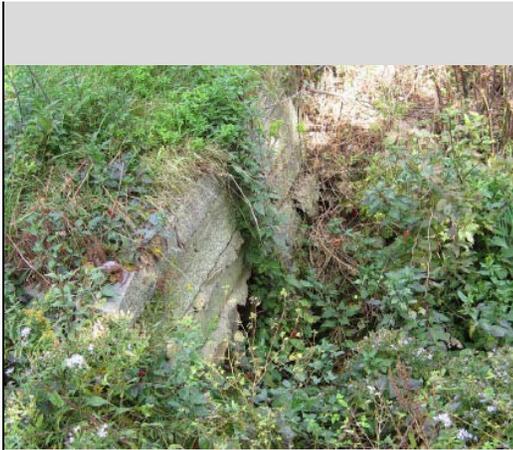
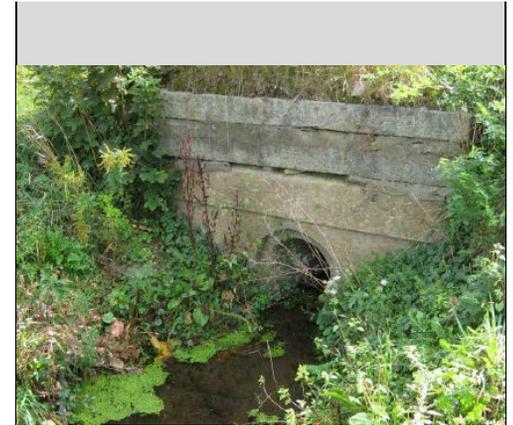
North Spencer Road 3

Characteristic	Field Observation
Date observed	11/22/2014
Type	Metal Pipe
Diameter	32"
Length	129'
Funding	Town
Stream Name (Tributary)	unknown (Seven Mile River)
Water Depth	5"
Outlet Drop	4" to stream bed

Structural assessment results:  
**fair condition (0.67/1)**

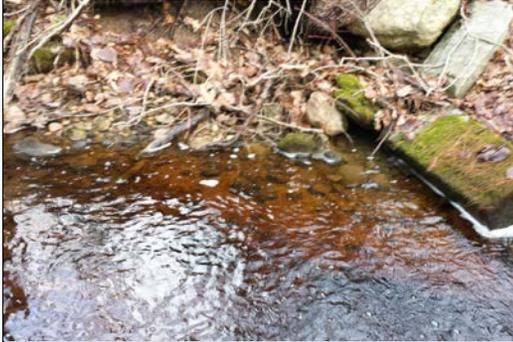
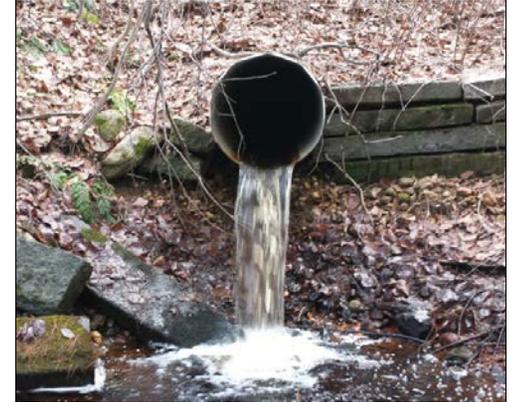
North Spencer Road 5

NOTE BROWN WATER AT OUTLET

Characteristic	Field Observation
Date observed	12/18/2014
Type	Metal/Concrete Pipe
Diameter	24"/30"
Length	120'
Funding	Town
Stream Name (Tributary)	unknown (Seven Mile River)
Water Depth	5"
Outlet Drop	48", Freefall

Structural assessment results:  
fair condition (0.67\*/1)

- \* Embankment
- Scouring and Erosion
- Pipe in two pieces
- Road Condition

- Pipe replacement (match slope of stream and increase capacity)

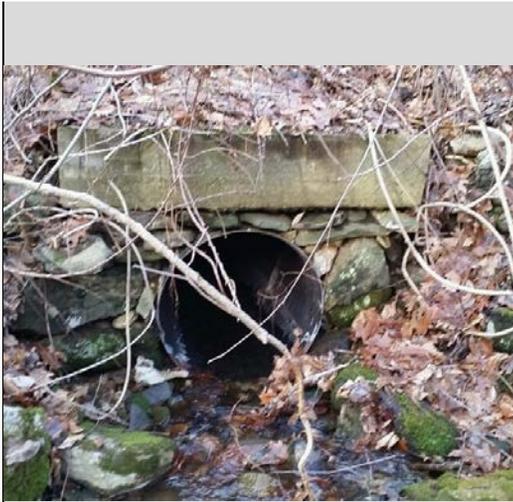
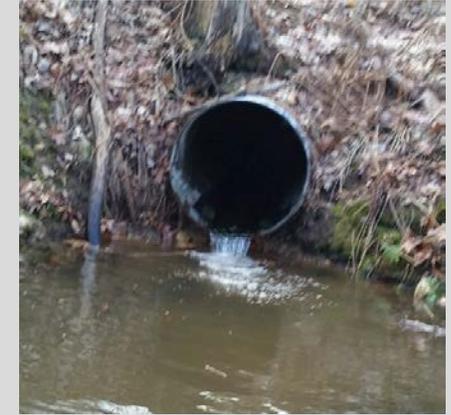
North Spencer Road 7

Characteristic	Field Observation
Date observed	12/18/2014
Type	Metal Pipe
Diameter	30"
Length	48'
Funding	Town
Stream Name (Tributary)	unknown (Seven Mile River)
Water Depth	1"
Outlet Drop	2", Freefall

Structural assessment results:  
**fair condition (0.73/1)**

- Adjust stream path through wetland area
- Pipe replacement

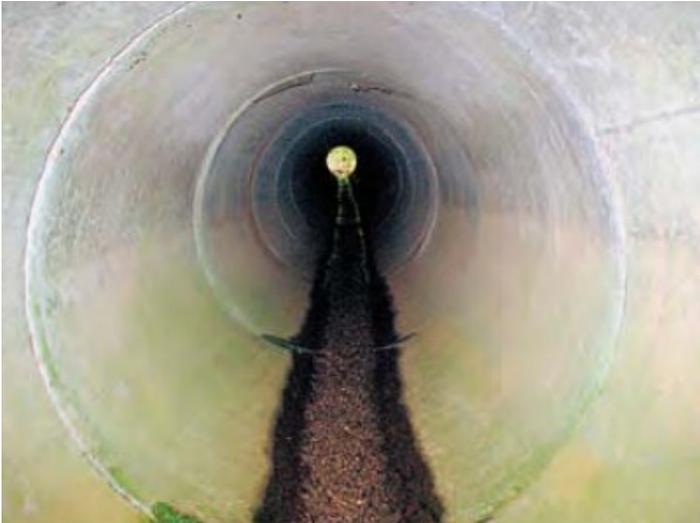
Good

Joints and seams are tight with no openings.<sup>1</sup>

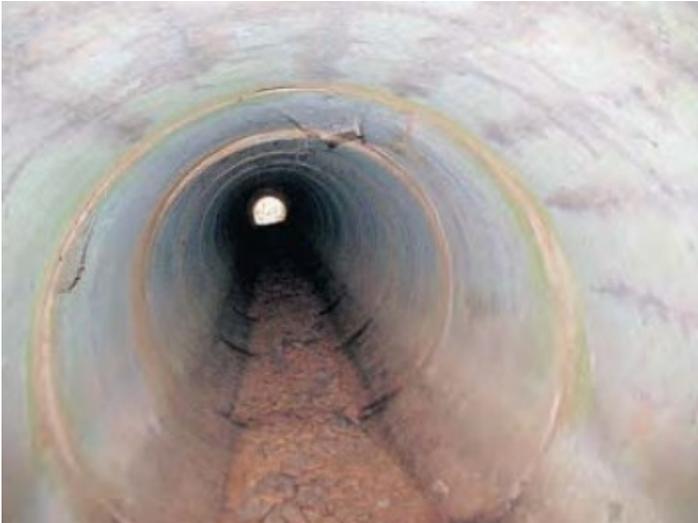
Good

No visual evidence of cracking, or only minor hairline cracking at isolated locations, or minor scaling of invert.<sup>1</sup>

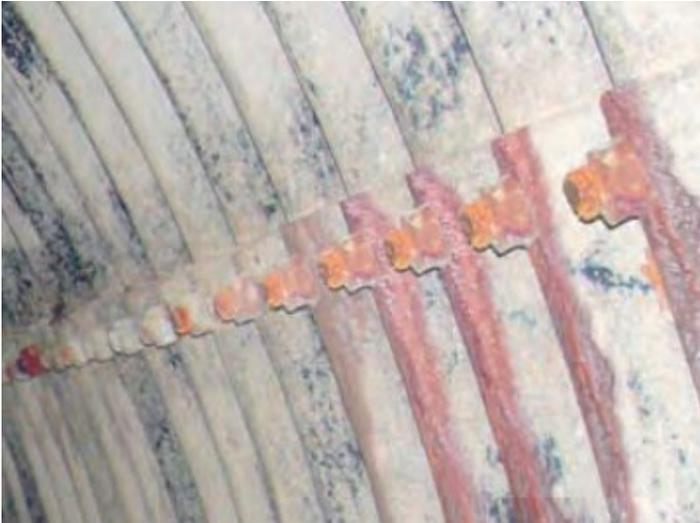
Good

No visual evidence of cracking along bolt holes or seams.<sup>1</sup>

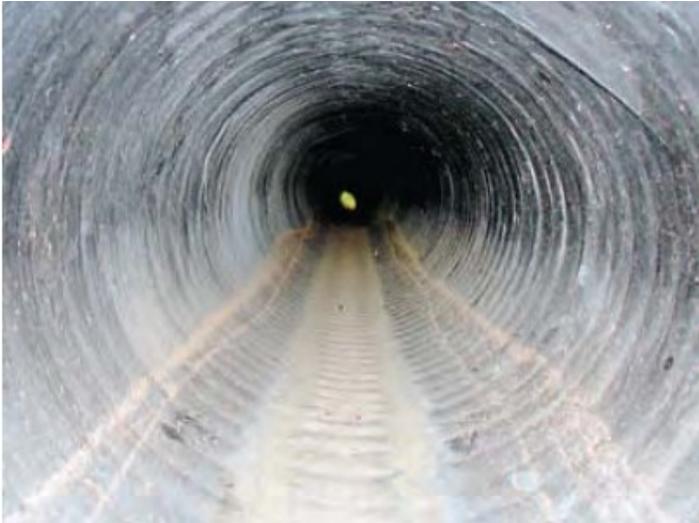
Fair

Minor isolated rip or tear caused by debris less than 6" in length and 1/2" in width. Minor cuts or gouges to end sections from maintenance or construction activities.<sup>1</sup>

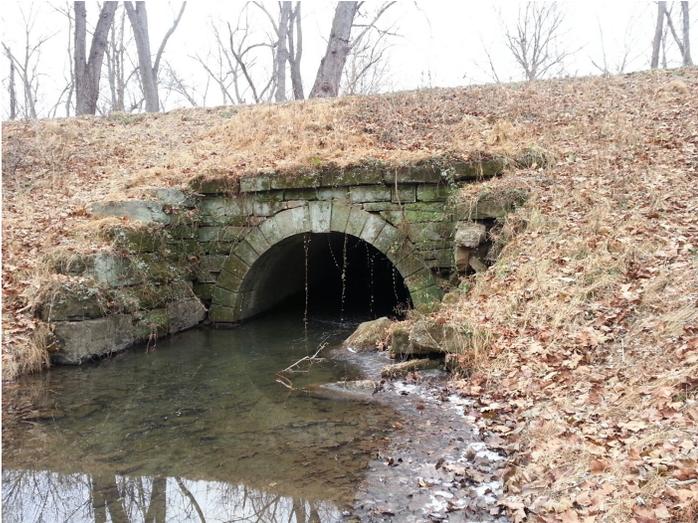
Good

Little or no deterioration. Masonry may have minor weathering (mortar joints are sound). Joints have no leakage.<sup>3</sup>

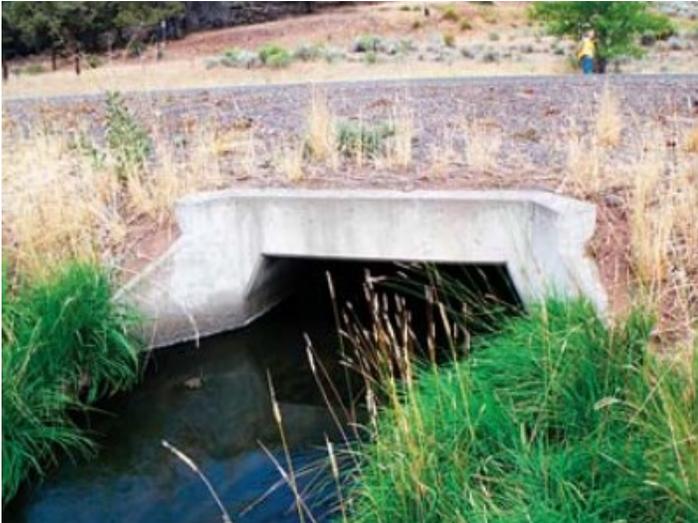
Good

Little or no cracking, rotation, or displacement. Light concrete scaling, metal corrosion, or other surface deterioration.<sup>4</sup>

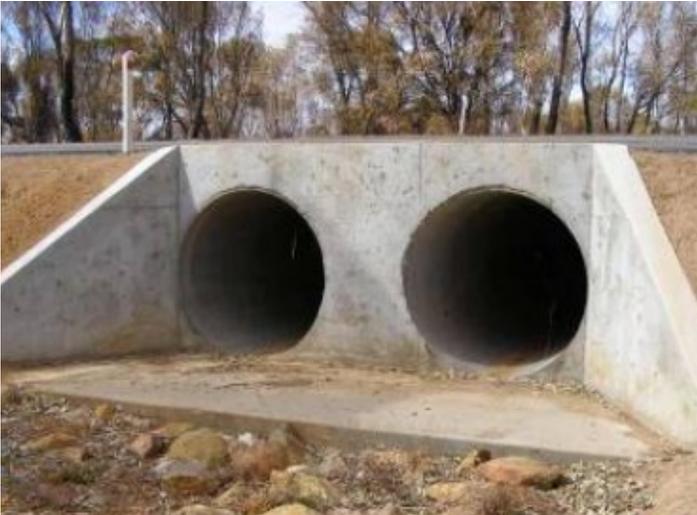
Good

No cracking, piping, or undermining.<sup>4</sup>

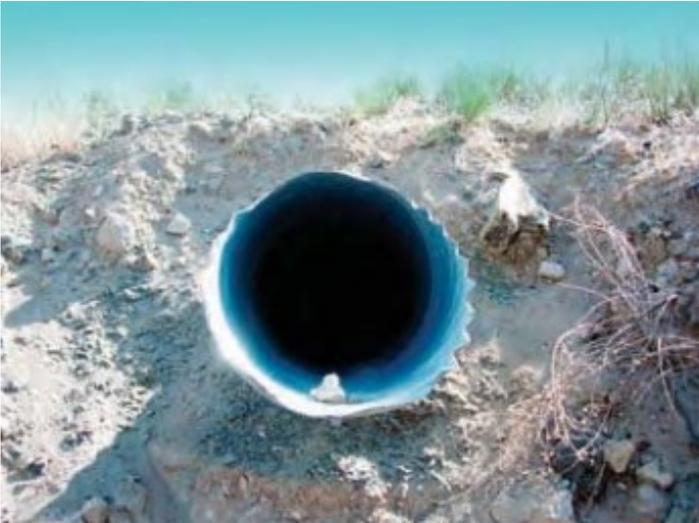
Good

No signs of flow through embankment on outside of culvert barrel.<sup>1</sup>

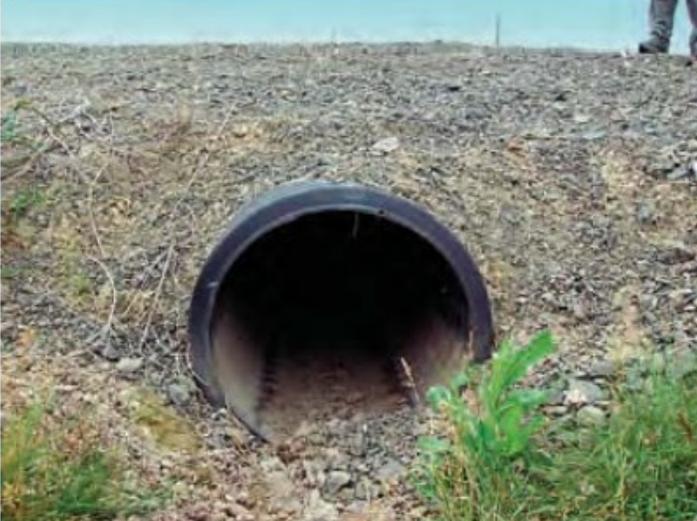
Good

No visual evidence of culvert undermining or exposed footings. Only minor scour hole is present. Culvert span to scour hole depth ratio is greater than 10.<sup>1</sup>

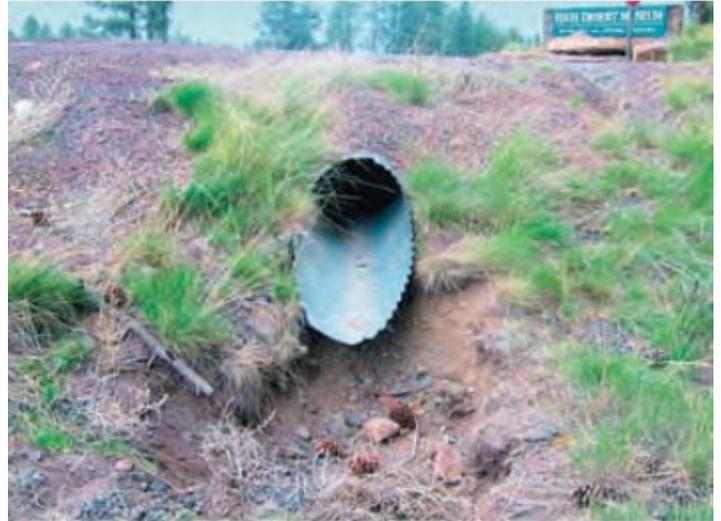
Fair

Minor undermining of the culvert barrel or top of footing is exposed. Culvert span to scour hole depth ratio is between 5 to 10.<sup>1</sup>

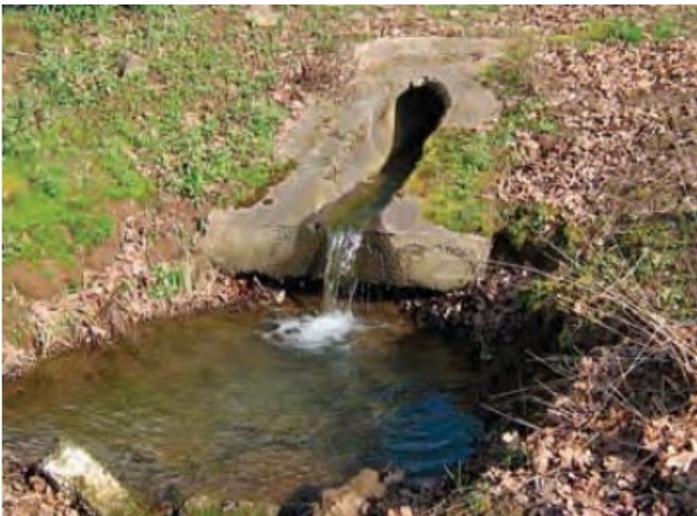
Poor

Significant undermining of the culvert barrel or undermining of the footing. Culvert span to scour hole depth ratio is between 2 to 5.<sup>1</sup>

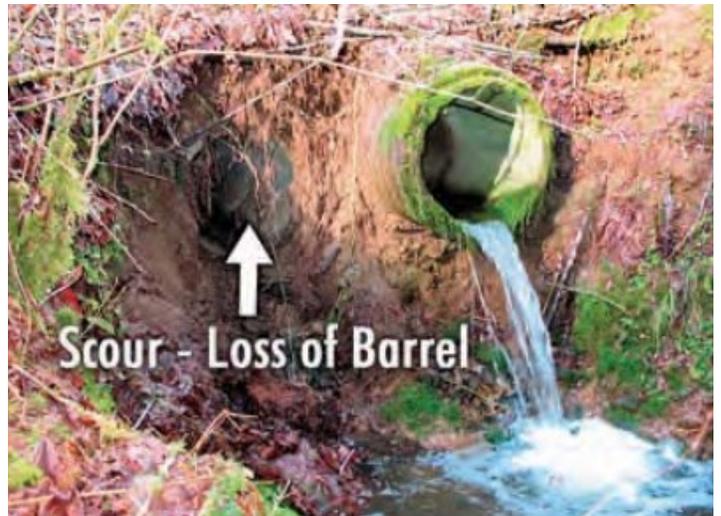
Critical

Extensive undermining of the culvert barrel or footing. Culvert span to scour hole depth ratio is less than 2.<sup>1</sup>

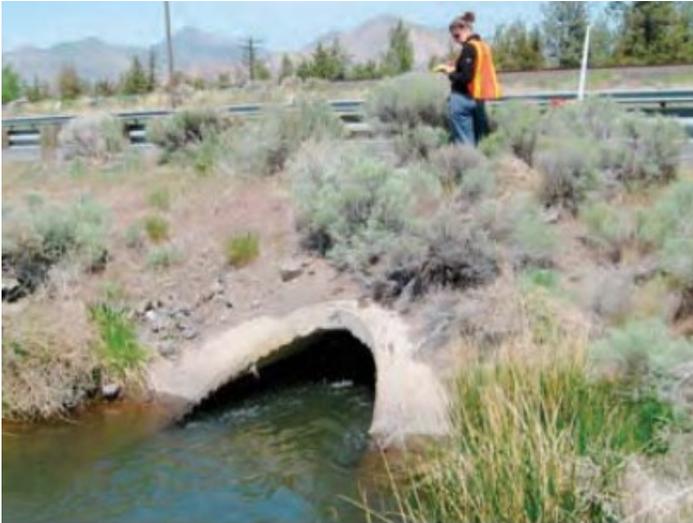
Good

Angle measured from upstream channel to centerline of culvert barrel is from 0-15 degrees.<sup>1</sup>

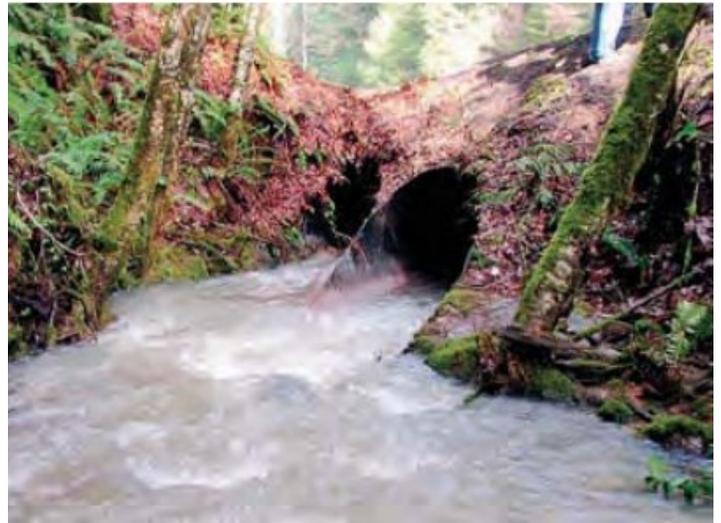
Fair

Angle measured from upstream channel to centerline of culvert barrel is from 15-45 degrees.<sup>1</sup>

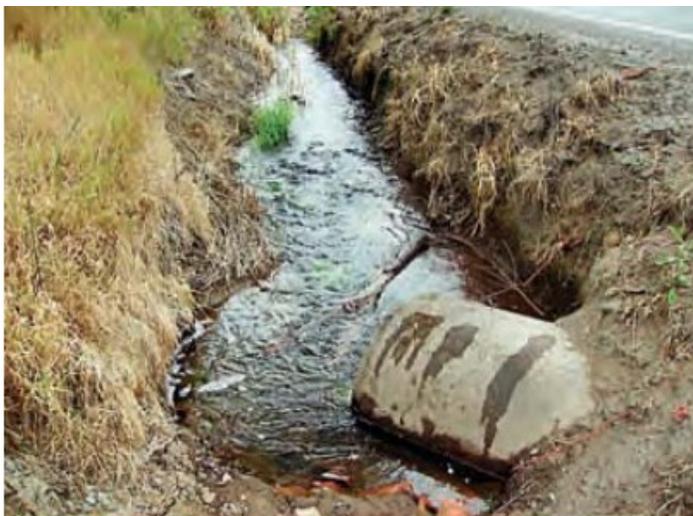
Poor

Angle measured from upstream channel to centerline of culvert barrel is from 45-75 degrees.<sup>1</sup>

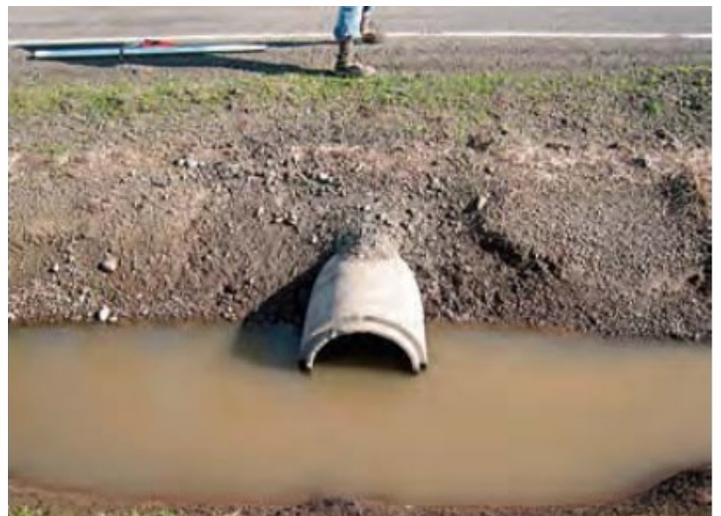
Critical

Angle measures from upstream channel to centerline of culvert barrel is larger than 75 degrees.<sup>1</sup>

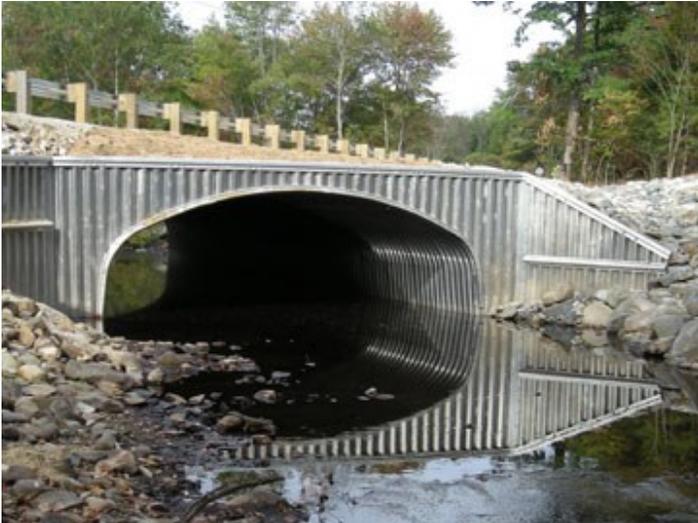
Good

Little or no deterioration. Concrete - minor cracking, leaching, or scaling. Masonry - minor weathering (joints are sound). No footing exposed.<sup>3</sup>

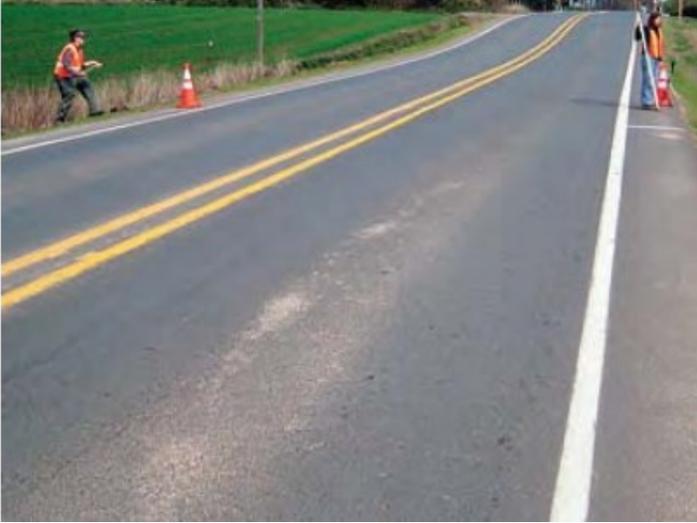
Good

Pavement has no visible defects, small cracks, or maintenance patches.<sup>1</sup>

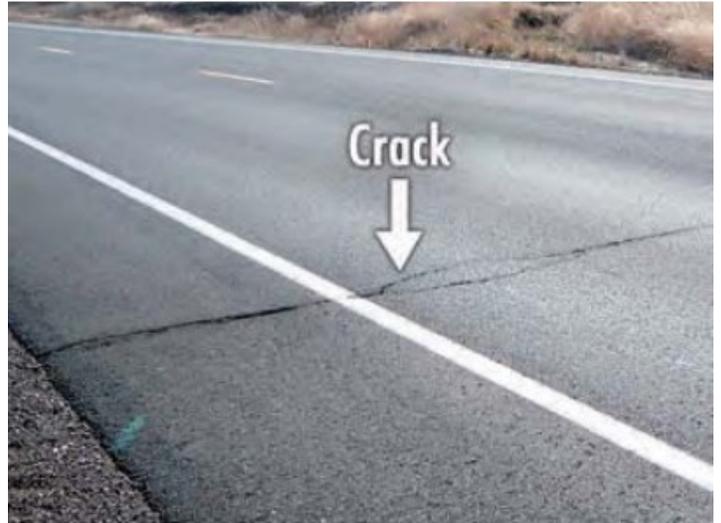
Fair

Minor isolated cracking and spalled areas.<sup>1</sup>

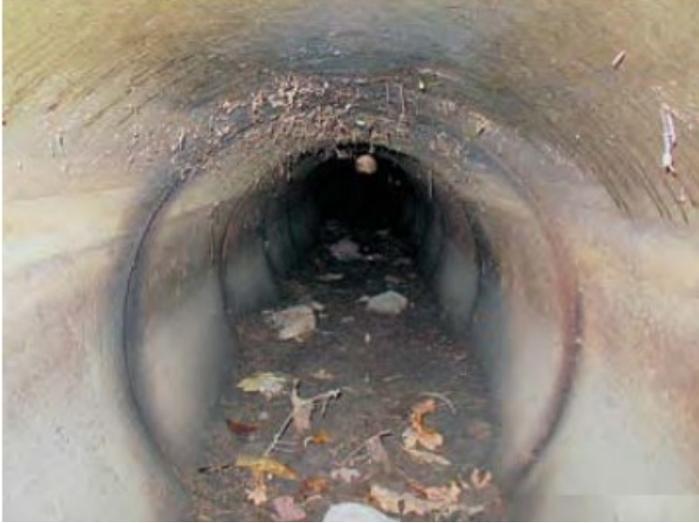
Good

Blockage occupies less than 10% of opening.<sup>1</sup>

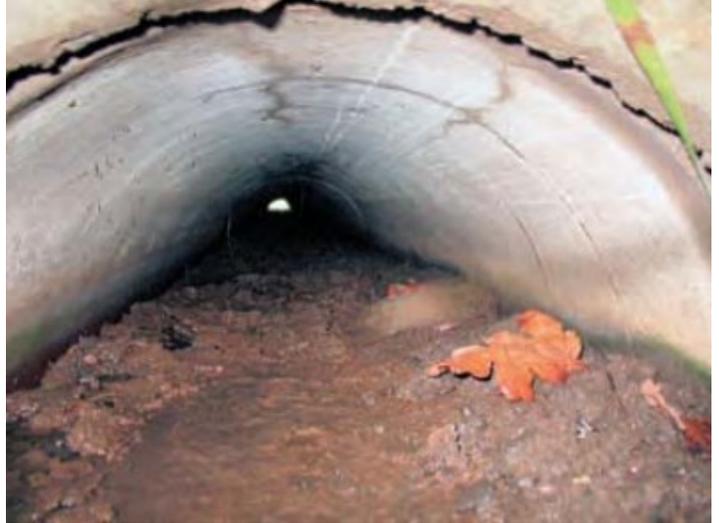
Fair

Blockage occupies 10-30% of opening.<sup>1</sup>

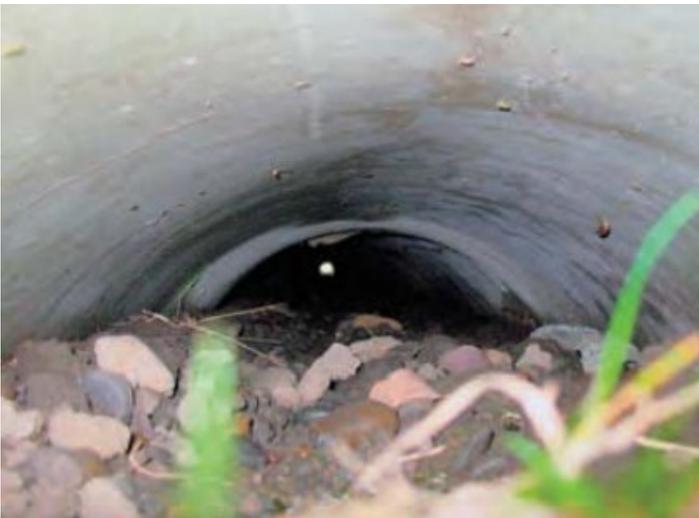
Poor

Blockage occupies 30-75% of opening.<sup>1</sup>

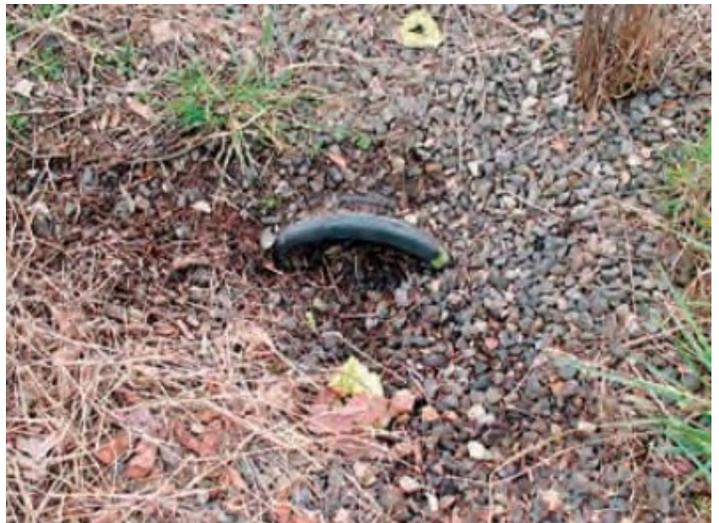
Critical

Blockage occupies >75% of opening.<sup>1</sup>

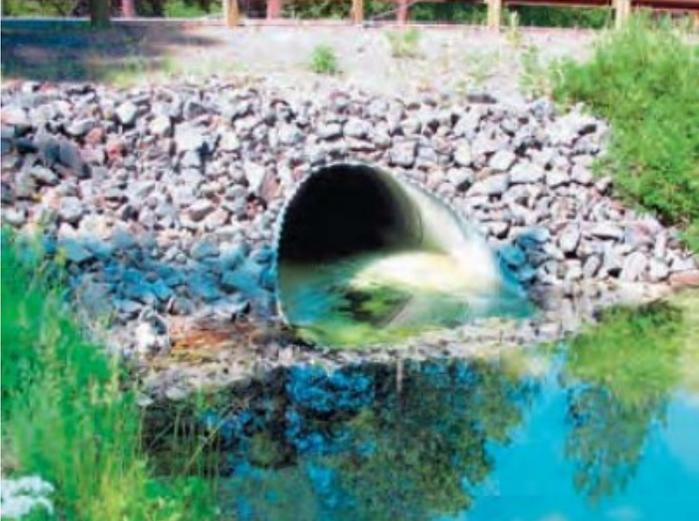
Good

No noteworthy deficiencies which affect the condition of the embankment protection.<sup>1</sup>
