20 April 2016

Existing Building Analysis for existing structure:

## **Lake Street School Spencer Massachusetts**

Lake Street School  
Spencer, MA  
Existing Conditions Systems Report  
J#683 001 00.00  
L#511101/Page 1/March 3, 2016

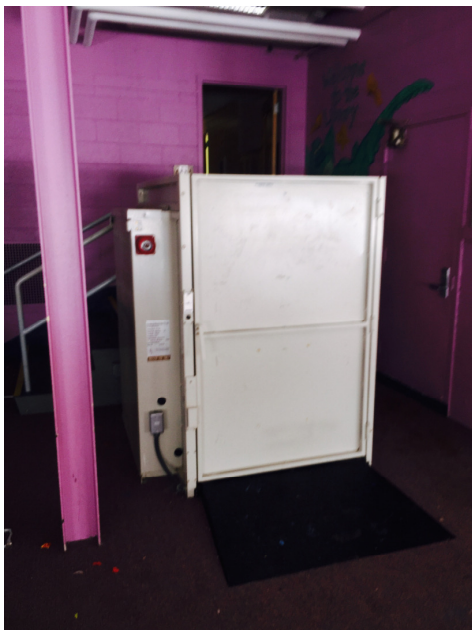
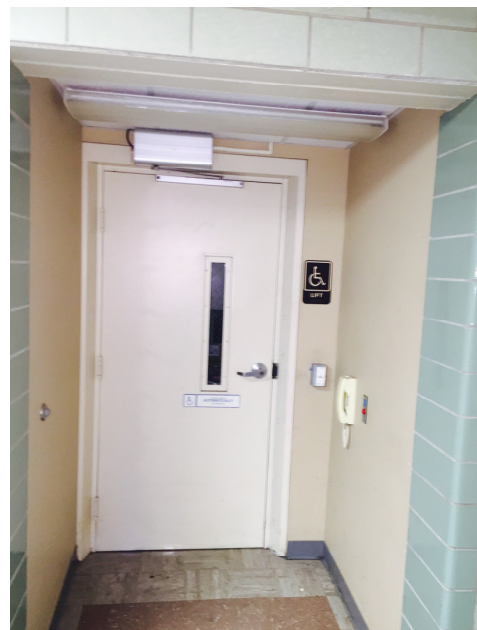
While attempts were made to provide an accessible environment, there are areas which are not completely available for use by all due to changes in levels with only stairs leading into them as in the case of the art rooms. As mentioned previously, there are spaces in the existing building that were modified from their original purpose to fulfill new roles through time. Most significant of these is the end shop area which resulted in the need for a wheel chair lift to be installed. Another lift was installed during the school's previous accessibility upgrades that provides access from the lower level to the main and the stage in the multi-purpose room. Both lifts appear to operate, though they are showing signs of their age (the larger lift enclosure was not accessible during the time of this visit). Accessible bathrooms are provided for the students in the 1977 addition and the original bathrooms were crudely modified to provide an accessible stall and sink in each of the boy's and girl's rooms, additionally there is a unisex accessible toilet that was created in the original building. There are numerous sinks located in several classrooms, not all of which are accessible or are protected as required.

Wheel chair lifts

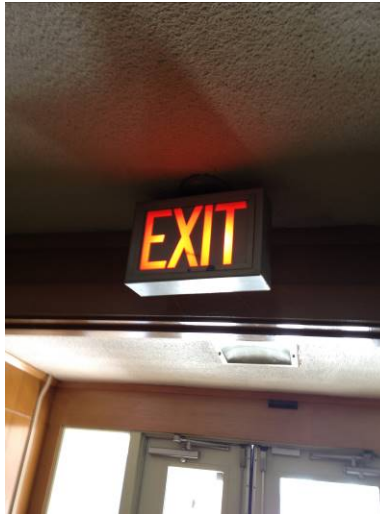
*Exit Sign*

There are no emergency lights at exterior doors. Most exit signs are not of the LED type. Exit signs in gym/multi-purpose room are locally switched; code requires exit signs to be "ON" during the occupied mode.

The emergency system should be replaced under a renovation program.

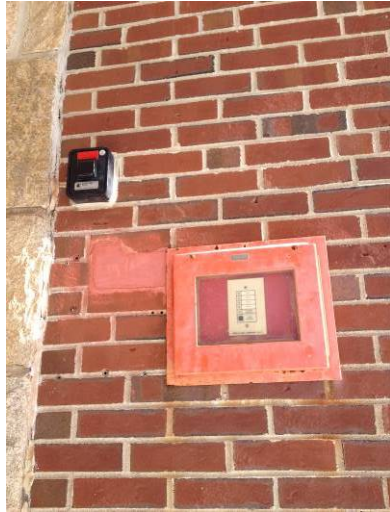
*Knox Box & Annunciator*

Smoke detectors and horn/strobes exist in corridors and stairwells. Classrooms do not have smoke detectors or horn/strobes. Corridor doors have magnetic hold opens. A knox box and flush annunciator are located at the exterior main entrance.

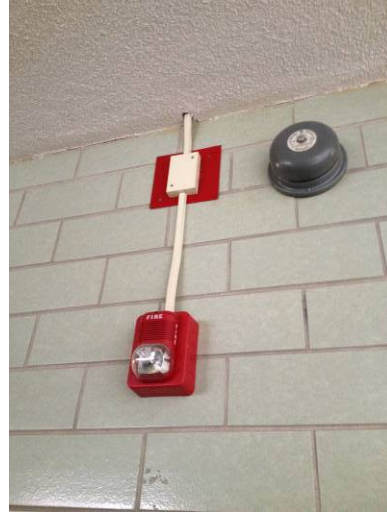
*Horn/Strobe*

The fire alarm system offers inadequate coverage of detection and notification devices for a non-sprinklered building. Current code requires voice evacuation in lieu of horns for K-12 Educational Facilities.

The fire alarm system should be replaced under a renovation program.

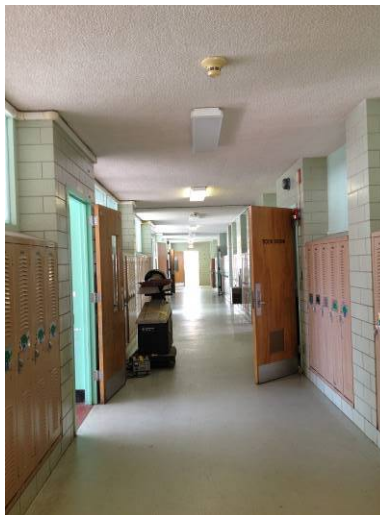
*Corridor Lights*

The corridor lighting consists of 1x4 wraparound fixtures with acrylic lens and T8 lamps. The addition has recessed 2x4 troffers. Corridor lighting is controlled with local switches.

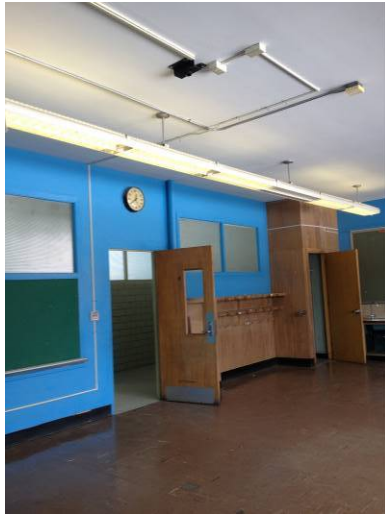
*Classroom Lights*

Typical classrooms in the 1956 building have two rows of pendant direct/indirect fixtures with steel baffles with (2) T12 lamps. The 1977 addition has recessed 2x4 troffers with T8 lamps. Classrooms have dual switches and occupancy sensors.

While the lighting in the addition is in fair condition, the lights in the original building are generally in poor condition.

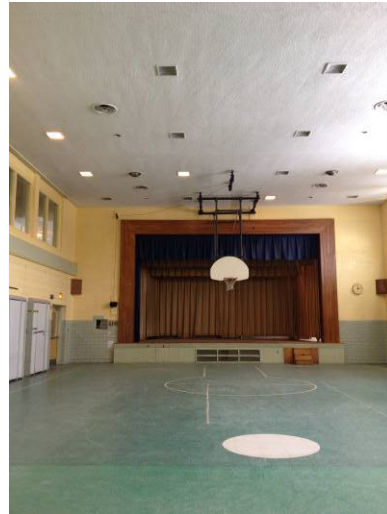
*Gymnasium Lights*

The gymnasium and platform have 18" square recessed HID lensed fixtures retrofitted with compact fluorescent lamps.

The lighting is breaker controlled from a local panel.

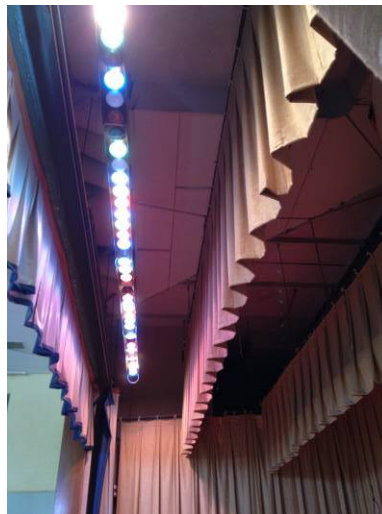
*Stage Lights*

The platform has one electric strip with border lights, also breaker controlled.

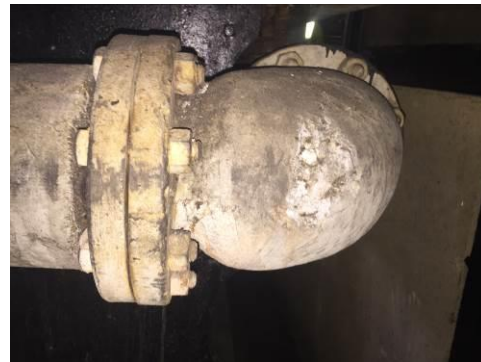
Hazardous materials are most likely also found in some of the plaster finishes used in that portion of the building as well. In the boiler room, it appears as much of the pipe wrapping work at the elbows possibly known to contain asbestos have already been mitigated, but that is unclear. Additionally, the boilers themselves also contain hazardous fibers in the internal chambers of the units. At the time of the visit, none of the potentially compromised materials were friable. Responsible removal is always recommended, but depending on the level of potential renovations, encapsulation is also an option.

Typical Asbestos Elbow Insulation

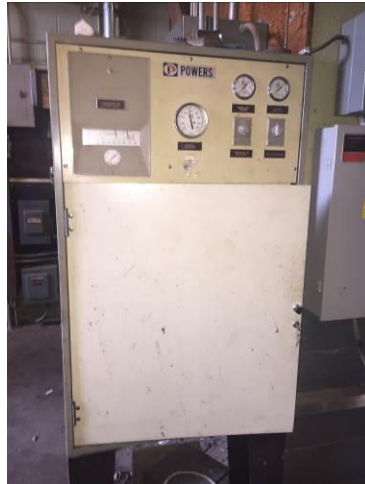
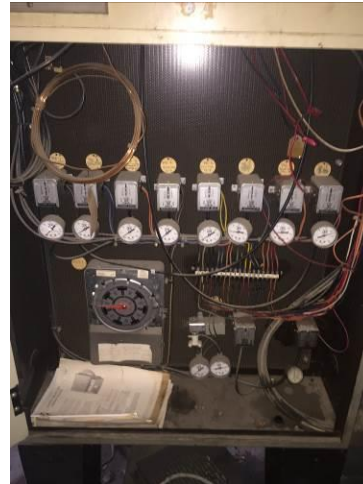
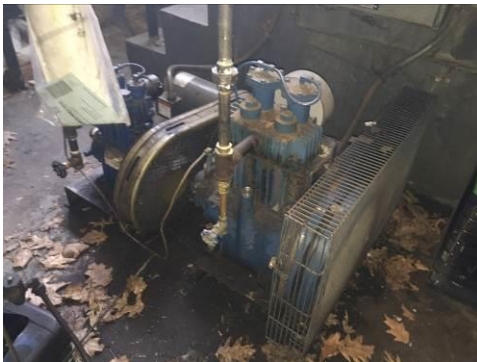
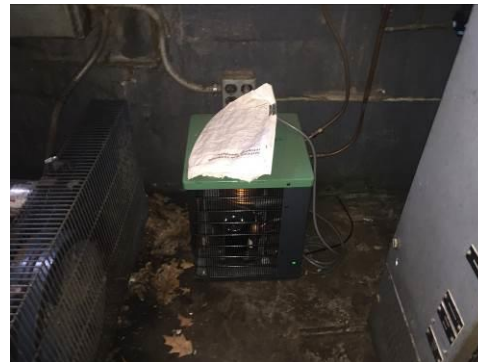
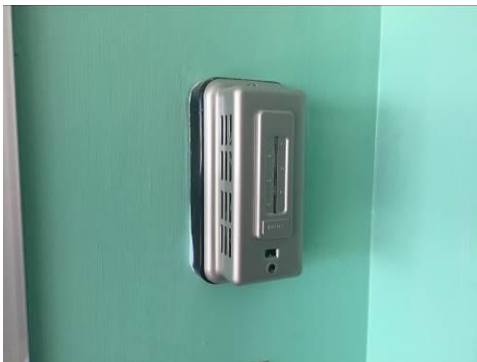
The building is equipped with the original pneumatic controls which was manufactured by Powers. All related equipment such as the air compressor and the refrigerant air dryer are all original as well. The pneumatic system controls all building components such as the unit ventilators, dampers and control valves associated with the indoor air handling unit and the wall mounted fin tube radiation. The existing control system is equipped with a master panel which provides manual control of all exhaust fans and unit ventilators, it also has a day cycle option for manual control or automatic control. Scheduling is completed through the use of a building time clock which connected to pneumatic control system. Overall the functionality of the existing control system is not adequate nor is it energy efficient. Complaints of spaces overheating or under heating is typical throughout the building which causes uncomfortable temperatures for the occupants. A complete upgrade of this system is required and a direct digital control system with web access should be considered.

Powers Pneumatic Control System

Pneumatic Transducers

Air Compressor for Control System

Refrigerant Air Dryer for Control System

Typical Pneumatic Thermostat

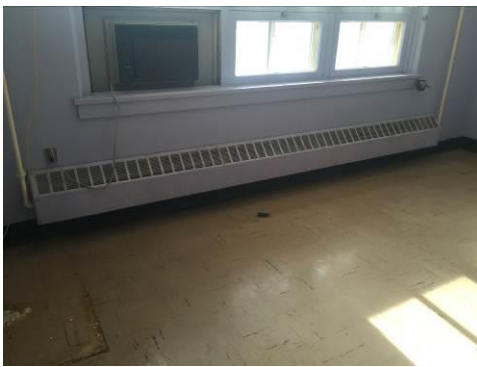
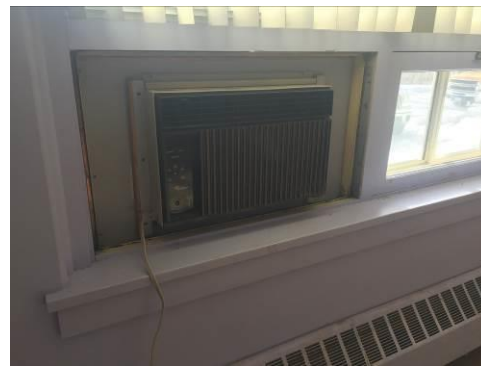
The administration area is provided with wall mounted fin tube radiation for heating purposes only. There is no mechanical ventilation system within this area and the operable windows are utilized for the spaces ventilation needs. Residential style window air conditioners are used for cooling purposes and are located throughout the areas. The fin tube radiation in some areas are damaged and missing components. Temperature controls for this area is accomplished with wall mounted pneumatic thermostats. Overall all, the components within this area is in poor condition and should be replaced.

Typical Wall Mounted Fin Tube Radiation

Typical Wall Mounted Air Conditioner

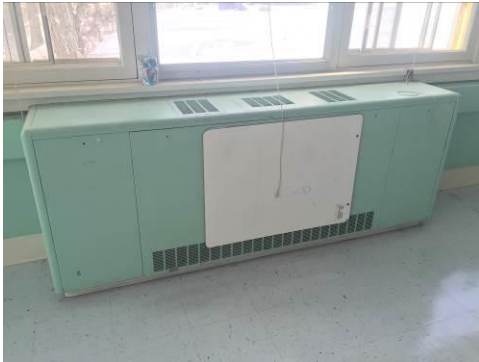
The original 1956 building and the 1977 addition both utilize unit ventilators for the heating and ventilation needs of the classrooms. These unit ventilators contain supply fans, hot-water heating coils, filters and a pneumatic actuator for outside air damper control and hot water control valve. The original building has Trane unit ventilators while the addition has Nesbitt units. Each unit is provided with outside air ventilation through the unit ventilators outside air louver which is wall mounted. Alongside each unit ventilator is wall mounted fin tube radiation which is also original to the building. This fin tube is not consistent throughout every classrooms. Each classroom is equipped with a low wall mounted exhaust register which is utilized to maintain a neutral pressure within the space due to the outside air that is introduced through the unit ventilator. This exhaust system is provided with a galvanized sheet metal duct distribution system which communicates to roof mounted exhaust fans. Each space is also provided with a Powers wall mounted pneumatic thermostat. These unit ventilators are internally dirty, missing components, some hot water coils have been disconnected due to potential freezing issues and overall antiquated and at the end of their serviceable life. The functionality of all the units is poor including the pneumatic controls.

Typical Wall Mounted Unit Ventilator in Original Building

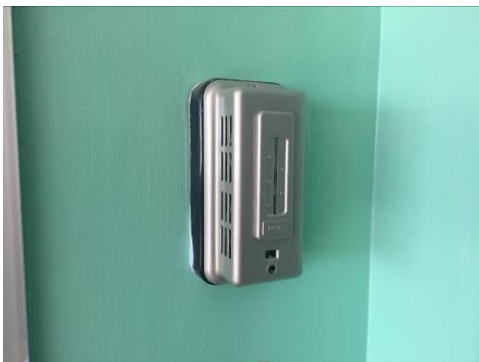
Typical Wall Mounted Pneumatic Thermostat

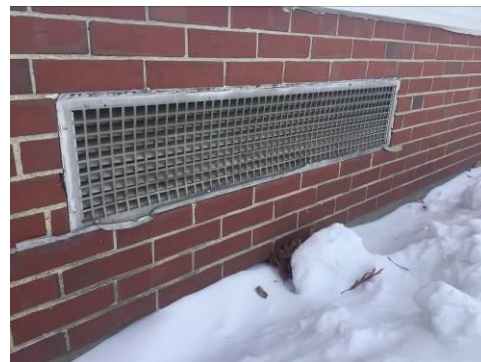
Typical Wall Mounted Louver for Unit Ventilator

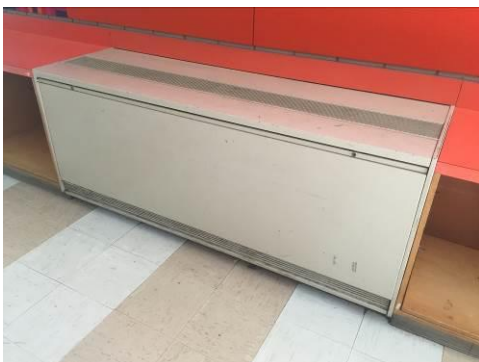
Typical Wall Mounted Unit Ventilator in the Addition

- The existing building hot water heating equipment, including classroom unit ventilators, indoor air handling unit, fin tube radiation, convectors and unit heaters should be replaced. Depending on the building future use, unit ventilators may not be the best option considering outside air ventilation is limited with unit ventilators and they are high maintenance. In a situation where higher ventilation needs would be required due to occupancy use group modifications then central roof top units or indoor air handling units should be utilized.

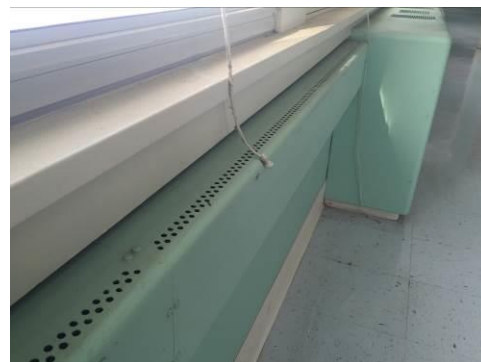
Typical Wall Mounted Fin Tube Along Side of Unit Ventilator

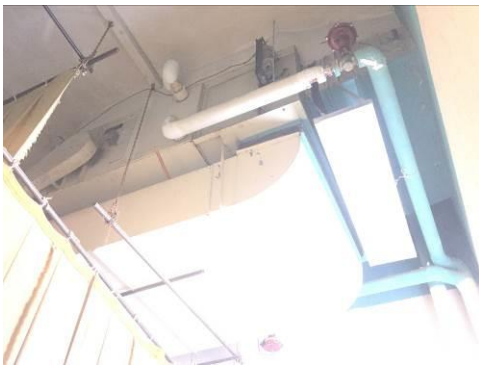
The gymnasium is utilized as several spaces, a Gym, a Cafeteria and an Auditorium. This space is provided with heated and ventilated air through a single central heating and ventilating unit located high within the stage area. The air handling unit is provided with outside air, return air, and supply air galvanized sheet metal duct distribution systems and provides heated ventilation air to the occupied space. None of the ductwork system are insulated. The tempered air terminates high within the space at the ceiling level. The style diffusers that are utilized are not appropriate for the height at which these diffusers are located. This causes heating issues since the tempered air cannot reach the occupied zone. The return air is captured and returned to the unit through a low wall mounted grille located at the base of the base. It was further noted that an individual roof exhaust fan is provided for minimum outside air control which is interlocked with the air handling unit. Generally speaking the entire installation would be considered in fair condition. Temperature control for the space is handled with wall mounted pneumatic thermostats. There are two, one is for day setpoint and the other is for night setpoint. Overall the system is in fair condition with the exception of the thermostats.

Indoor Air Handling Unit

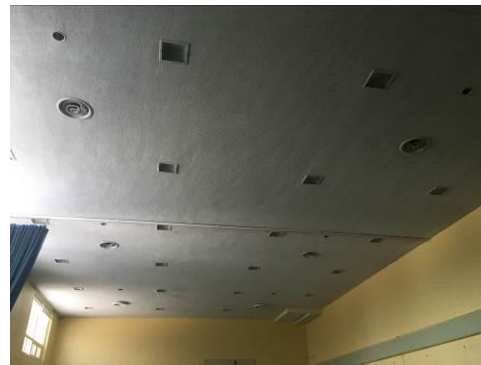
Ceiling Mounted Diffusers

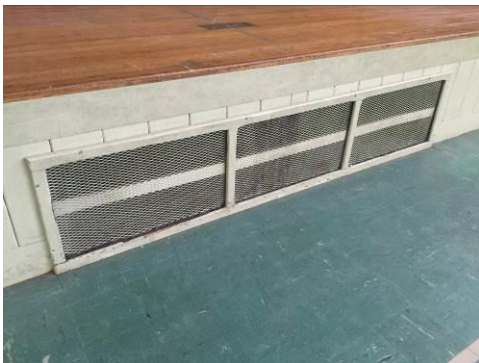
Low Wall Return Grille

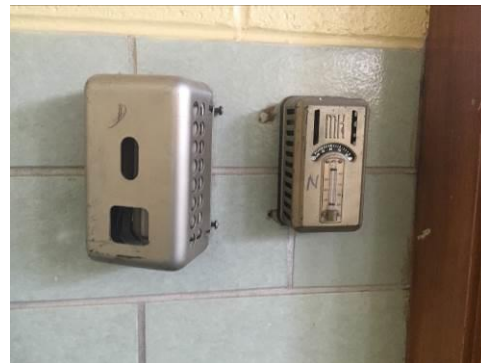
Space Day/Night Thermostat

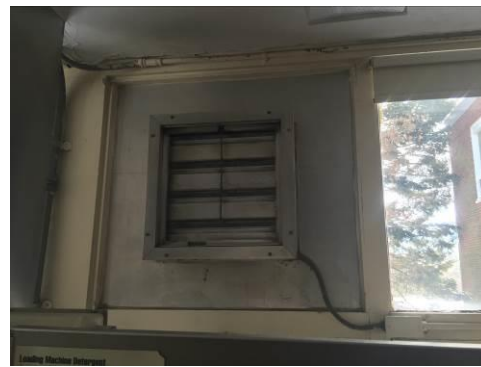
The kitchen is equipped with a cooking hood however it does not contain a fire suppression system, it does have a dedicated roof mounted exhaust fan however there is no mechanical ventilation unit for makeup air. Makeup air for the hoods exhaust system is accomplished through a wall mounted louver which opens upon activation of the kitchen hood. The kitchen itself is heated through the use of a vertical style propeller unit heater which is controlled via a standalone thermostats, which does appear to be damaged. The adjacent locker room area is heated with wall mounted fin tube radiation which is controlled via a wall mounted pneumatic thermostat which is damaged. Also located within the kitchen is a dishwashing system, this system is equipped with what appears to be a stainless steel exhaust duct which travels up to the roof. This system appeared to be relatively new however it was unknown if the system was functional. Overall the equipment associated with the equipment within this space does not meet today's standards and code requirements.

Makeup Air Louver

- All existing ductwork should be replaced.
- A new kitchen exhaust hood should be provided, along with a new exhaust fan and make up air system.
- Ventilation air systems should be provided for the corridors.

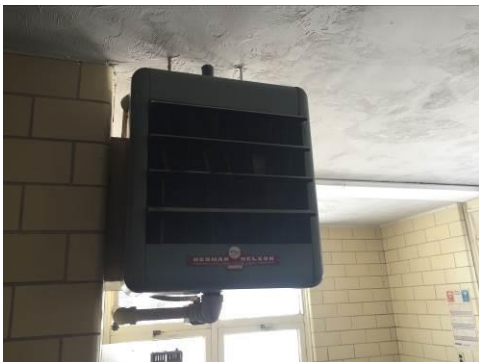
Vertical Unit Heater

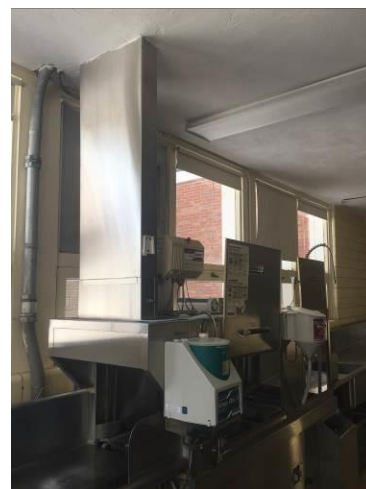
Dishwasher Exhaust System

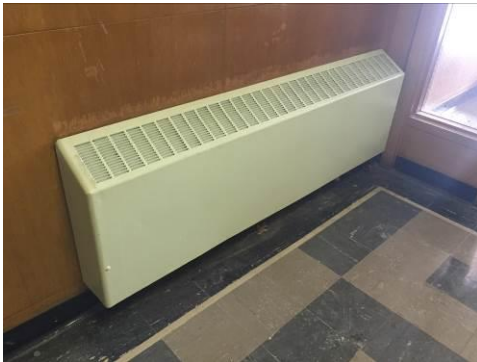
The common areas such as corridors, vestibules, restrooms and lobbies are provided with supplemental heat through the use of wall mounted convectors, fin tube radiation and unit heaters. Each component appears to have an original wall mounted pneumatic thermostats associated with it however, it's unclear as to whether or not the thermostat is functioning. The corridors do not have any ventilation air provided which is not code compliant.

Typical Convector

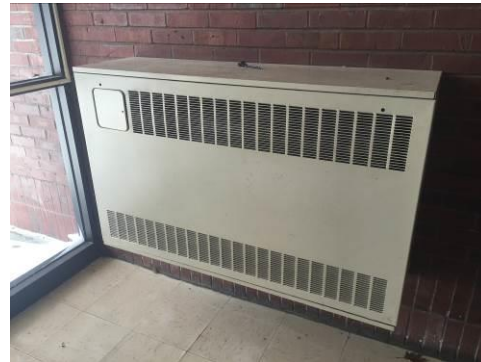
Typical Unit Heater

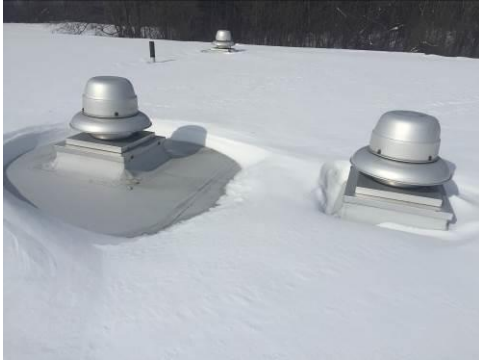
Throughout the building general exhaust is provided through the use of roof mounted exhaust fans. These fans are located in areas such as toilet rooms, storage rooms, custodial closets, mechanical spaces and electric rooms. The manufacture varies and so does the installation date, some fans are original while other appear to have been replaced. All the fans are associated with their own independent galvanized sheet metal duct distribution systems and all terminate within the spaces with ceiling or wall mounted grilles. Overall some fans were operating while others were not, the original exhaust fans appear to have reached the end of their serviceable life.

Roof Mounted Exhaust Fans in Addition

- All the exhaust air fans should be replaced.
- A high efficiency air conditioning and ventilation system should be provided for areas that require air conditioning. This would provide a more efficient method to cooling spaces in lieu of residential style air conditioners.

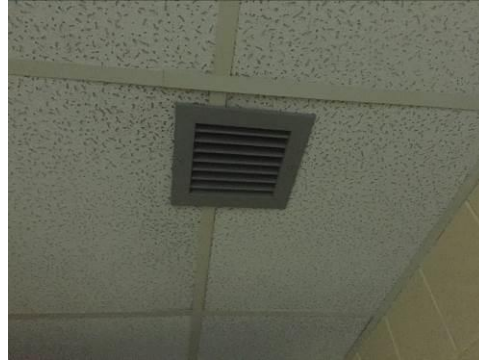
Typical Ceiling Register in Corridor

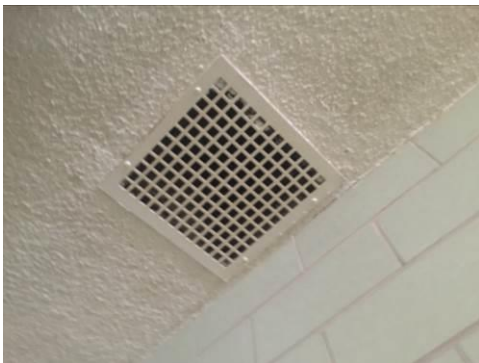
Typical Ceiling register in Toilet Rooms

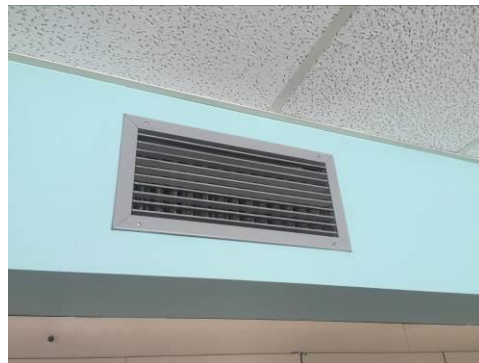
Typical Register in Addition

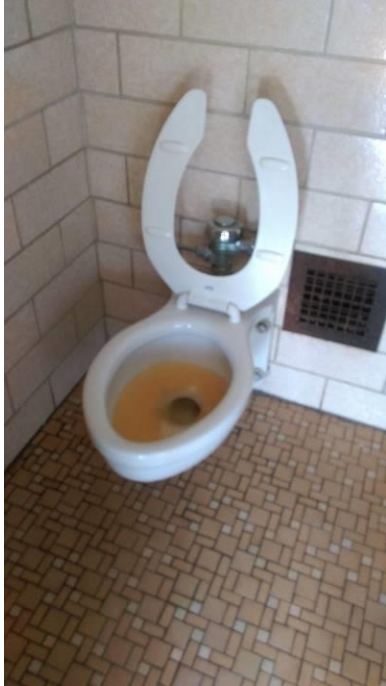
The plumbing fixtures are in fair condition. Attempts have been made to make bathroom fixtures accessible, however, the majority of fixtures do not meet current accessibility codes. In general, the fixtures appear to have served their useful life. Current Access Code requires accessible fixtures wherever plumbing is provided. In terms of the water conservation fixtures, their use is governed by the provisions of the Plumbing and Building Code. Essentially, the code does not require these fixtures to be upgraded, but where new fixtures are installed, as may be required by other codes or concerns, the new fixtures need to be water conserving type fixtures. All new fixtures are recommended.

*Typical Water Closet*

- Original plumbing fixtures should be replaced. New toilet rooms shall be made accessible per current Accessibility Codes. Fixtures should be water conserving type.

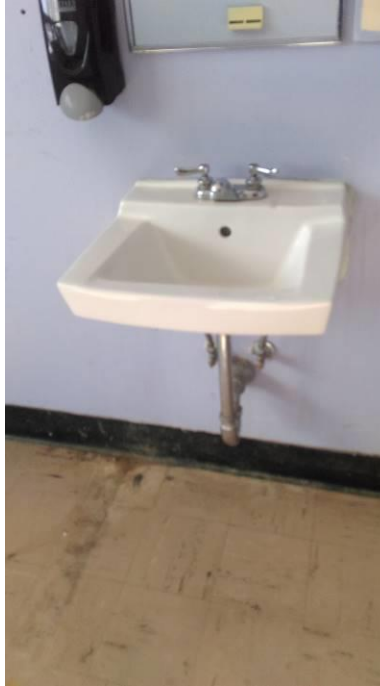
Lavatories are wall hung vitreous china. The majority of lavatories have been retrofitted with dual handle metering faucets. Most lavatories are fitted with hot and cold water handle faucets.

*Typical Lavatory*

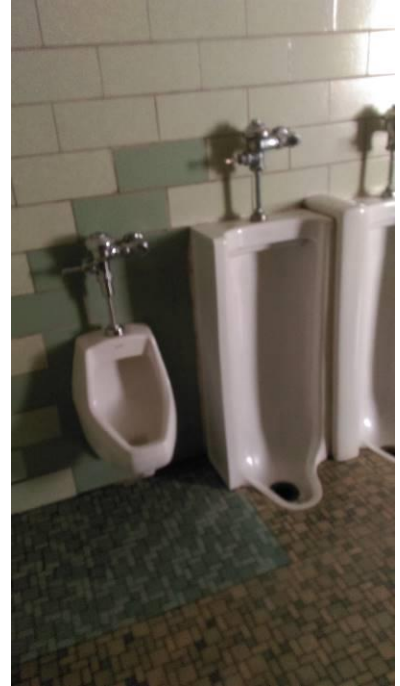
*Typical Urinal*

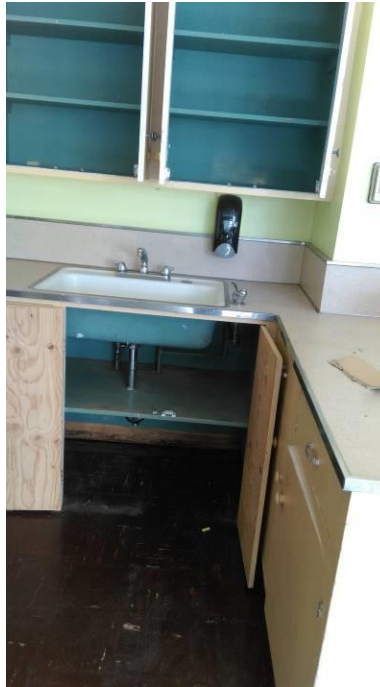
Classroom sinks are vitreous china, drop-in type with cold and hot water faucets and bubbler.

*Classroom Sink*

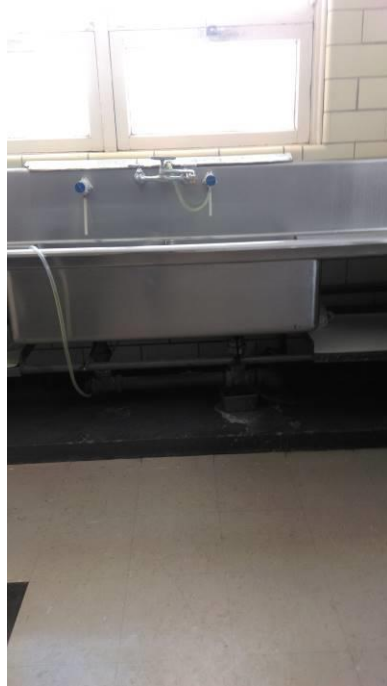
Kitchen area fixtures are in fair condition. The pot washing sink is fitted with a point-of-use, in-ground grease interceptor. The General Kitchen drainage is not directed to an exterior grease trap.

*Pot Washing Sink*

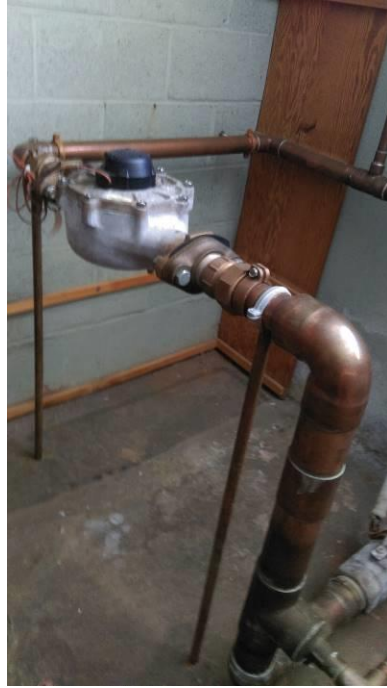
*Water Meter*

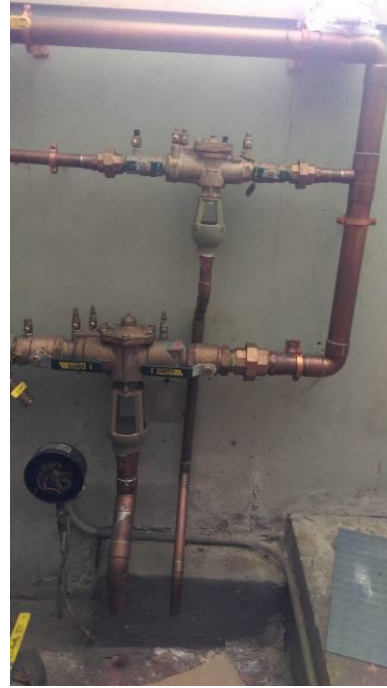
*Backflow Preventers for Make-up Water*

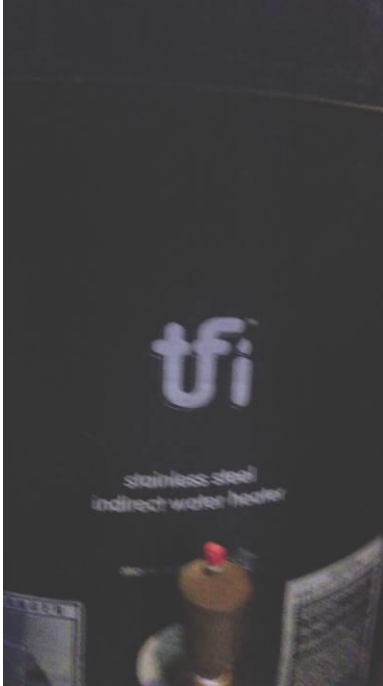
Domestic hot water in the building is generated through an oil-fired boiler with a newer indirect storage tank. A large insulated storage tank which may have been original is located in the Boiler Room appears to have been left abandoned. The hot water systems are recirculated. There is a thermostatic mixing valve on the system used to prevent scalding. The domestic hot water system is inefficient by today's standards.

*Indirect Storage Tank*

A new high efficiency domestic water heating system with thermostatic mixing valve, expansion tank and recirculation pump is recommended.

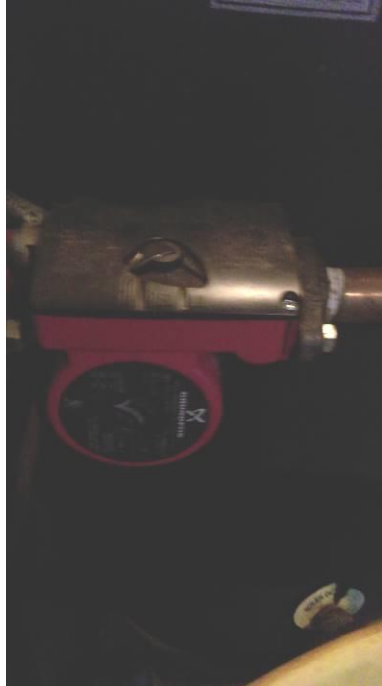
*Recirculation Pump*

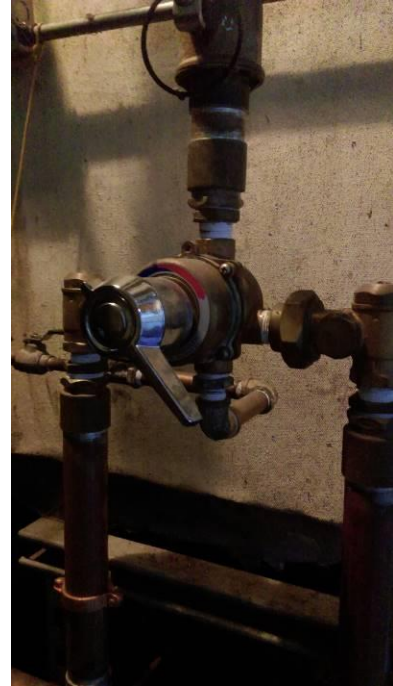
*Mixing Valve*

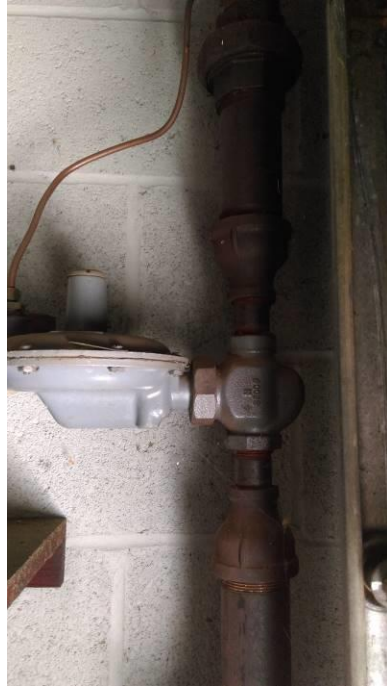
An elevated pressure natural gas service is supplied to the building to serve the Kitchen equipment only. The pressure regulator and gas meter are located in the building interior room which may have been a Garage at one time.

*Gas Service Regulator*

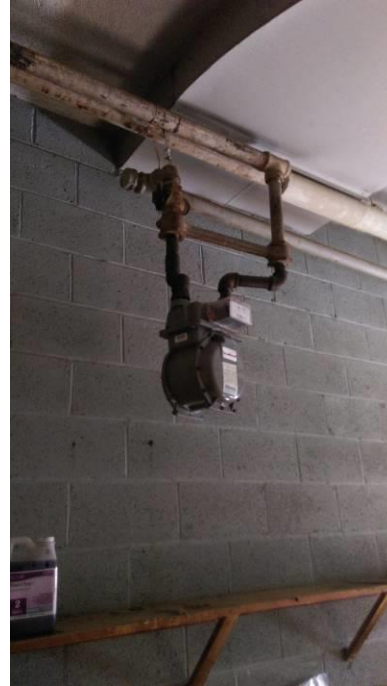
*Gas Meter*

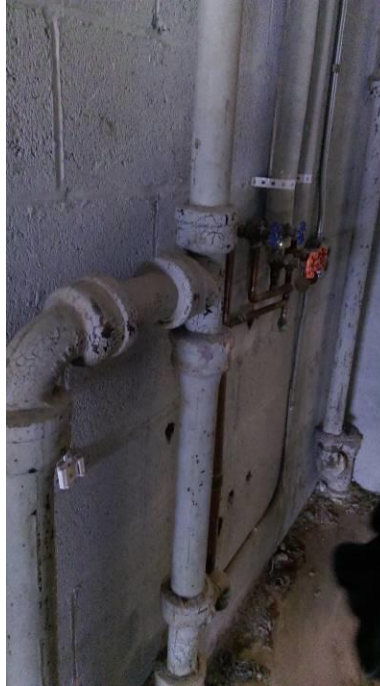
Cast iron is used for sanitary and storm drainage. Where visible, the cast iron pipe appears to be in fair to poor condition. Smaller pipe sizes appear to be copper.

*Cast Iron Piping*

We recommend a contractor videotape the drainage piping to determine interior condition. In general, the drainage piping can be reused where adequately sized for the intended new use if evidence from videotaping suggests this. Otherwise, all original drainage piping should be replaced.

- All original sanitary, waste, vent and storm piping shall be replaced in its entirety. All horizontal storm piping shall be insulated to prevent condensation.
