20 December 2016

Building Analysis for existing structure: **Sugden Building Block, Spencer Massachusetts**

Richard Sugden Commercial Block Building
Spencer, MA
Plumbing Existing Conditions Systems Report
J#683 002 0000
L#53665/Page 1/September 22, 2016

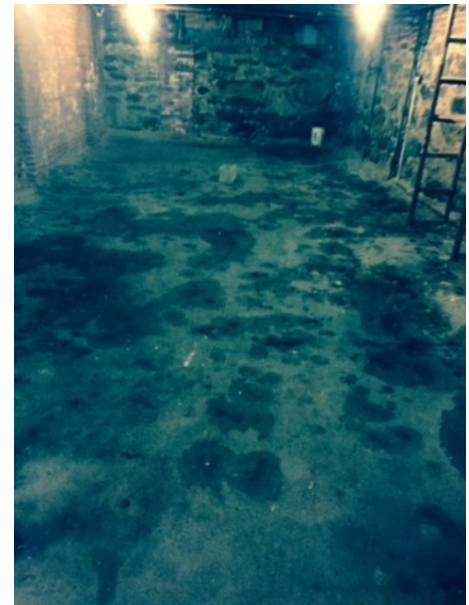
While no investigation into hidden voids or non-accessible spaces such as the underside of the roof, were performed during this visit, all framing is assumed to be heavy timber as is the floor framing which is visible from the basement below. The first floor framing, in the basement area does contain joists that have cracked, deflected or have been improperly cut to run piping or other items over the years and there are many joists that will require replacement or repair. Additionally, there is insufficient support at most joists.

Splitting, cracking and improperly supported joists (first floor framing)

- **Brick masonry bearing walls and piers:** All brick masonry bearing walls and piers should be repointed / repaired as required.
 - **Cracked, split or improperly cut joists:** All joists that have failed or have been improperly cut should be replaced or repaired with an approved method.

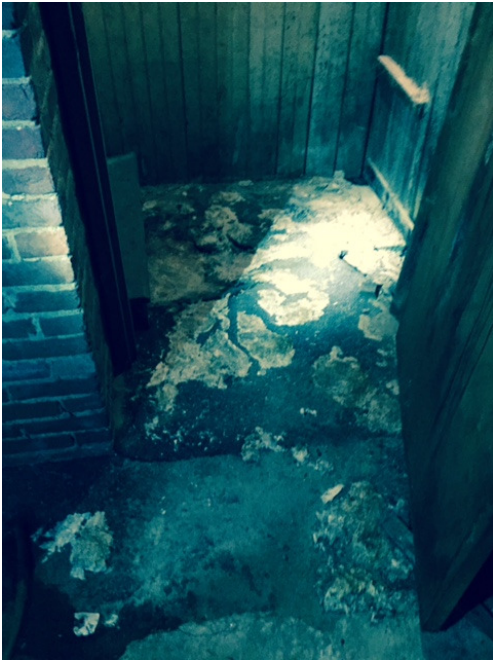
Repeat sewerage issues at basement

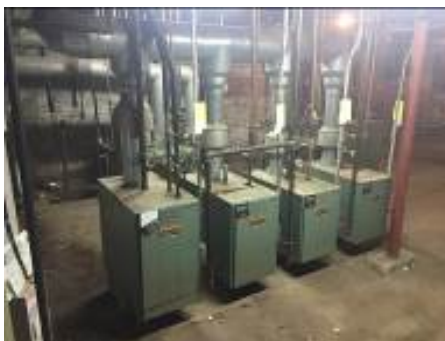
First Floor Boilers

First floor is associated with (4) Peerless firetube boilers, model MMW-85 which were replaced approximately twenty years ago. Each boiler has a single galvanized breeching system from each boiler which combines into one and then exits into an existing masonry chimney. The system has a vertical non-insulated residential style expansion tank. The boiler or piping did not have any inline pumps associated with it, the facility personnel were unaware of any pumps in the system. The boiler plant provides heating for the two suites and the restaurant. There is a total of three programmable thermostats which appear to operate the boilers, zoning of the boilers was unknown however one would assume that the restaurant would utilize two boilers while the other two boilers are used for the two suites.

- **Hot Water Plant:** The existing hot water plant including boilers, pumps, controls and accessories should be replaced.
- **Ventilation:** Mechanical ventilation system should be added for entire building. Most spaces rely on operable windows currently with the exception of two spaces on first floor which have none.

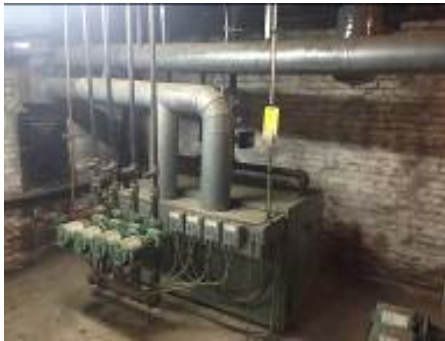
Second Floor Boilers

Second floor is associated with (1) Peerless firetube boiler, model G-1361 which was replaced approximately twenty years ago. The boiler has two galvanized breeching flues which combine into one and then exits into an existing masonry chimney. The system has a vertical non-insulated residential style expansion tank. The hot water produced is circulated throughout the second floor through the use of four inline Taco pumps, each with a 1/8HP motor. The boiler plant provides heating for nine suites located on the second floor including the main lobby. There is a total of four programmable thermostats which appear to operate the boiler and the associated inline pumps. Each zone utilizes an inline pump which is activated through the thermostat. The location of the thermostats appears to be arbitrary and not consistent throughout the building.

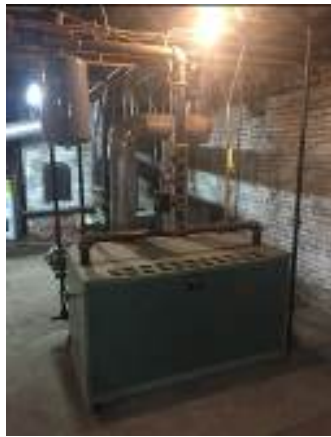
Third Floor Boiler

Third floor is associated with (1) Peerless firetube boiler, model G-1361 which was replaced approximately twenty years ago. The boiler has two galvanized breeching flues which combine into one and then exits into an existing masonry chimney. The system has a vertical non-insulated residential style expansion tank. The hot water produced is circulated throughout the third floor through the use of four inline Taco pumps, each with a 1/8HP motor. The boiler plant provides heating for two large suites located on the third floor. There is a total of four programmable thermostats which appear to operate the boiler and the associated inline pumps. Each zone utilizes an inline pump which is activated through the thermostat. Each of the large suites have two segregated areas within them, each area is equipped with its own programmable thermostat.

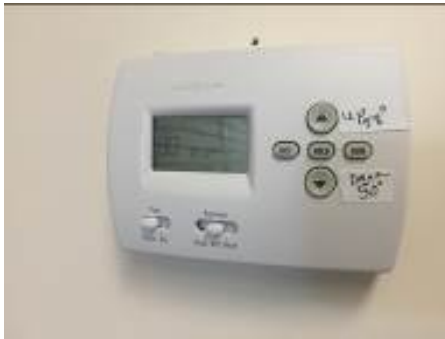
Typical Programmable Thermostat

The building is equipped with standalone electronic controls. Programmable thermostats are utilized to activate the boiler relays which in turn activate the boiler, depending on the thermostat the associated inline pump will also be activated. Overall the functionality of the existing control system is not adequate nor is it energy efficient. Complaints of spaces overheating or under heating is typical throughout the building which causes uncomfortable temperatures for the occupants. A complete upgrade of this system or a refined zoning approach should be provided. Ultimately a direct digital control system with web access should be considered, this would provide far better comfort and energy usage for each suite as well as providing off site monitoring and alarm notifications via text or email.

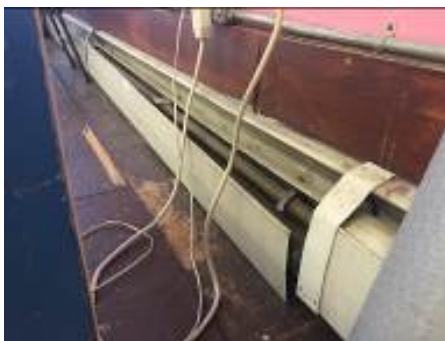
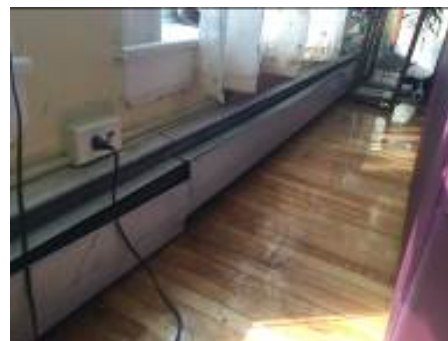
Typical Fin Tube Radiation

Temperature controls for the suites are accomplished with wall mounted programmable thermostats. Some of the suites are not provided with any thermostats and rely on the suite/occupant with the thermostat to control the overall temperature. This condition provides over and under heating of spaces and new temperature controls should be considered. **Overall all, the heating elements within all of these suites are in poor condition and should be replaced.**

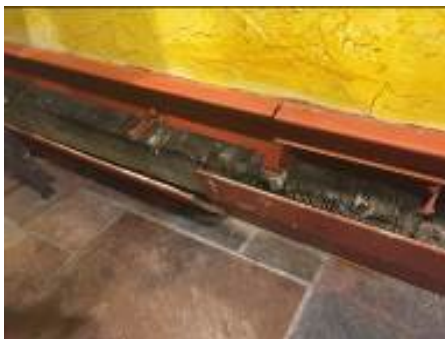
Basement Fin Tube

Within the restaurant space on the first floor there is a basement and upper restaurant area. Both areas utilize fin tube radiation for heating however they utilize split cooling systems for air conditioning. The basement of the restaurant is equipped with two one and half ton units which are in poor condition and in need of replacement. These units are antiquated in nature, missing covers, have broken vents and appear to have potential issues with condensate removal. The first floor part of the restaurant utilizes three ducted indoor air handling units which are connected to a duct distribution system, all of which is located above the ceiling. This ducted system terminates at ceiling mounted grilles throughout the restaurant. These units are associated with three outdoor air cooled condensers, insulated refrigerant piping connects the two components. Each of the three units are controlled via wall mounted programmable thermostats, all are manufactured by Honeywell. All of these units appear to be in good condition. The kitchen which is located on the first floor is provided with fin tube radiation for heating and is also equipped with a commercial grade kitchen hood. The hood is provided with an exhaust system which consists of an exterior wall mounted commercial grade exhaust fan with a grease trap. The exterior fan is connected to the hood through a stainless steel exhaust duct. The exhaust fan itself is controlled through a wall mounted push to start button, the fan is functioning and in fair condition. There does not appear to be a dedicated makeup air unit for the kitchen therefore when the kitchen hood exhaust fan is activated a negative pressure is created throughout the restaurant which in turns creates higher infiltration rates through the exterior walls, this relates to higher energy usage for heating and cooling.

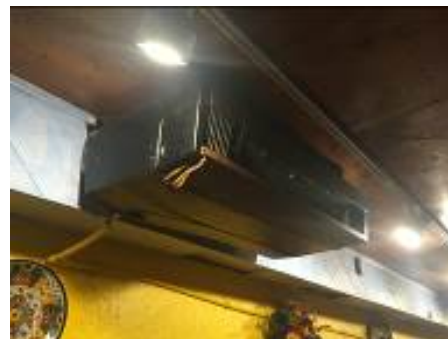
Basement Cooling Unit

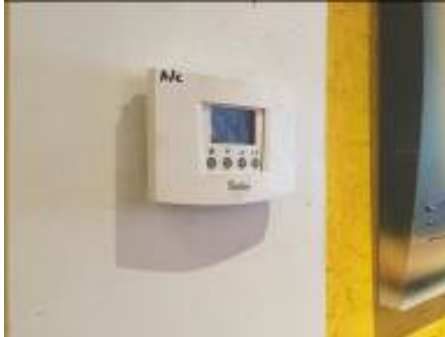
AC Thermostat

Depending on the future use of the building and if individual utilities will be subdivided according to the number of suites created, consideration should be given to providing individual high efficiency HVAC building systems for each suite. This would eliminate temperature control issues, eliminate excessive energy usage and provide individual metering of utilities for rental purposes. If this approach is not feasible then the building as a whole can be tempered through the use of one large boiler plant which would have as many zones as there are suites. The boiler plant could be a condensing type system which would offer higher energy savings during those swing months where high temperature water is not required. Zoning for each suite could easily be done with a direct digital control system or a specific zoning control package such as a Taco Zone Valve Control Panel. Either option would provide higher energy efficiencies than the current systems that are installed.

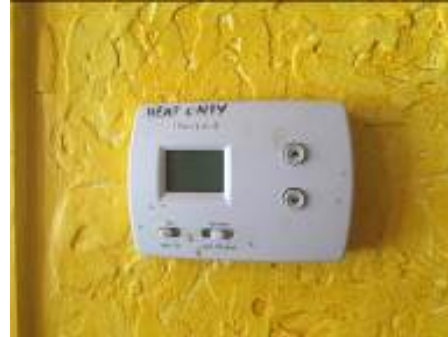
Heating Thermostat

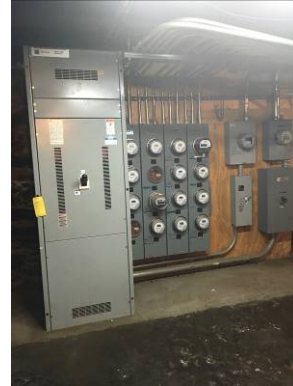
Main Breaker & Meter Center

The Switchgear is generally in fair to poor condition and has outlined it's intended useful life. One of the panels in the third floor consists of plug-in fuses and knob and tube wiring, it is not clear if it is still live.

- Replace meter center with new, due to its age and condition. The main breaker and service may remain.
- Replace tenant panels, feeders and all Romex branch wiring as spaces undergo renovations.

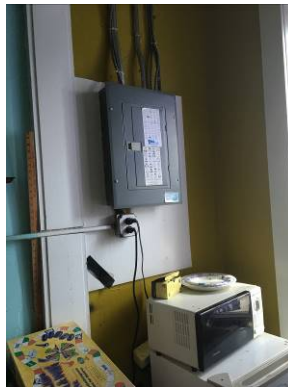
The tenant panels are located remotely at each tenant space and are typically rated at 100Amps, 120/208V, 1Ø, 3W main lug only. Each remote 100Amp panel is fed with 1" conduit from the meter center. Some of the panels are shared with more than one tenant in which case the Owner pays the electric bill. The meter center and remote panels were Manufactured by Sylvania GTE. Most panels are full.

Typical Tenant Panel

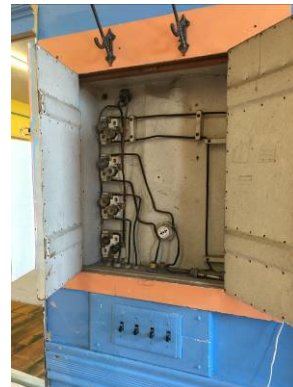
Flush Fusible Knob & Tube Panel

- Remove all lights and panels fed with knob and tube wiring.
- Replace common area and tenant lights with energy efficient LED sources.
- Provide occupancy sensors to conserve energy.

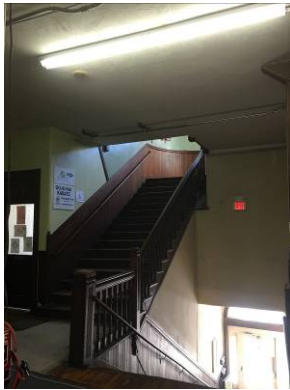
Common area lighting ranges from circline fluorescent fixtures to 8' strips with T12 lamps generally in poor condition. Elevator lobbies have surface mounted circline fixtures generally in good condition.

Common Area Strips

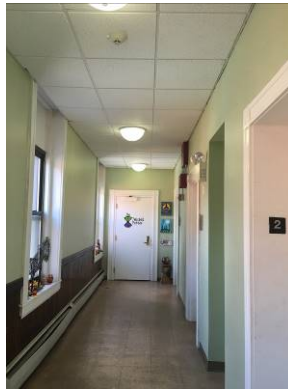
Elevator Lobby Lights

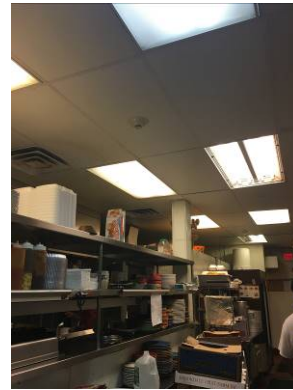
The kitchen has 2x4 recessed troffers in poor condition., some missing lens.

Kitchen Lights

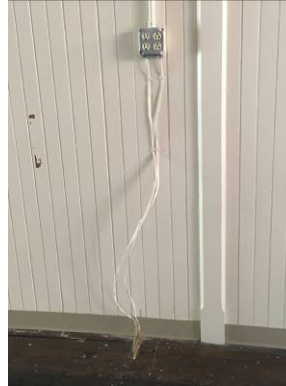
Receptacle density in most tenant spaces is minimal. Some receptacles have been improperly installed.

Tenant Receptacles

- Confirm that fire alarm device addresses match the numbering in tenant spaces.
- Replace improperly installed receptacles.
- Install a lightning protection system.

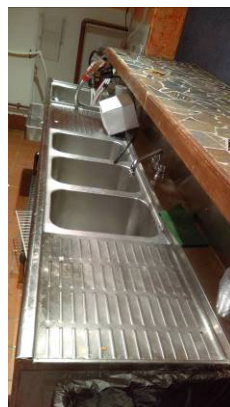
At the First Floor Restaurant, the Kitchen area fixtures are in fair condition. The pot washing sink is fitted with an on the floor grease interceptor. The dishwasher is currently not directed to a grease interceptor and the entire Kitchen drainage system is not directed to an exterior grease trap, which is inconsistent with current Plumbing and Sewer Code requirements.

Stainless Sink

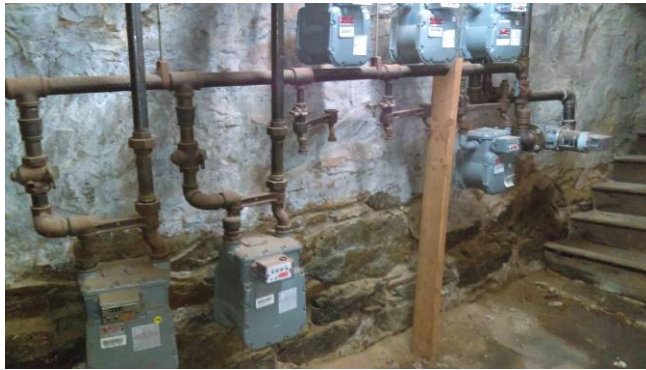
An elevated pressure natural gas service is supplied to the building. A pressure regulator reduces the elevated pressure to serve the Building equipment. Interior gas sub meters are located in the Basement. There is a total of (6) six sub meters. Each of the (4) four First Floor tenants has a small gas meter rated for 250,000 BTU's to serve a gas fired heating Boiler serving the respective Tenant. The gas fired water heater for the Restaurant is served from the meter dedicated to its space. The (2) two remaining sub meters are each serving a gas fired Boiler dedicated to the heating a floor, either Second or Third Floor.

Building Gas Meter

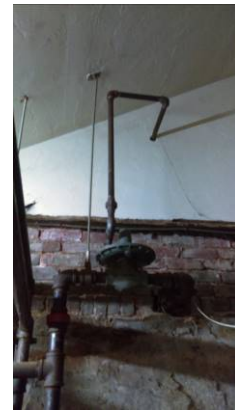
Building Gas Regulator

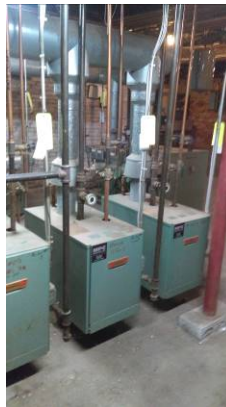
Gas Fired Boilers

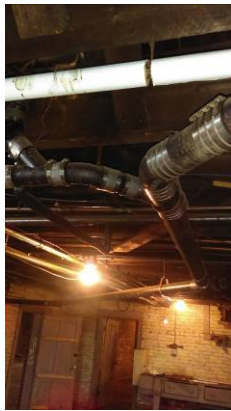
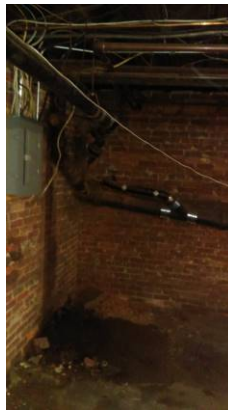
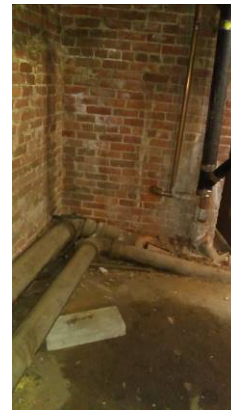
Cast iron is used for sanitary and storm drainage. Where visible, the cast iron pipe appears to be in fair condition. Smaller pipe sizes appear to be copper. It was reported by the staff that there are partial blockages in the drainage lines.

Typical drainage

In general, the cast iron drainage piping can be reused even in a major renovation where adequately sized for the intended new use.

- The original sanitary, waste, vent, Kitchen waste, vent and storm drainage piping should be video recorded by a Plumbing Contractor to determine the condition. Any leaks or blockages should be repaired. All horizontal storm drainage piping should be insulated to prevent condensation.
