TOWN OF SPENCER – LAKE STREET SCHOOL REMOVAL PROJECT

HAZARDOUS MATERIALS SURVEY REPORT

FORMER LAKE STREET SCHOOL
17 LAKE STREET
SPENCER, MA 01562

June 8, 2023
Revised: July 14, 2023
Partner Project No. 22445977

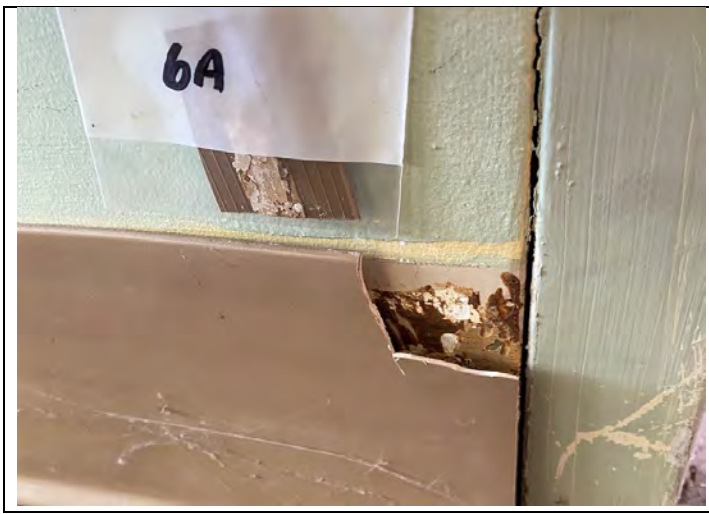
7. View of 6" tan base board

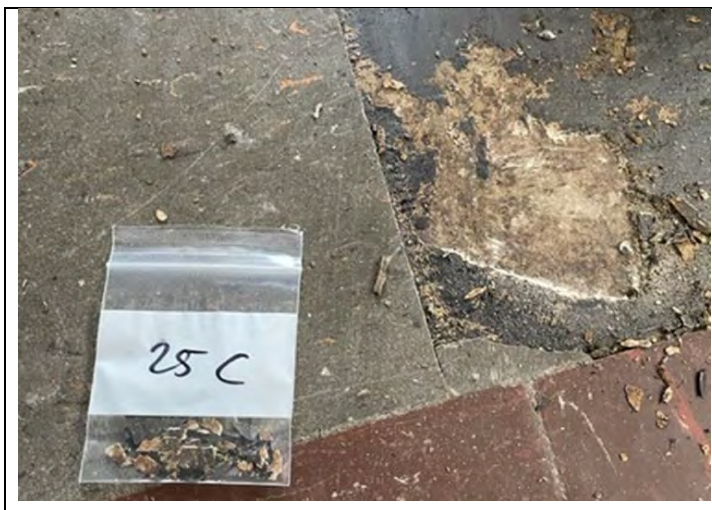
26. View of 12x12 black floor tile

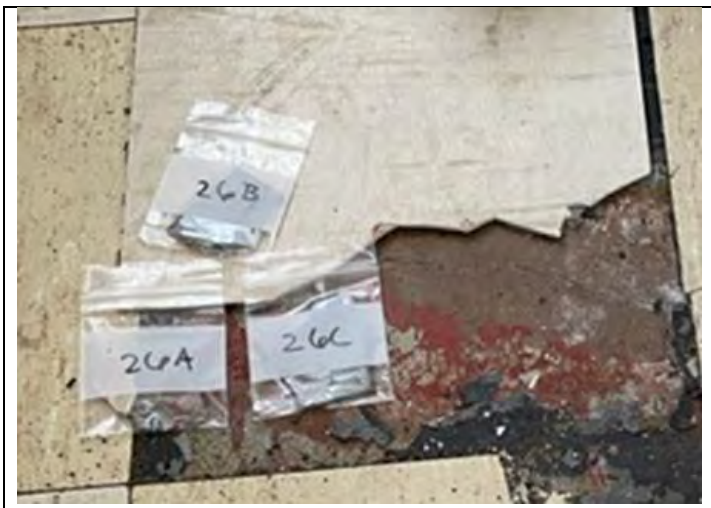
27. View of 12x12 white floor tile

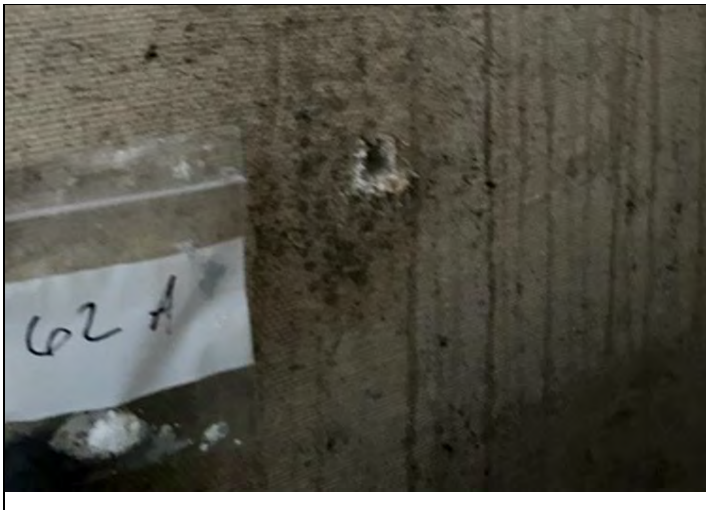
63. View of boiler TSI
