ROAD SAFETY AUDIT

Main Street (Route 9)
Elm Street to Maple Street (Route 31)

Town of Spencer

Prepared For: MassDOT Highway Division

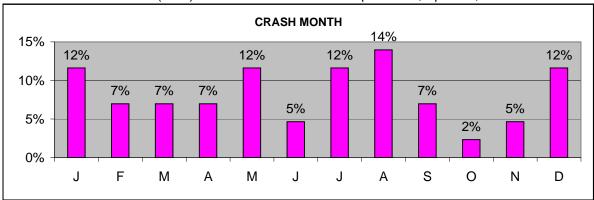
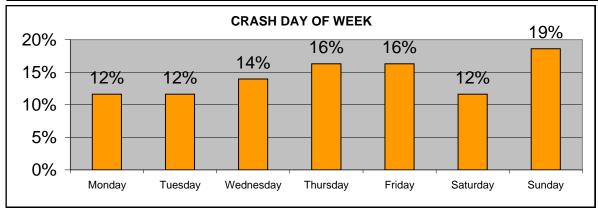
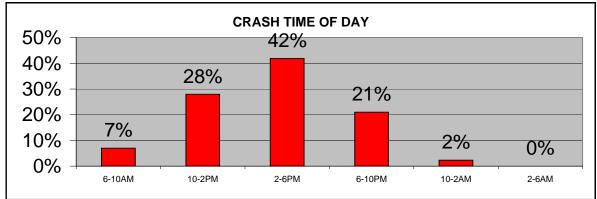
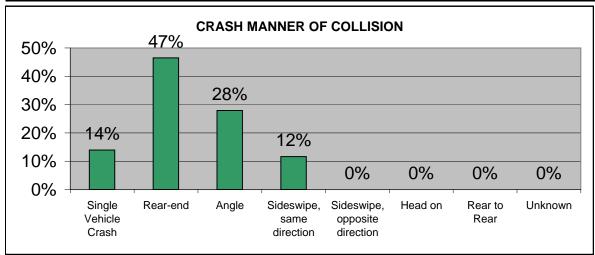
Crash Data Summary Tables and Charts

Main Street (Rt. 9) between Elm Street and Maple Street; Spencer, MA

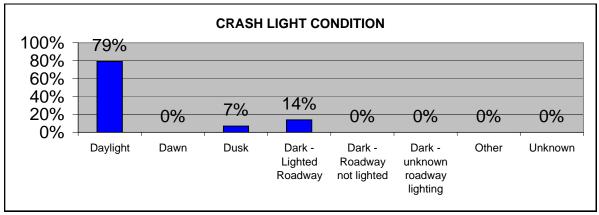
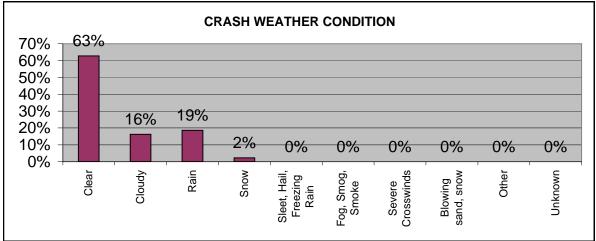
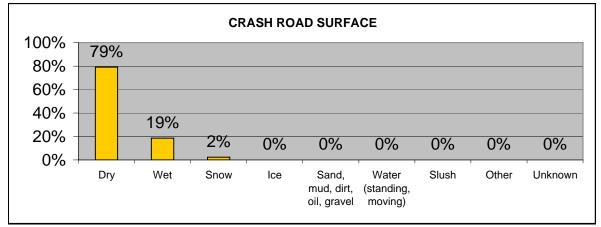
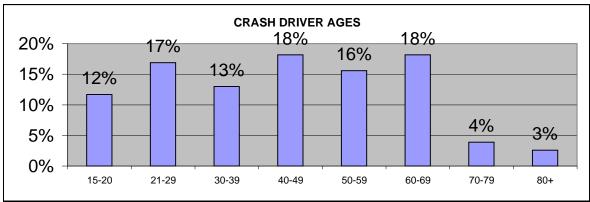
Crash Data Summary Tables and Charts

Main Street (Rt. 9) between Elm Street and Maple Street; Spencer, MA
