TOWN OF SPENCER – LAKE STREET SCHOOL REMOVAL PROJECT

HAZARDOUS MATERIALS SURVEY REPORT

FORMER LAKE STREET SCHOOL
17 LAKE STREET
SPENCER, MA 01562

June 8, 2023
Revised: July 14, 2023
Partner Project No. 22445977

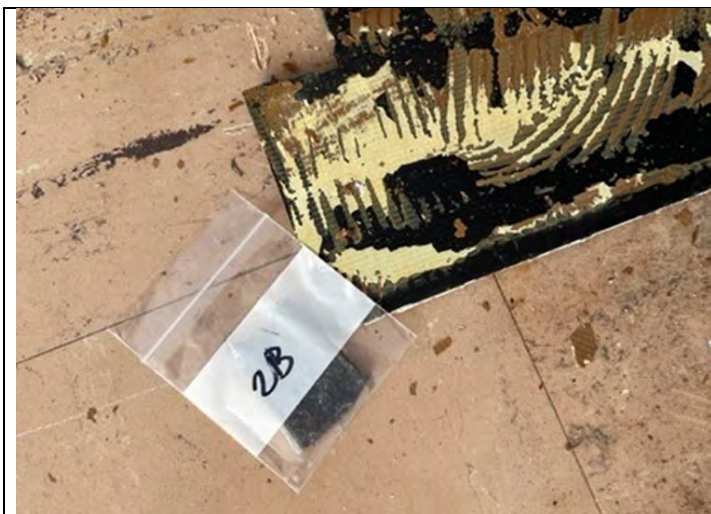
3. View of 6" black base board

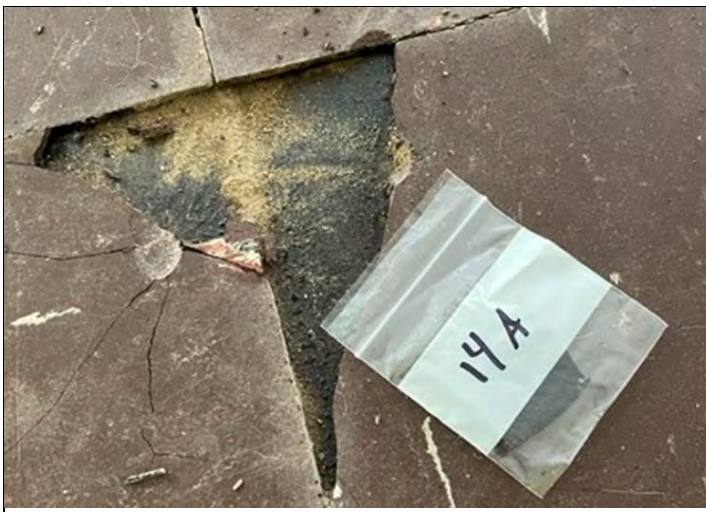
15. View of 9x9 red tile

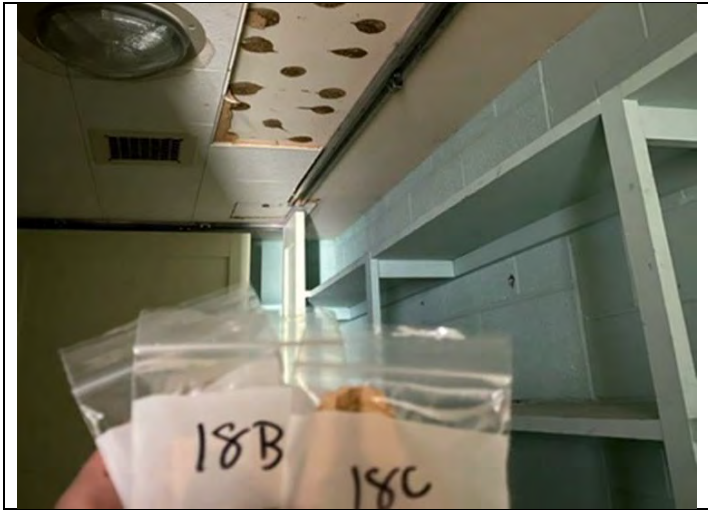
19. View of sound board

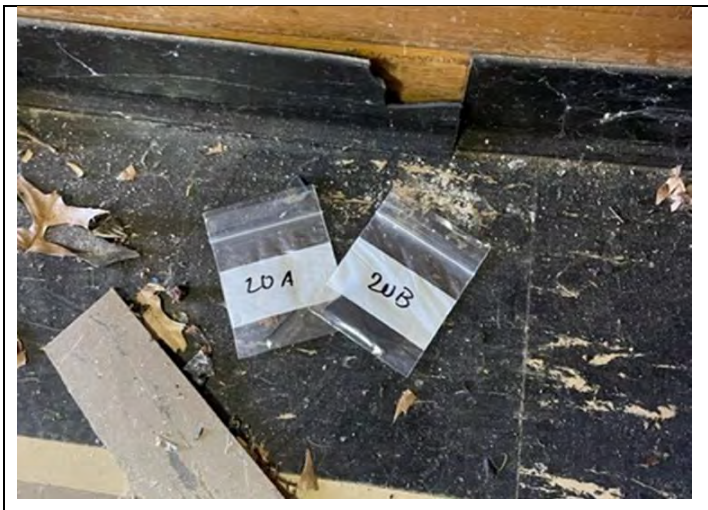
21. View of 4" black base board

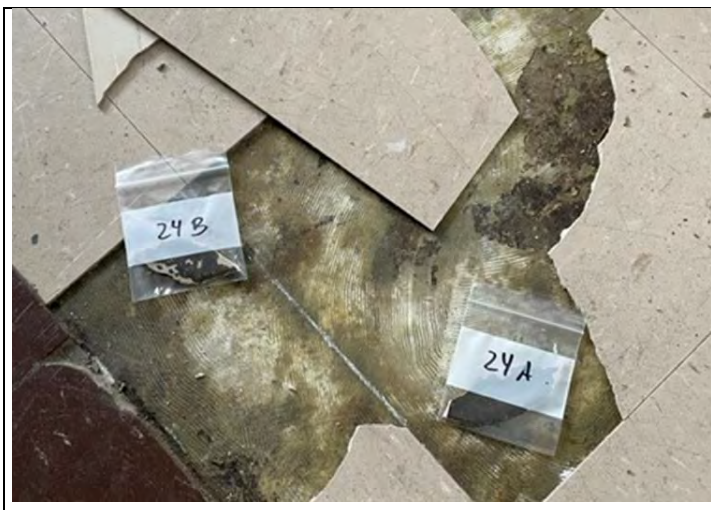
25. View of 12x12 tan floor tile

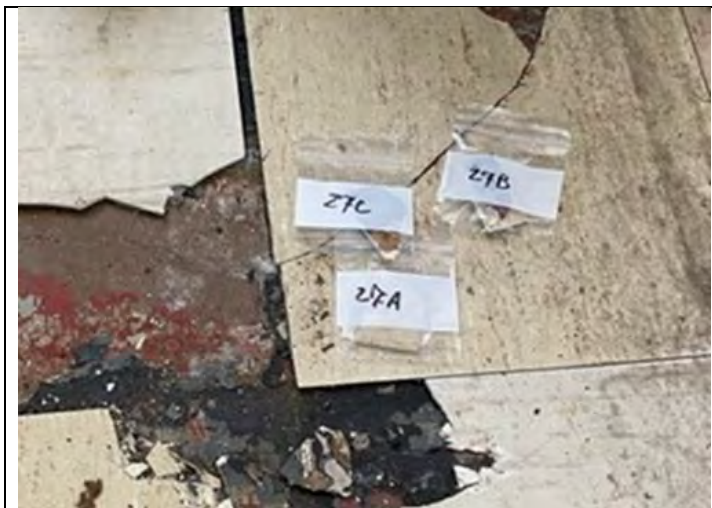
28. View of 12x12 beige yellow floor tile

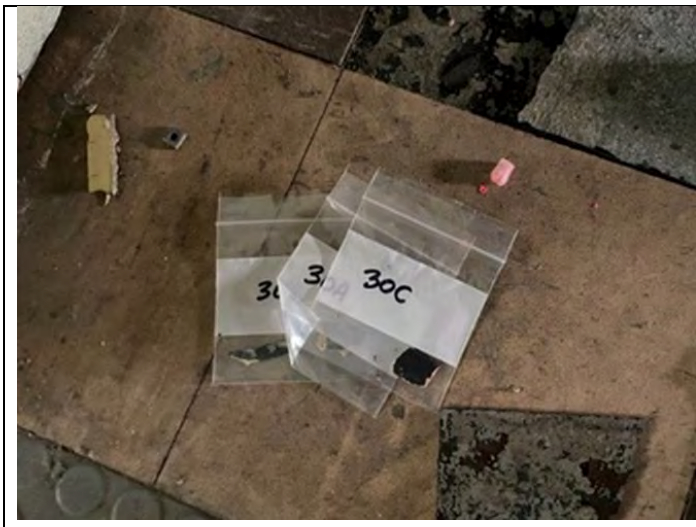
31. View of 9x9 white tile

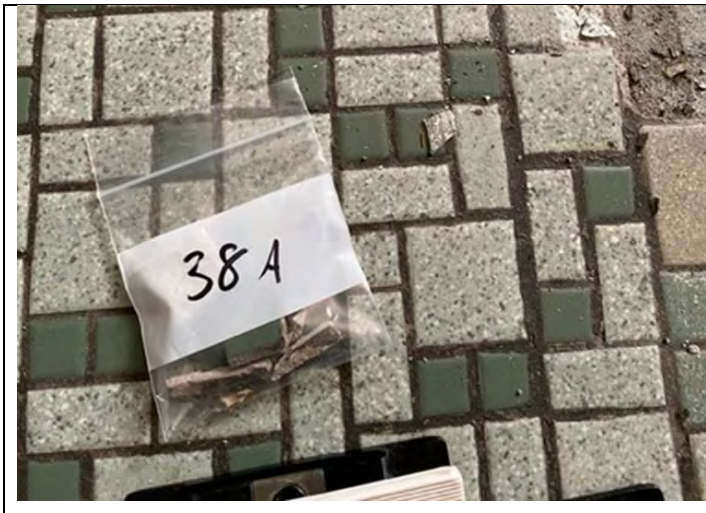
39. View of blue ceramic patterned flooring tiles

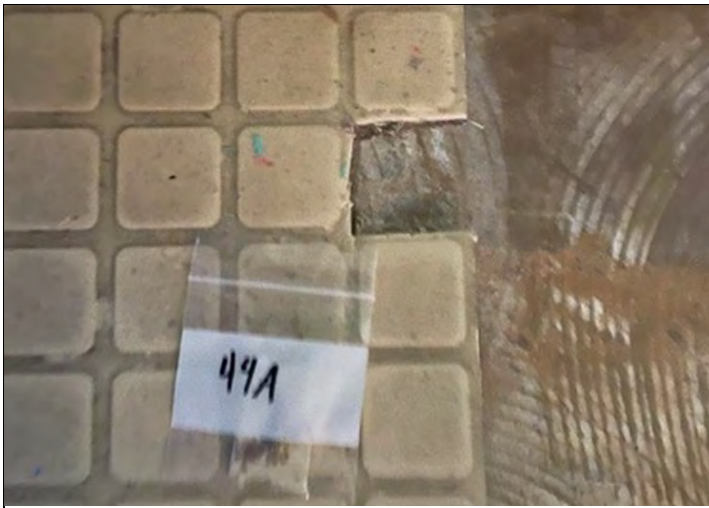
45. View of tan floor tread and tan mastic

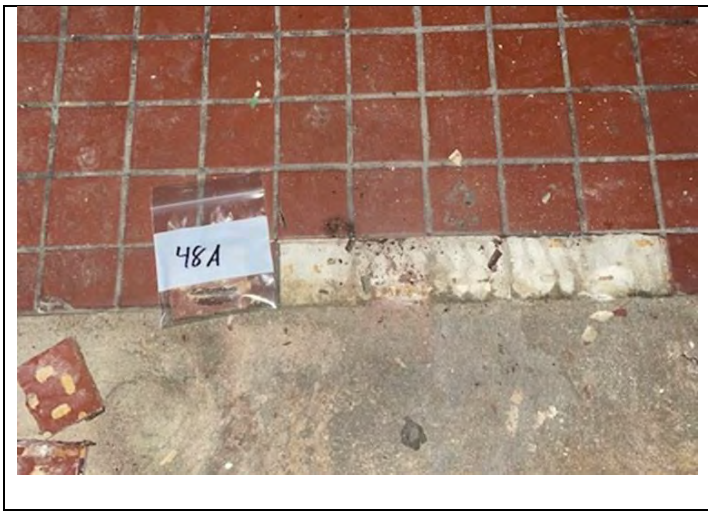
49. View of 2x2 red ceramic tile

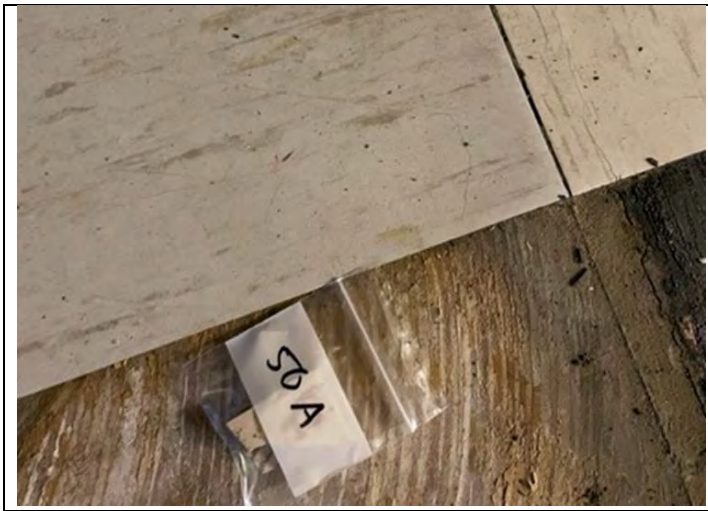
51. View of 12x12 white gray flecked flooring tile 1977

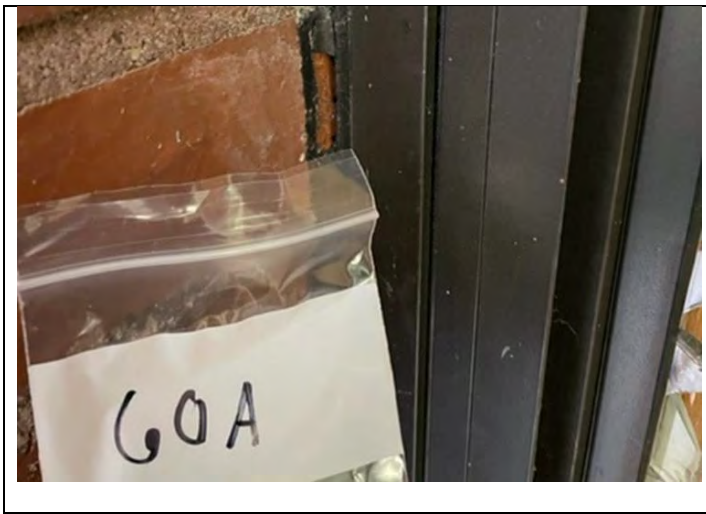
61. View of black window caulking

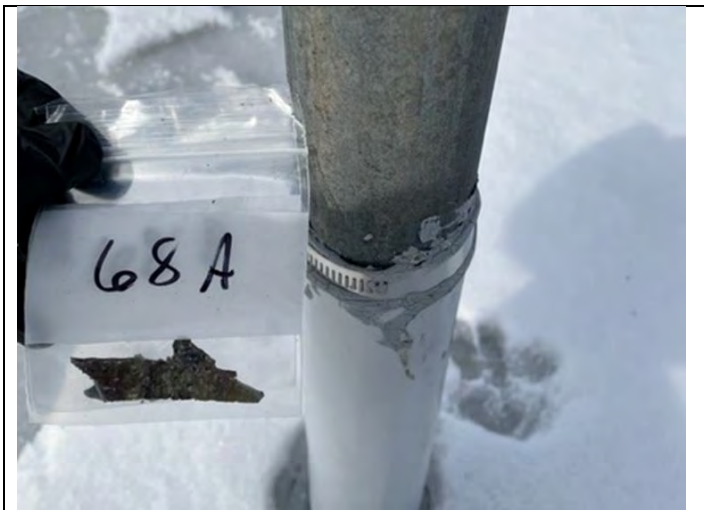
69. View of white chimney caulking

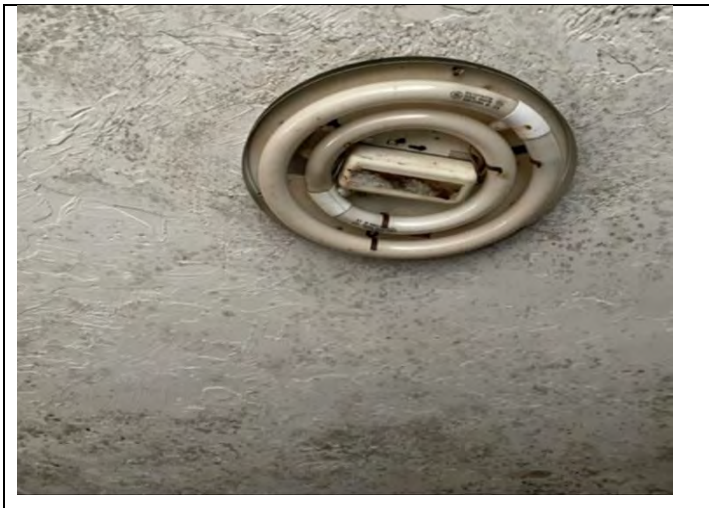
75. View of circular light

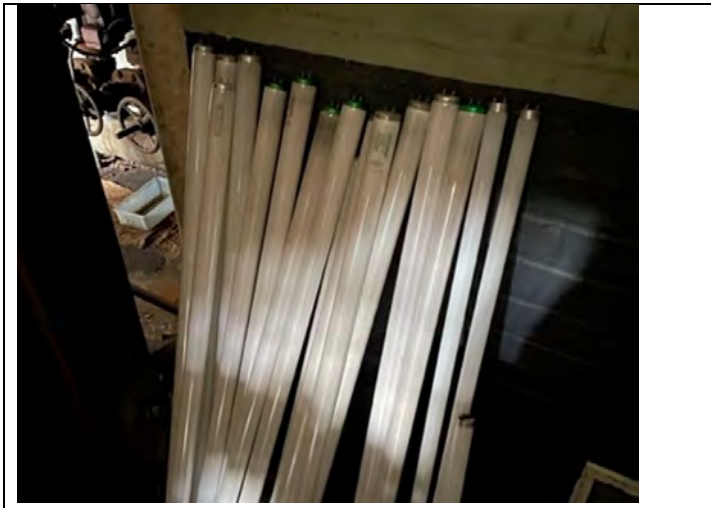
75. View of 4ft fluorescent lights
